Arborist Report for

Camp Ramah New Machon

385 Fairview Road

February 7, 2019

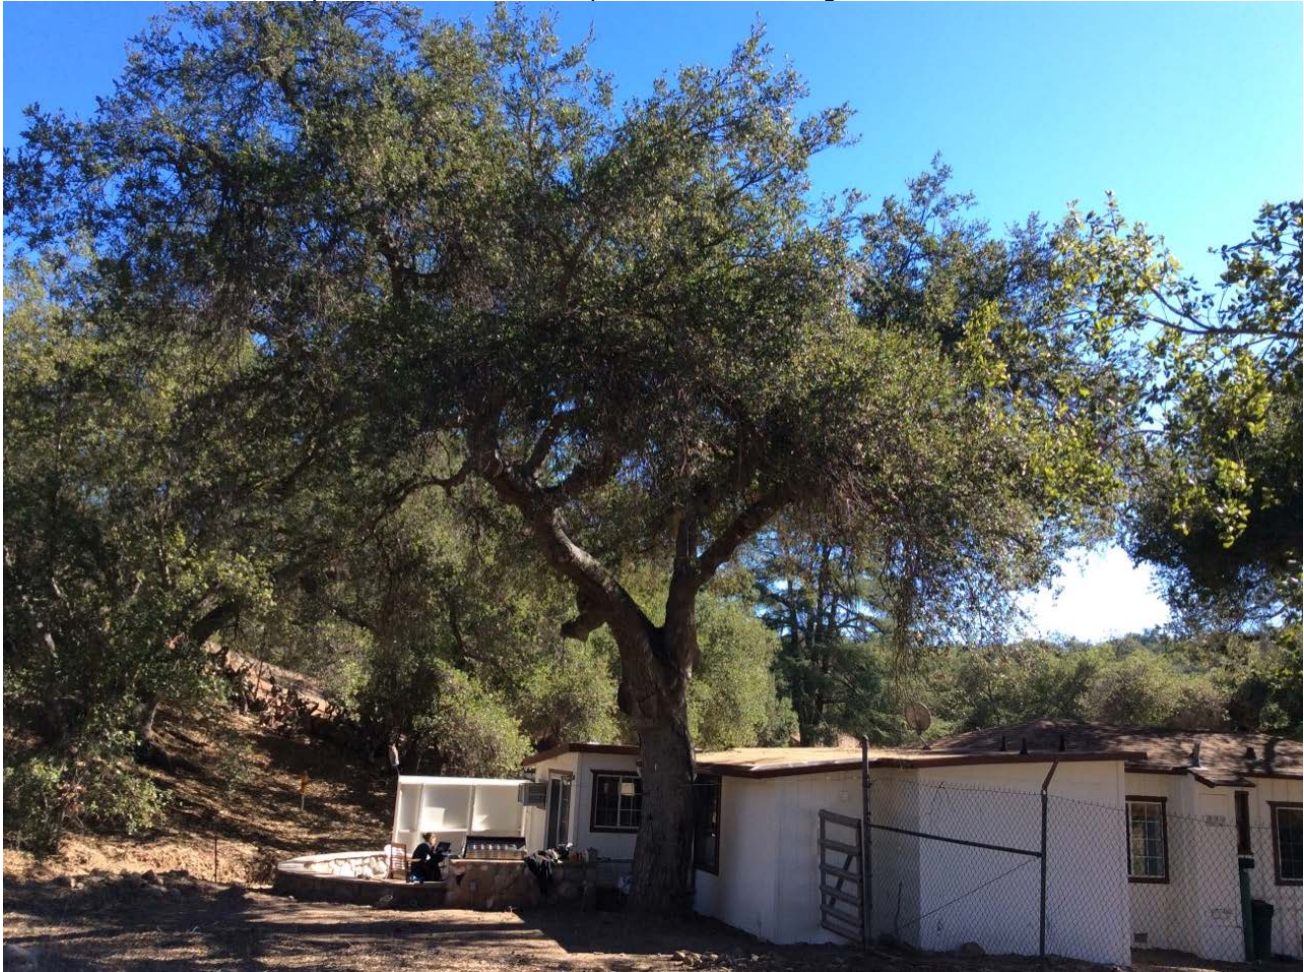
Tree Number: 387
Species: Coast Live Oak (*Quercus agrifolia*)
Number of Trunks: 1
Girth at 54": 97" (DBH 31") - Heritage
Height: 30'
Dripline: 40'
Observations: Scaffold limbs 90 degrees over residence
Overall Health: Good
Project Impact: None
Recommendations: Optional fence around dripline + 5' = 45' during construction, mulch

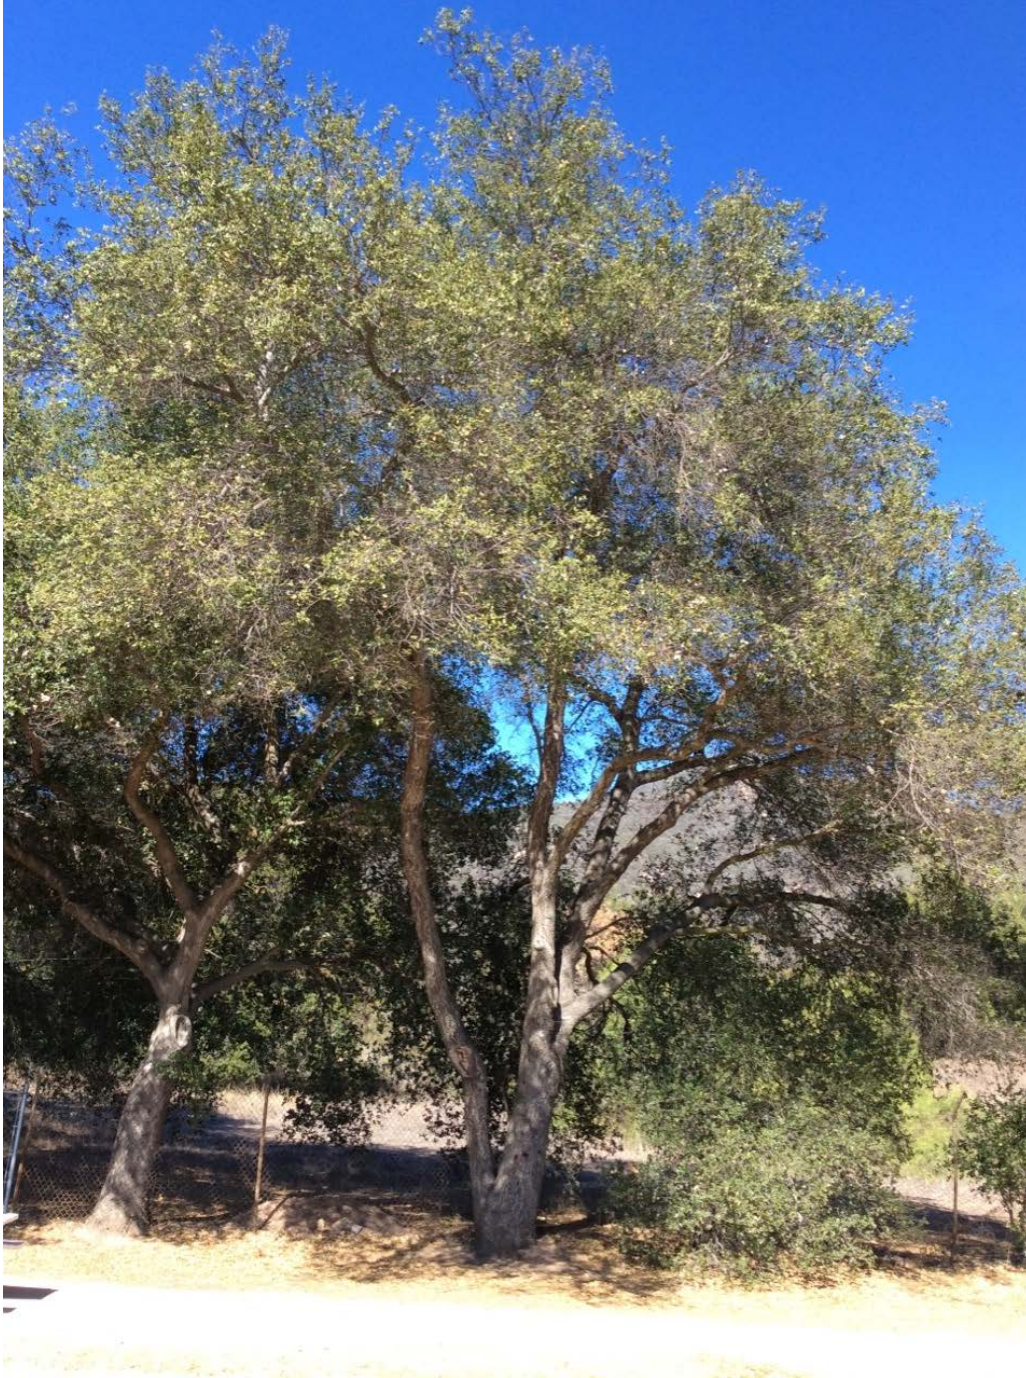
Tree Number: 395
Species: Coast Live Oak (*Quercus agrifolia*)
Number of Trunks: 2
Girth at 54": 115" (DBH 14" + 23" = 37") - Heritage
Height 40'
Dripline 50'
Observations: Crown raised, overextended branches, one scaffold leaning at 45 degrees
Overall Health: Good
Project Impact: None
Recommendations: Optional fence around dripline + 5' = 55' during construction, mulch

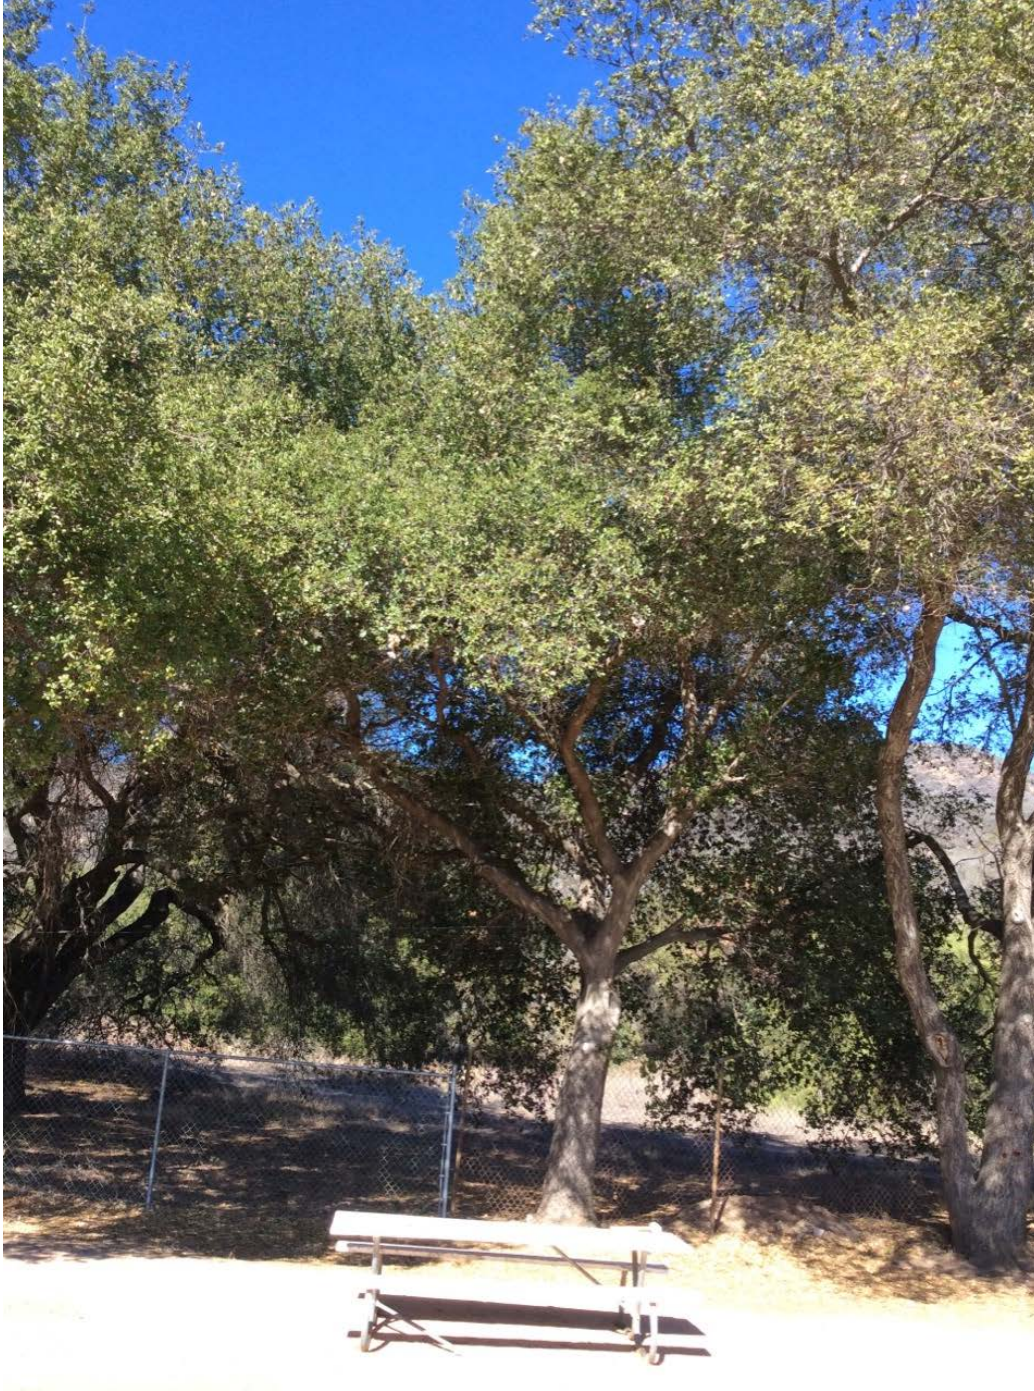
Tree Number: 396
Species: Coast Live Oak (*Quercus agrifolia*)
Number of Trunks: 1
Girth at 54": 62" (DBH 20")
Height 40'
Dripline 40'
Observations: Crown raised, reduced, next to table
Overall Health: Good
Project Impact: None
Recommendations: Optional fence around dripline + 5' = 45" during construction, mulch

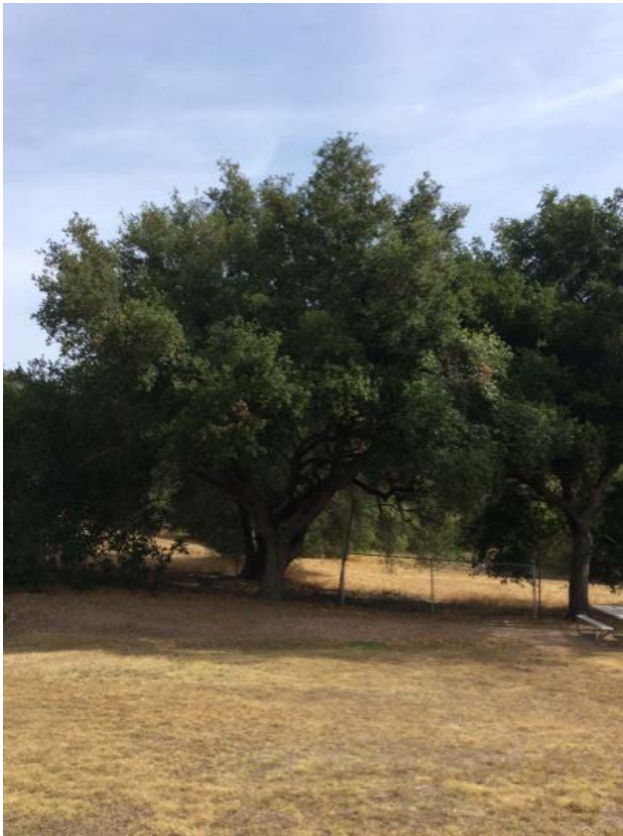
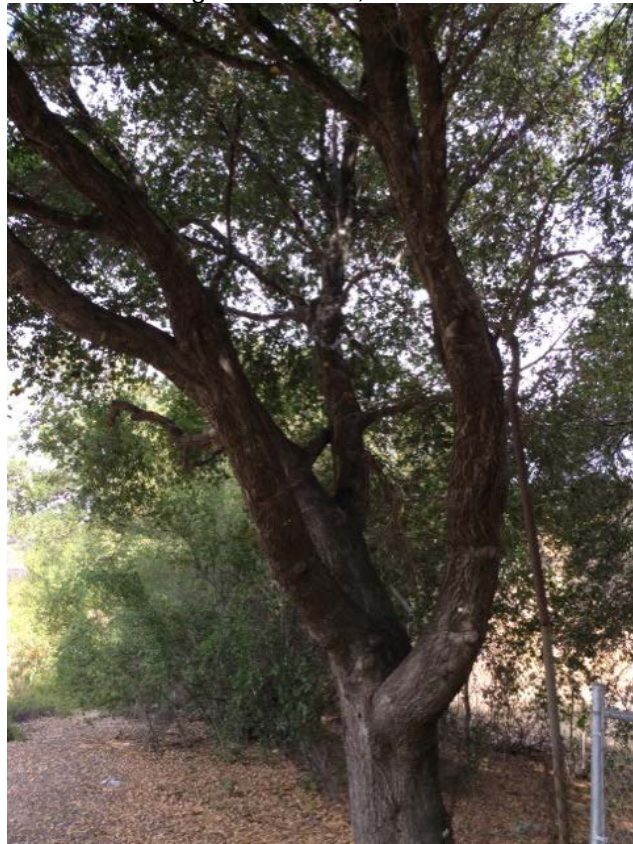
Tree Number: 397
Species: Coast Live Oak (*Quercus agrifolia*)
Number of Trunks: 1
Girth at 54": 80" (DBH 26")
Height: 40'
Dripline: 45'
Observations: Crown raised, overextended branches, next to table
Overall Health: Good
Project Impact: None
Recommendations: Optional fence around dripline + 5' = 50' during construction, mulch

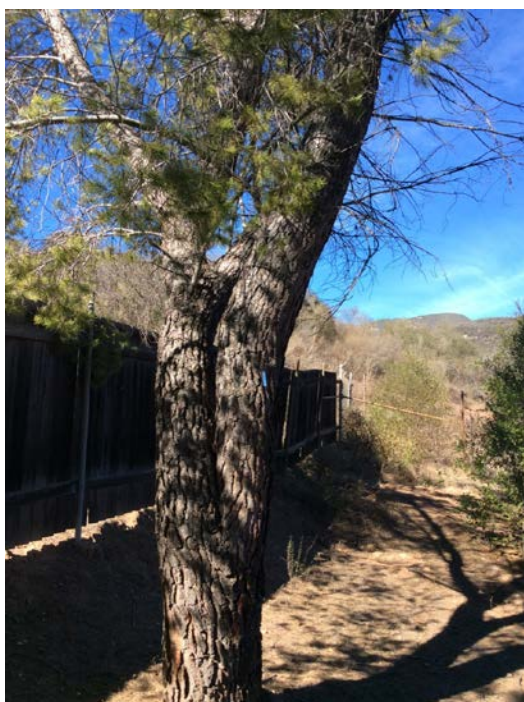
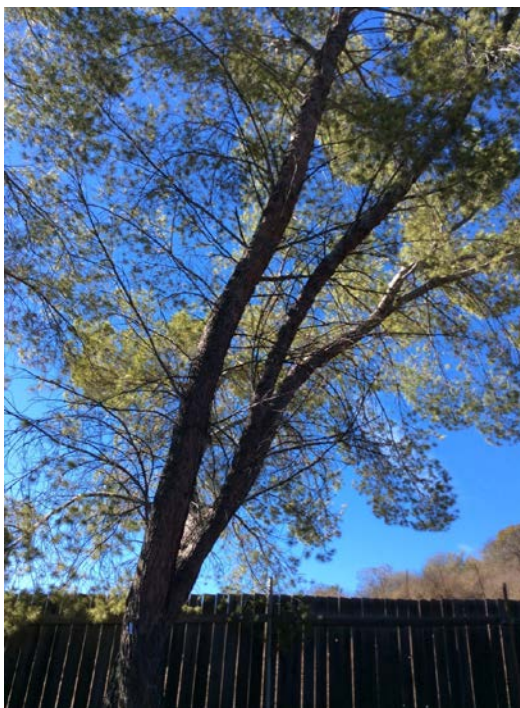
Tree Number: 398
Species: Aleppo Pinus – Pinus halepensis
Number of Trunks: 1
Girth at 54": 62" (DBH 20")
Height 60'
Dripline 35'
Observations: Leaning 30" girth trunk removed to improve safety
Overall Health: Died from insect infestation and removed
Project Impact: None
Recommendations: None

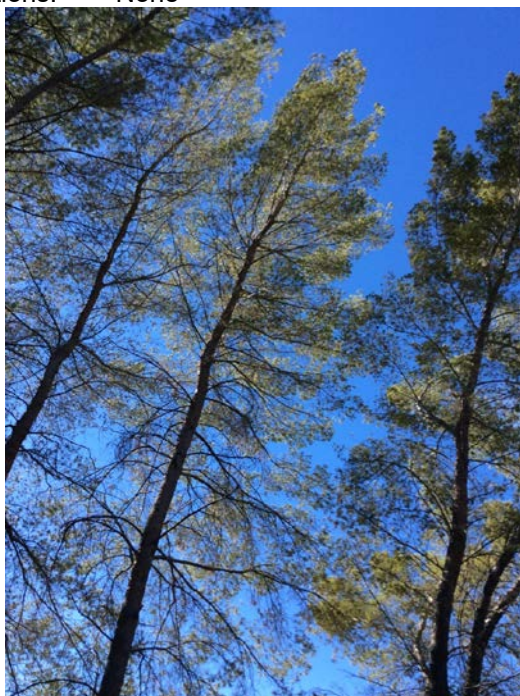
Tree Number: 399
Species: Aleppo Pinus – Pinus halepensis
Number of Trunks: 1
Girth at 54": 50" (DBH 16")
Height 65'
Dripline 30'
Observations: Lower dead branches have been removed
Overall Health: Died from insect infestation and removed
Project Impact: None
Recommendations: None

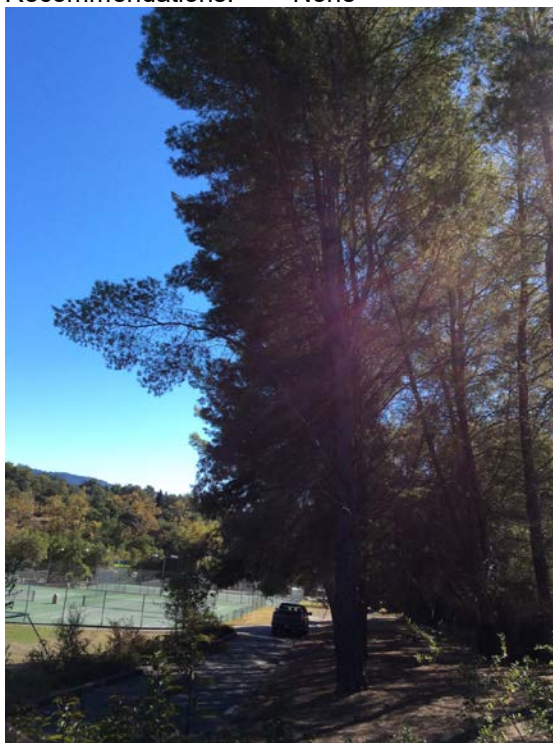
Tree Number: 401
Species: Aleppo Pinus – *Pinus halepensis*
Number of Trunks: 1
Girth at 54": 72" (DBH 23")
Height 80'
Dripline 30'
Observations: Upper codominant trunk has been removed for structural safety
Overall Health: Died from insect infestation and removed
Project Impact: None
Recommendations: None

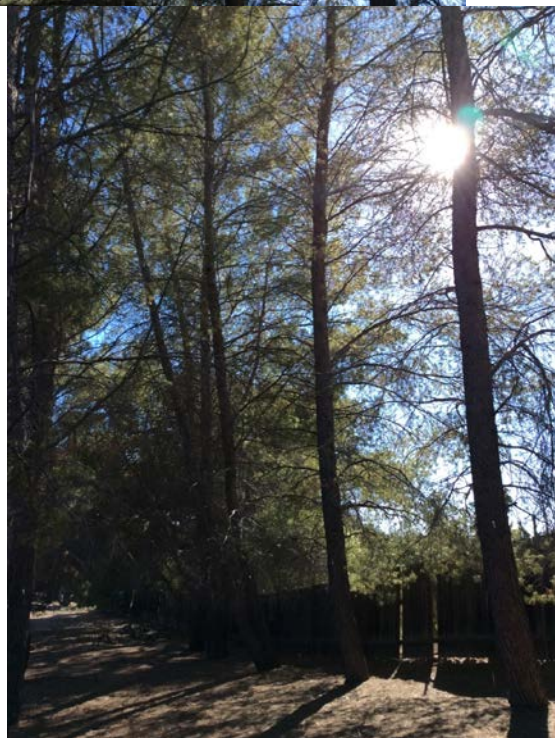
Tree Number: 403
Species: Aleppo Pinus – Pinus halepensis
Number of Trunks: 1
Girth at 54": 45" (DBH 15")
Height 70'
Dripline 30'
Observations: South codominant trunk removed for structural safety
Overall Health: Died from insect infestation and removed
Project Impact: None
Recommendations: None

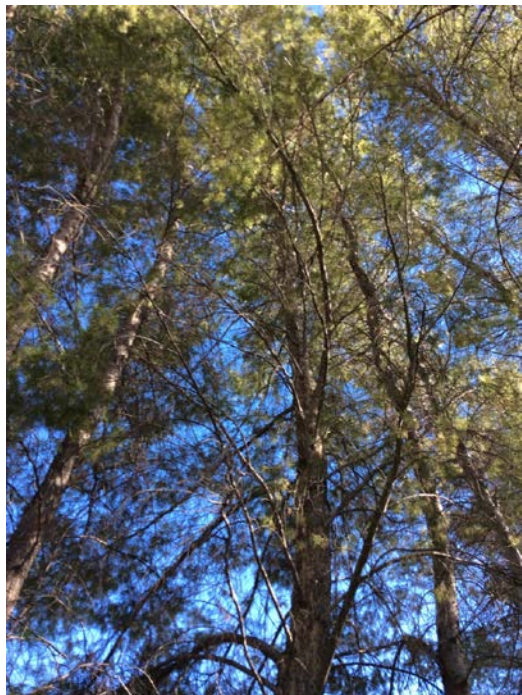
Tree Number: 404
Species: Aleppo Pinus – Pinus halepensis
Number of Trunks: 1
Girth at 54": 55" (DBH 18")
Height 80'
Dripline 30'
Observations: Dead branches removed for safety to people
Overall Health: Died from insect infestation and removed
Project Impact: None
Recommendations: None

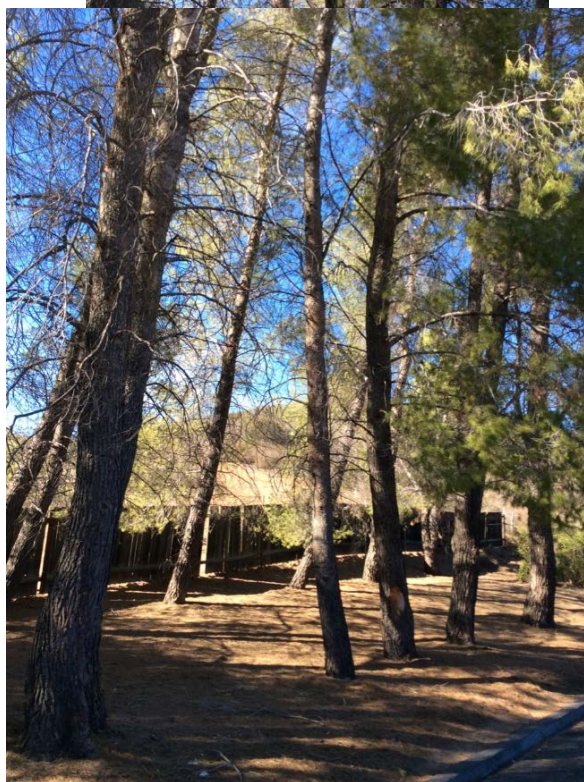
Tree Number: 405
Species: Aleppo Pinus – Pinus halepensis
Number of Trunks: 1
Girth at 54": 40" (DBH 13")
Height 80'
Dripline 30'
Observations: Dead branches removed for safety to people
Overall Health: Died from insect infestation and removed
Project Impact: None
Recommendations: None

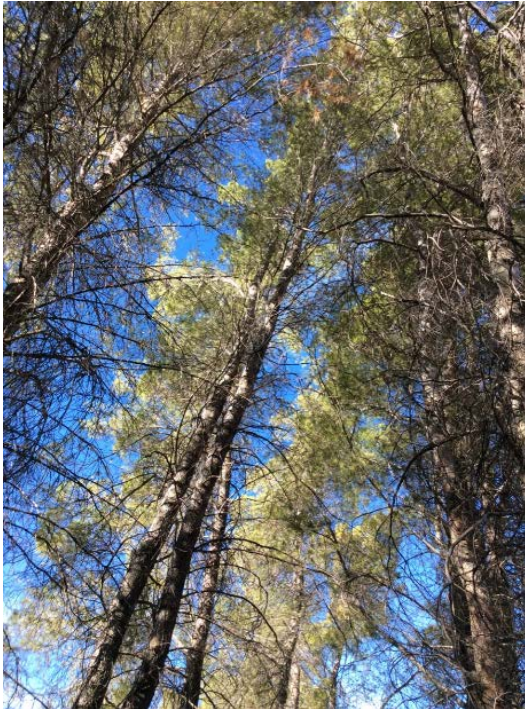
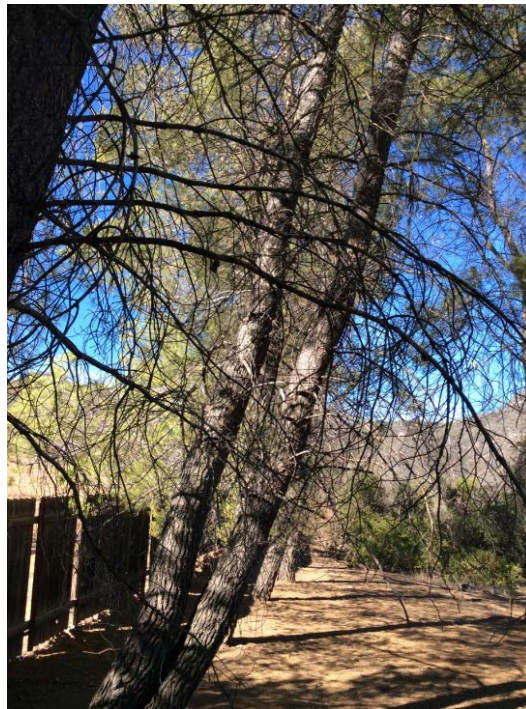
Tree Number: 406
Species: Aleppo Pinus – *Pinus halepensis*
Number of Trunks: 2
Girth at 54": 45" (DBH 12" + 13")
Height 70'
Dripline 30'
Observations: 12" DBH lower trunk removed for structural safety
Overall Health: Died from insect infestation and removed
Project Impact: None
Recommendations: None

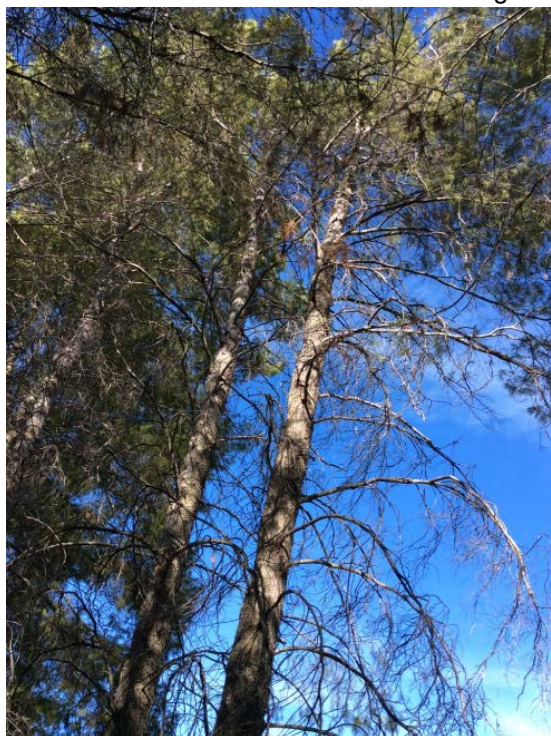
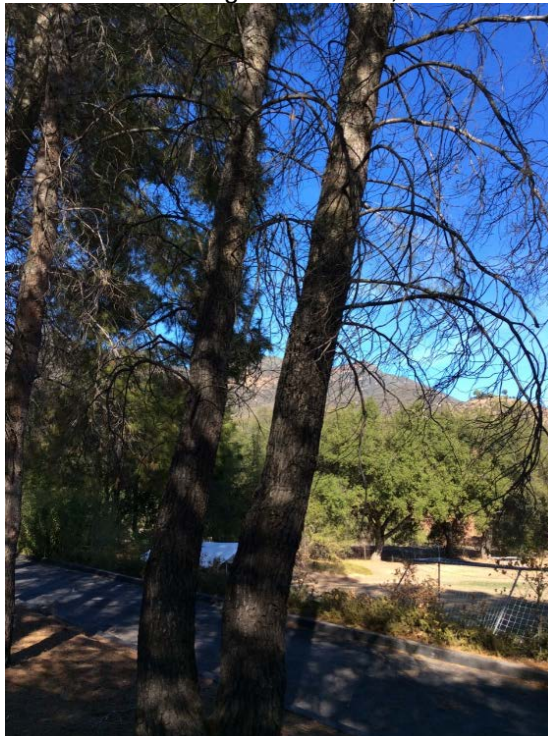
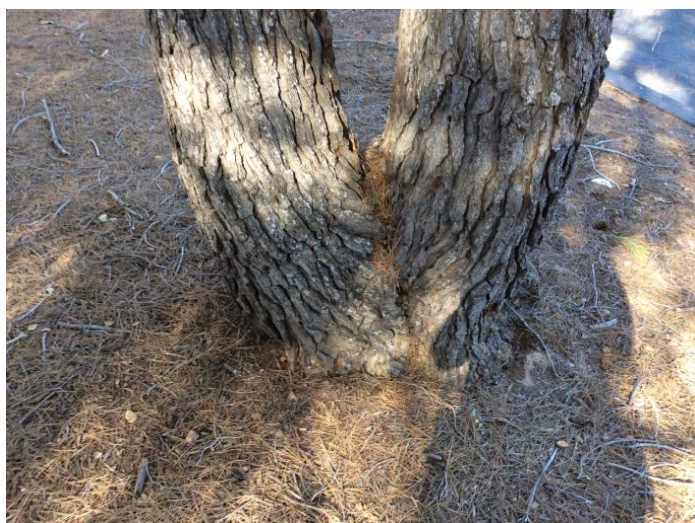
Tree Number: 407
Species: Aleppo Pinus – *Pinus halepensis*
Number of Trunks: 2
Girth at 54": 45" (DBH 16" + 18" = 34") – Not a protected tree
Height 80'
Dripline 30'
Observations: Two trunks cabled for structural safety. Root crown located about two feet from curb.
Overall Health: Good
Project Impact: Minimal if road widened on east side. See TPP
Recommendations: Install fence along west side of road during construction, mulch

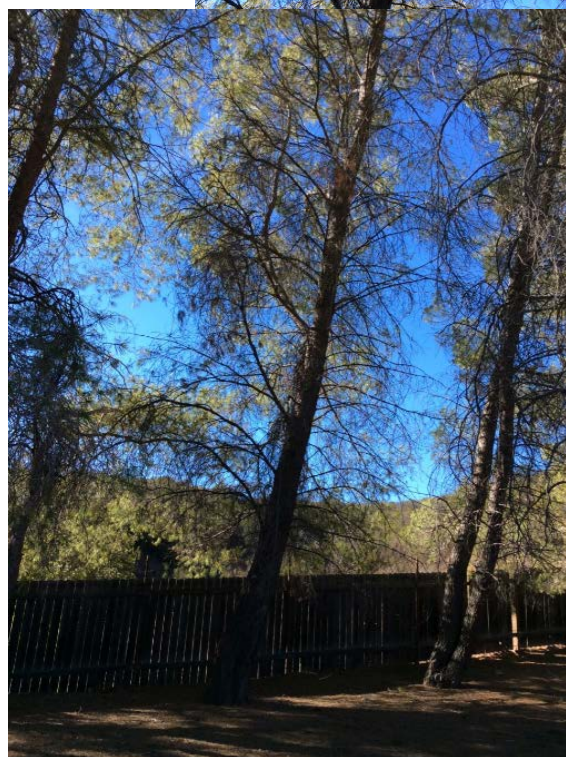
Tree Number: 408
Species: Aleppo Pinus – *Pinus halepensis*
Number of Trunks: 2
Girth at 54": 62" (DBH 20")
Height 70'
Dripline 30'
Observations: 20% trunk lean
Overall Health: Died from insect infestation and removed
Project Impact: None
Recommendations: None

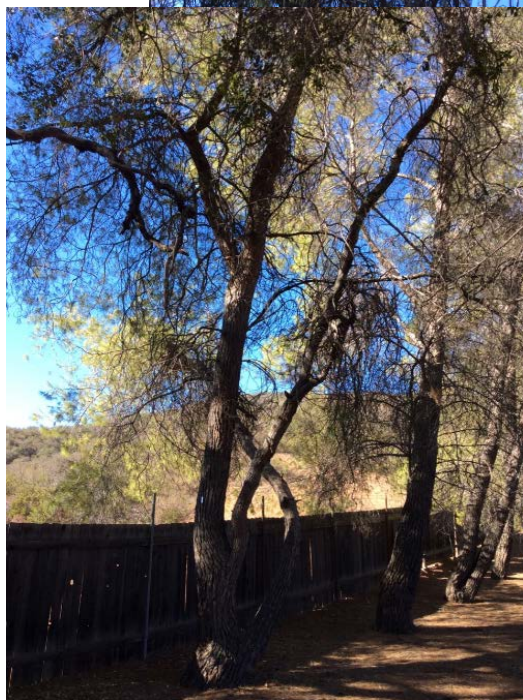
Tree Number: 409
Species: Aleppo Pinus – Pinus halepensis
Number of Trunks: 1
Girth at 54": 90" (DBH 29") - Heritage
Height 60'
Dripline 30'
Observations: two trunks 19", 10", codominant branches
Overall Health: Died from insect infestation and removed
Project Impact: None
Recommendations: None

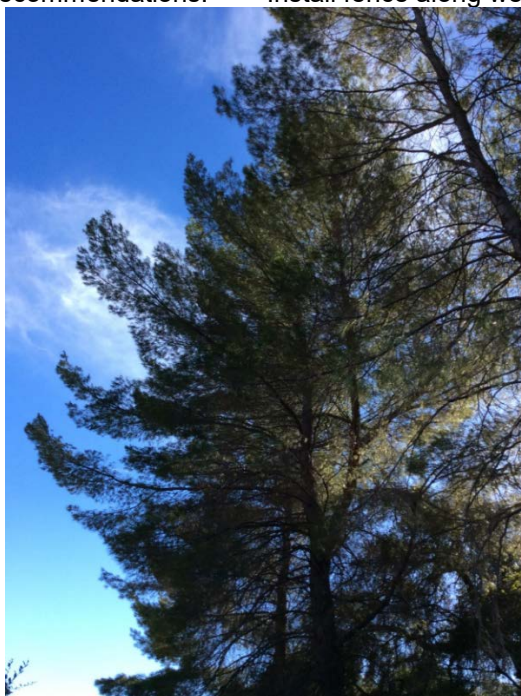
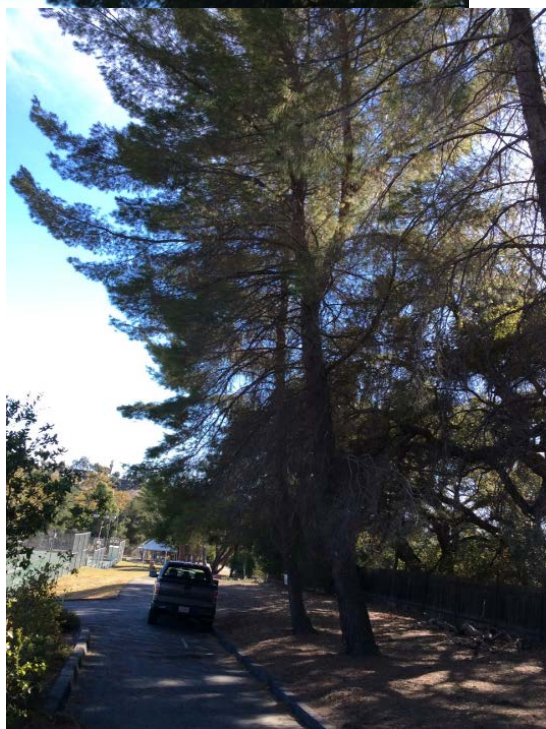
Tree Number	410
Species:	Aleppo Pinus – Pinus halepensis
Number of Trunks:	1
Girth at 54":	75" (DBH 24")- Not a protected tree
Height	70'
Dripline	40'
Observations:	Codominant branches. Root crown located about two feet from curb.
Overall Health:	Good
Project Impact:	Minimal if road widened on east side. See TPP
Recommendations:	Install fence along west side of road during construction, mulch

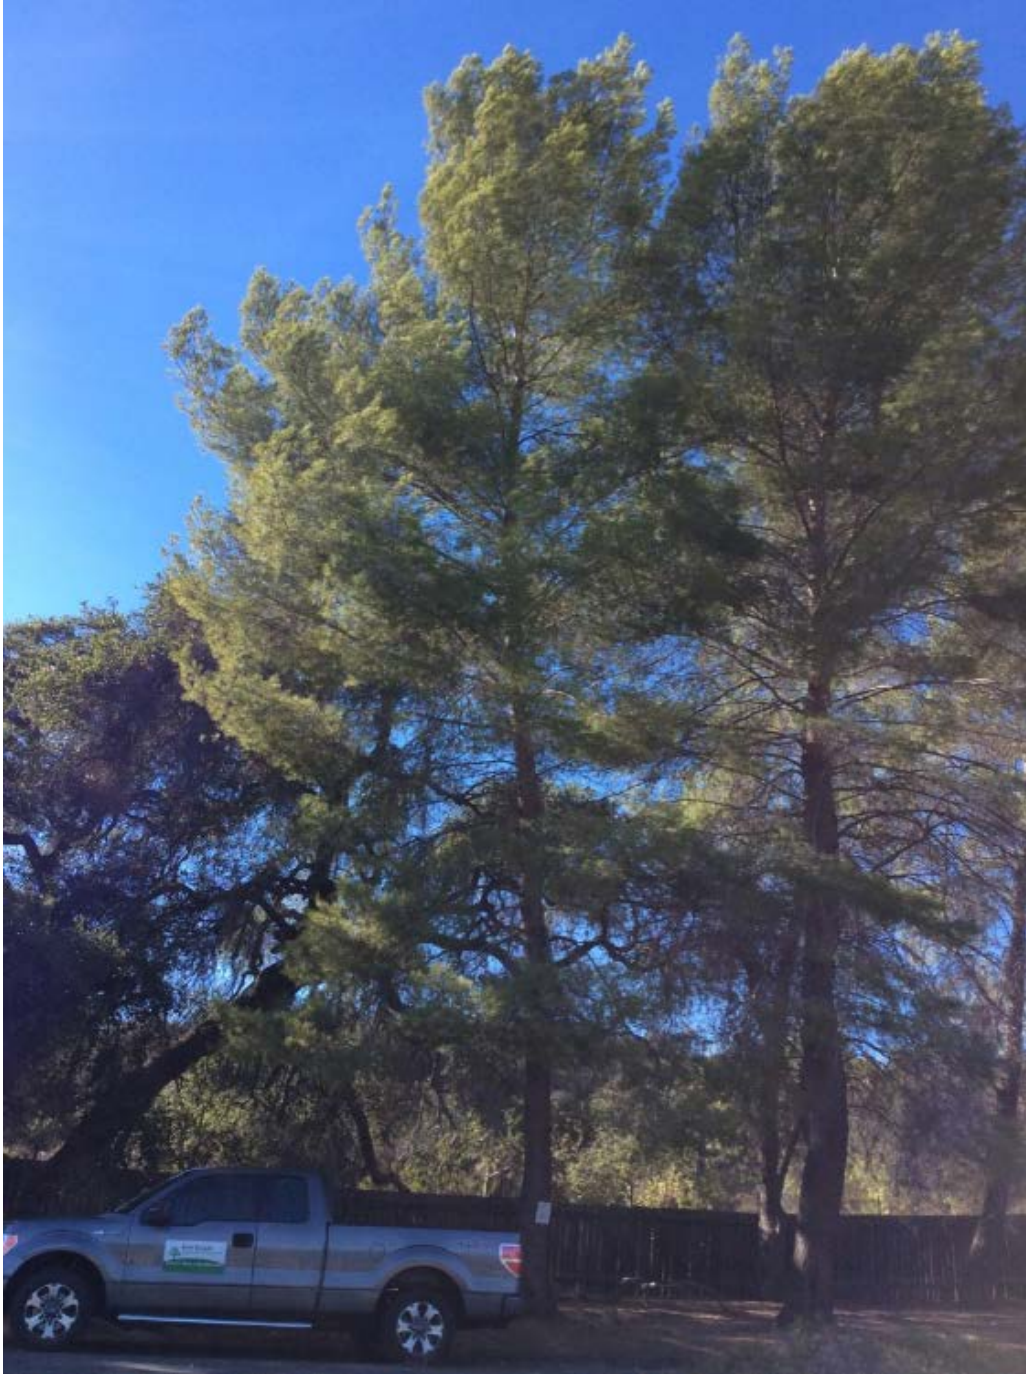
Tree Number	411
Species:	Aleppo Pinus – <i>Pinus halepensis</i>
Number of Trunks:	1
Girth at 54":	52" (DBH 17") – Not a protected tree
Height	60'
Dripline	50'
Observations:	Root crown located approximately two feet from curb.
Overall Health:	Good
Project Impact:	Minimal if road widened on east side. See TPP
Recommendations:	Install fence along west side of road during construction, mulch

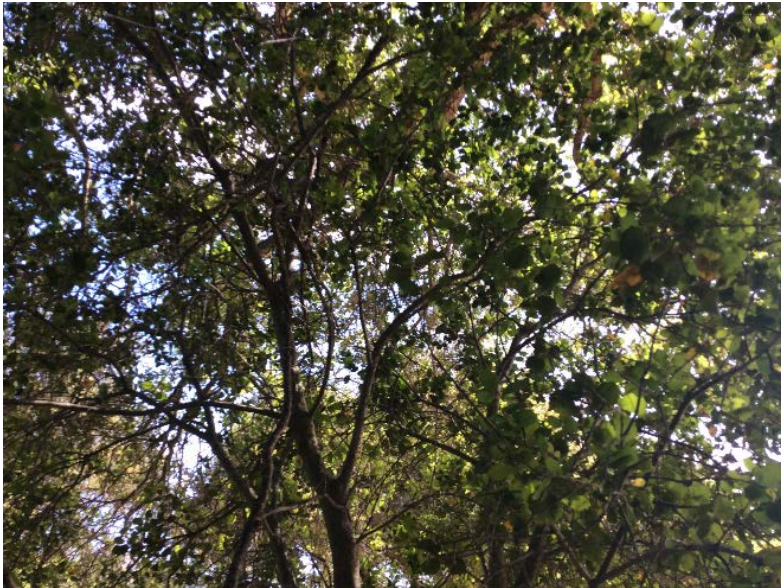
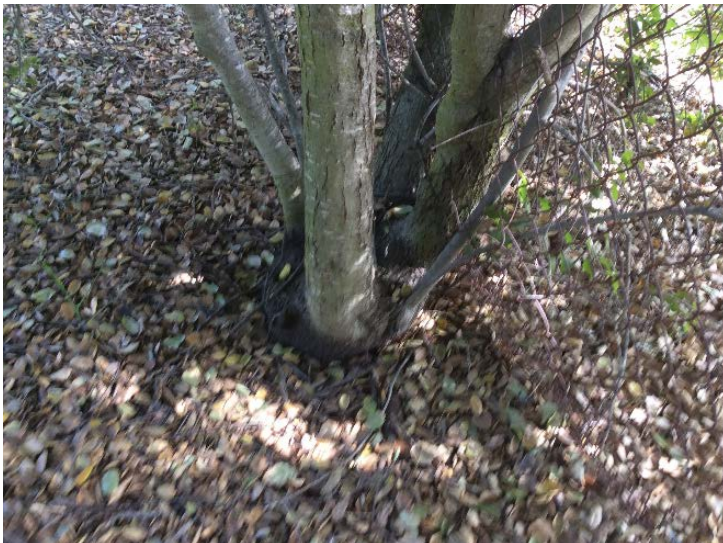
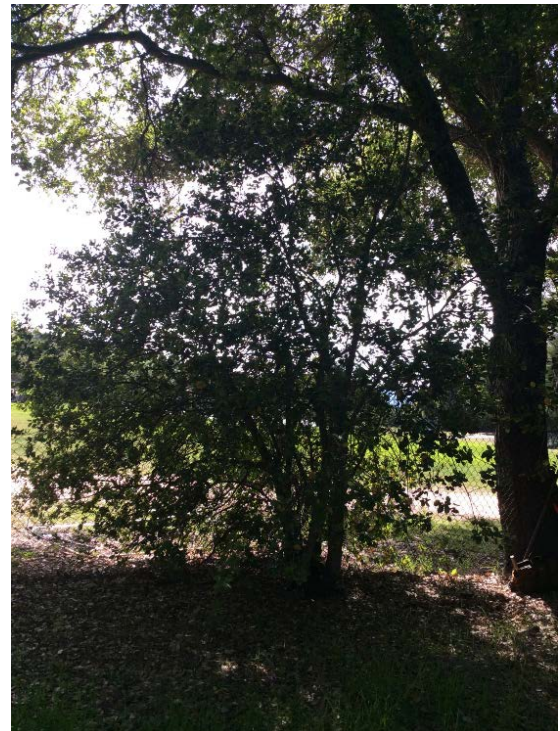
Tree Number	427
Species:	Coast Live Oak – <i>Quercus agrifolia</i>
Number of Trunks:	5
Girth at 54":	43" (6", 9", 11", 10", 7")
Height	25'
Dripline	25'
Observations:	Appears to be regrowth from a stump, located 6' east of tree 395 on the fence line
Overall Health:	Good
Project Impact:	No impact
Recommendations:	Install fence around dripline + 5' = 30' during construction, mulch

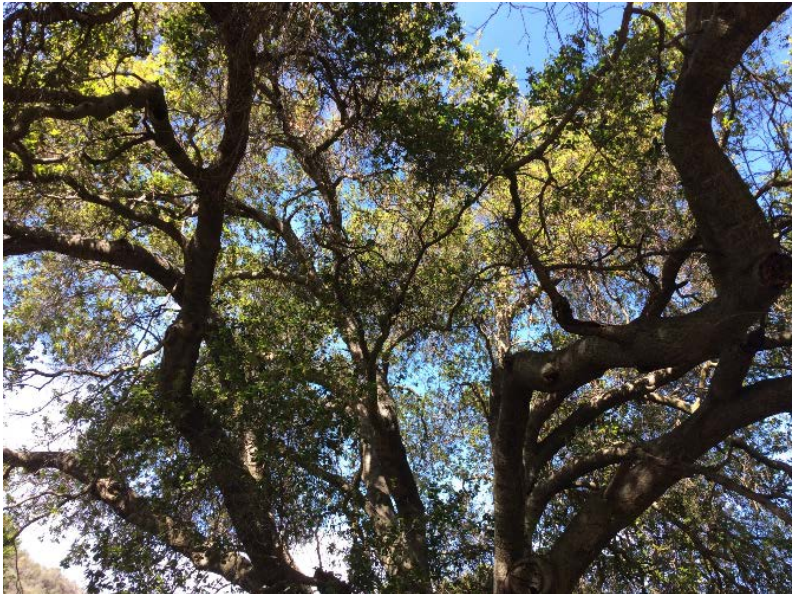
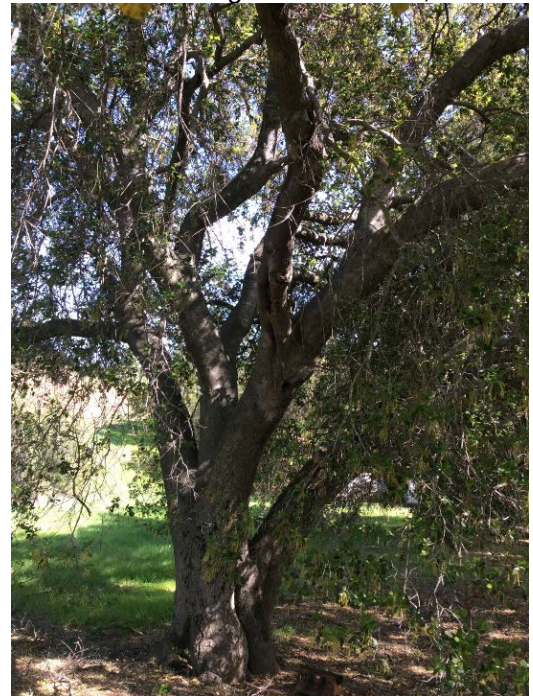
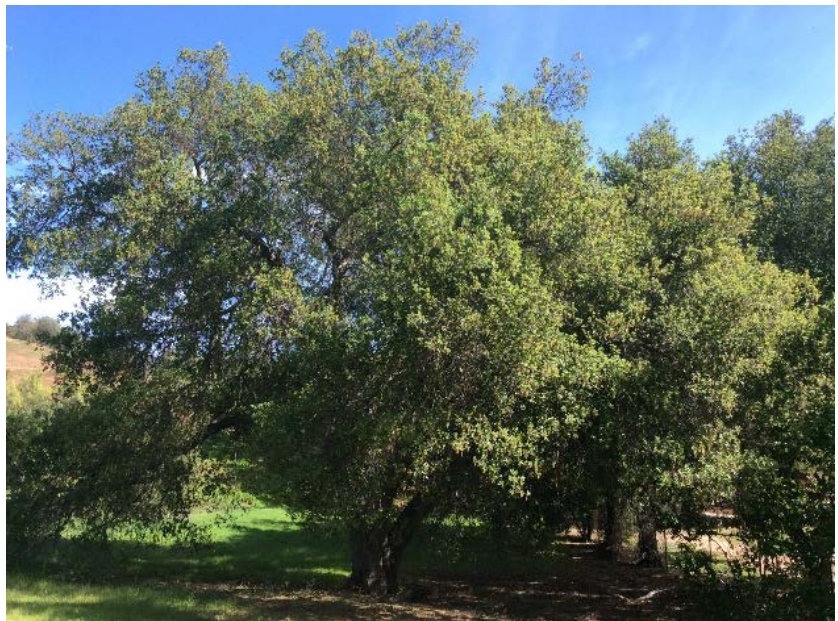
Tree Number 428
Species: Coast Live Oak – *Quercus agrifolia*
Number of Trunks: 1
Girth at 54": 160" - Heritage
Height 40'
Dripline 50'
Observations: Located 29' north of tree 397, northern branches resting on ground
Overall Health: Good
Project Impact: Cabin to be constructed 30' west of tree affecting about 15% of CRZ. See TPP.
Recommendations: Install fence around dripline + 5' = 55' during construction, mulch

Condition reflects the health and structural integrity of the tree. The tree is in a rural portion of the camp that is seldom unused. The health of the tree is good. Ventura county classifies this tree as a Heritage Tree.

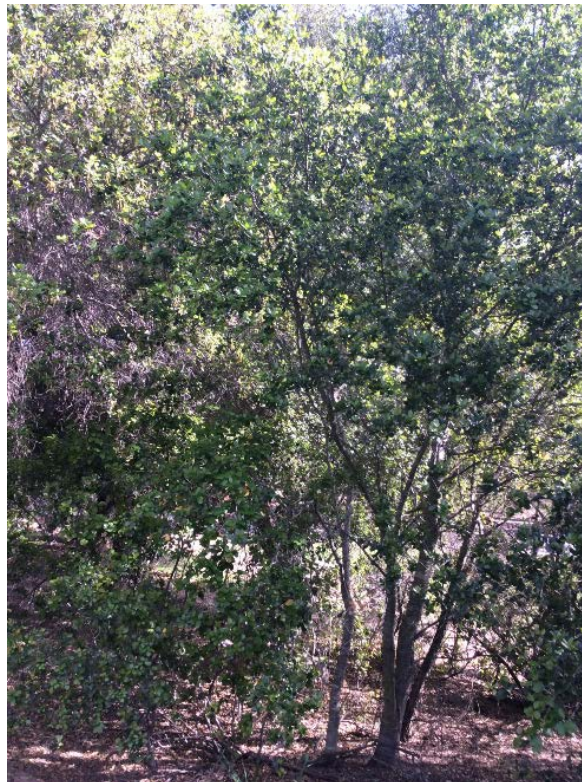
Tree Number	429
Species:	Coast Live Oak – <i>Quercus agrifolia</i>
Number of Trunks:	1
Girth at 54":	9.5"
Height	15'
Dripline	15'
Observations:	Located 29' west of tree 397 and 12' north of the fence
Overall Health:	Good
Project Impact:	None
Recommendations:	Install fence around dripline + 5' = 20' during construction, mulch

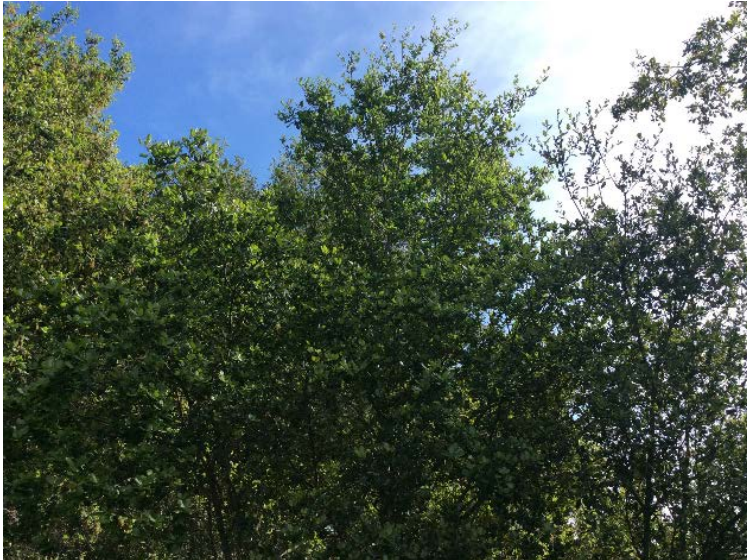
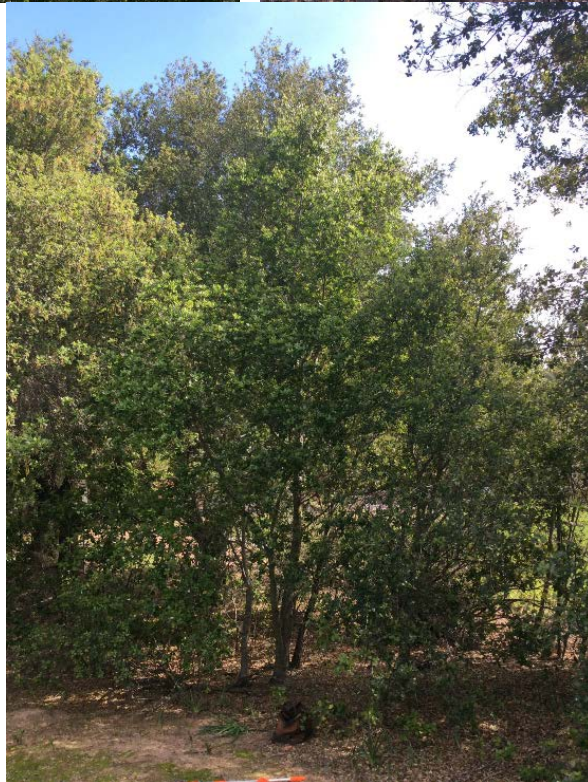
Tree Number	430
Species:	Coast Live Oak – <i>Quercus agrifolia</i>
Number of Trunks:	1
Girth at 54":	15"
Height	20'
Dripline	20'
Observations:	Codominant branches. Located 1' south of tree 429 and 11' north of the fence
Overall Health:	Good
Project Impact:	No impact
Recommendations:	Install fence around dripline + 5' = 25' during construction, mulch

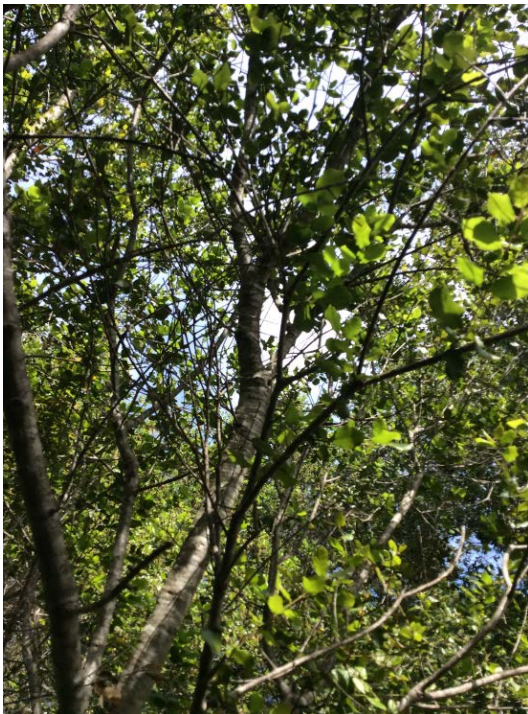
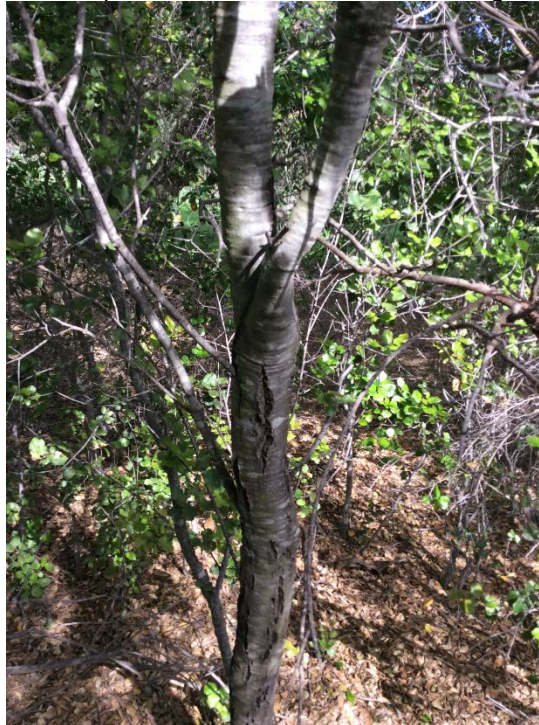
Tree Number 431
Species: Coast Live Oak – *Quercus agrifolia*
Number of Trunks: 1
Girth at 54": 10.5"
Height 20'
Dripline 20'
Observations: Codominant branches. Located 2' southeast of tree 430 and 9' north of the fence
Overall Health: Good
Project Impact: None
Recommendations: Install fence around dripline + 5' = 25' during construction, mulch

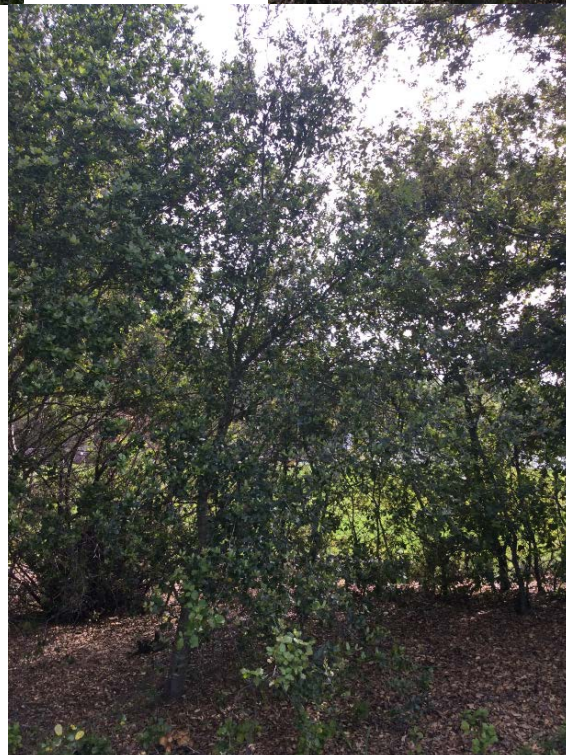
Tree Number 432
Species: Coast Live Oak – *Quercus agrifolia*
Number of Trunks: 1
Girth at 54": 11.5"
Height 20'
Dripline 20'
Observations: Located 5' west of tree 430 and 10' north of the fence
Overall Health: Good
Project Impact: None
Recommendations: Install fence around dripline + 5' = 20' during construction, mulch

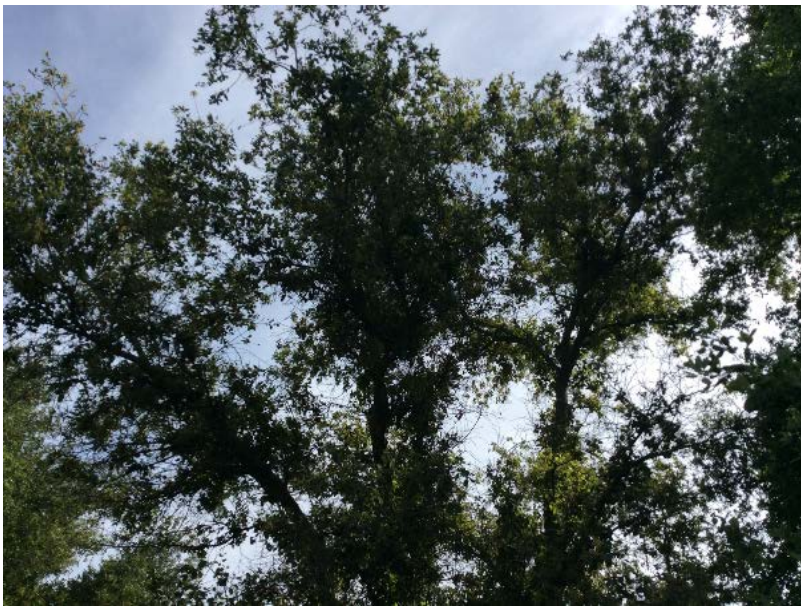
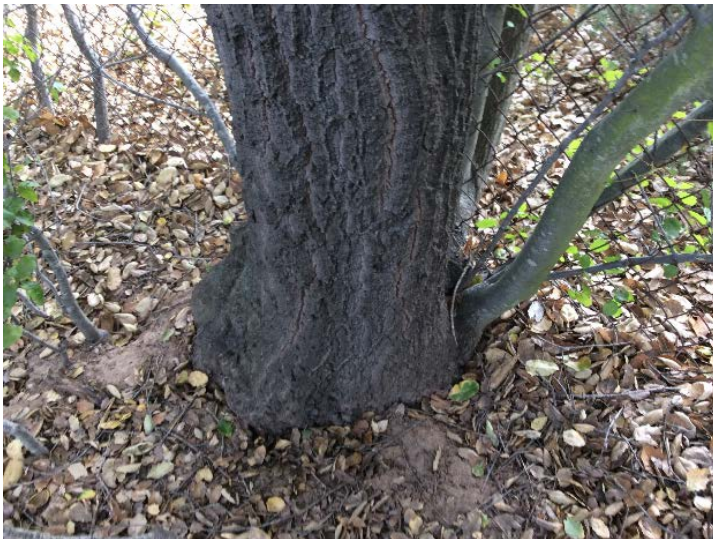
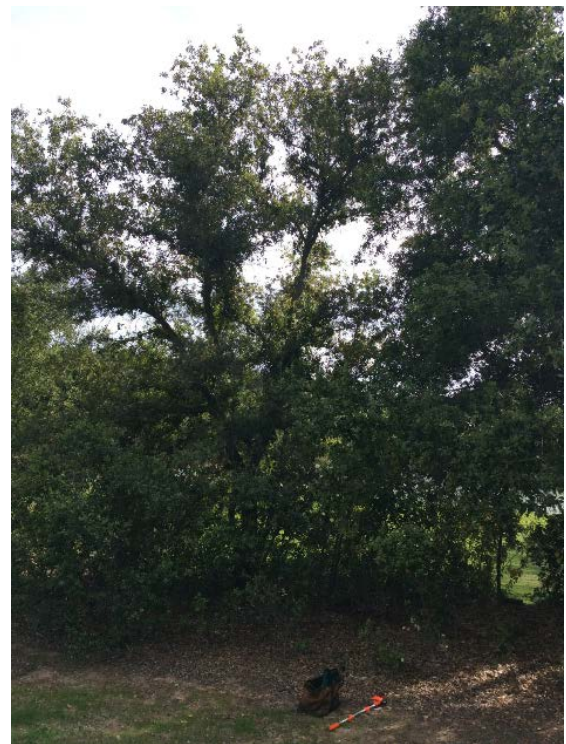
Tree Number	433
Species:	Coast Live Oak – <i>Quercus agrifolia</i>
Number of Trunks:	1
Girth at 54":	38"
Height	30'
Dripline	35'
Observations:	Located 1' north of fence, 16' west of tree 432 west of tree 430 and 10' north of the fence
Overall Health:	Good
Project Impact:	None
Recommendations:	Install fence around dripline + 5' = 40' during construction, mulch

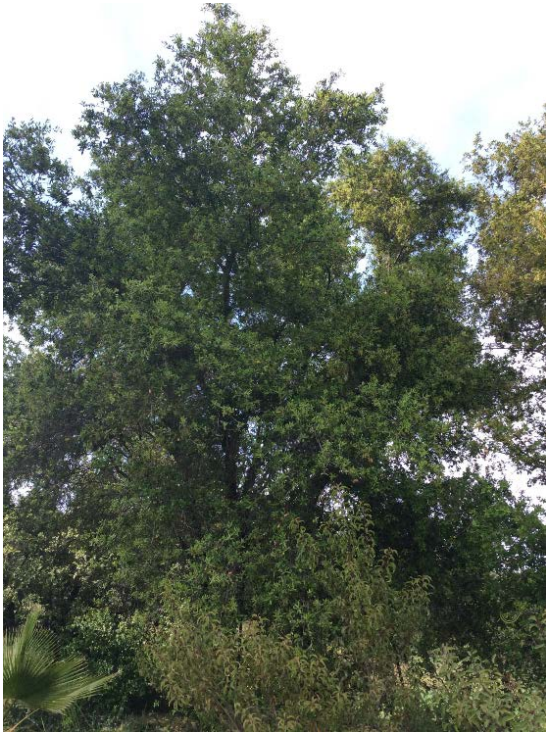
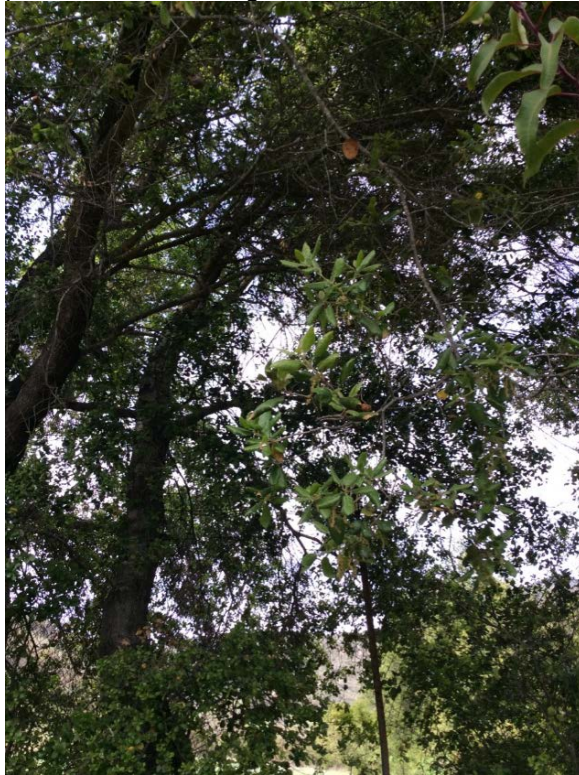
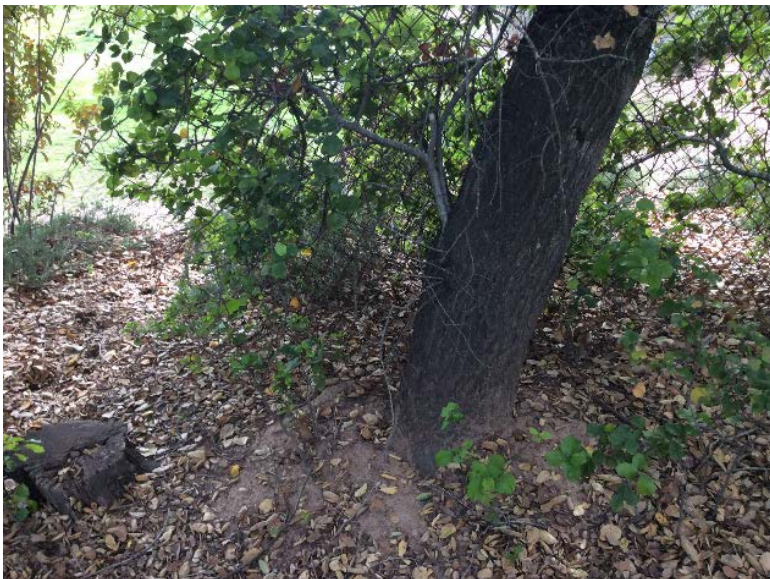
Tree Number 434
Species: Coast Live Oak – *Quercus agrifolia*
Number of Trunks: 1
Girth at 54": 37"
Height 30'
Dripline 35'
Observations: Located just north of fence, 16' west of tree 433
Overall Health: Good
Project Impact: None
Recommendations: Install fence around dripline + 5' = 40' during construction, mulch
