Arborist Report for

Camp Ramah New Machon

385 Fairview Road

February 7, 2019

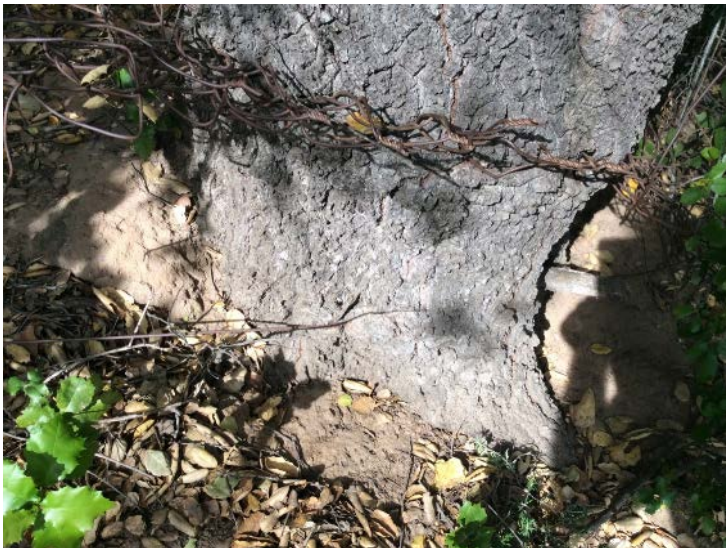
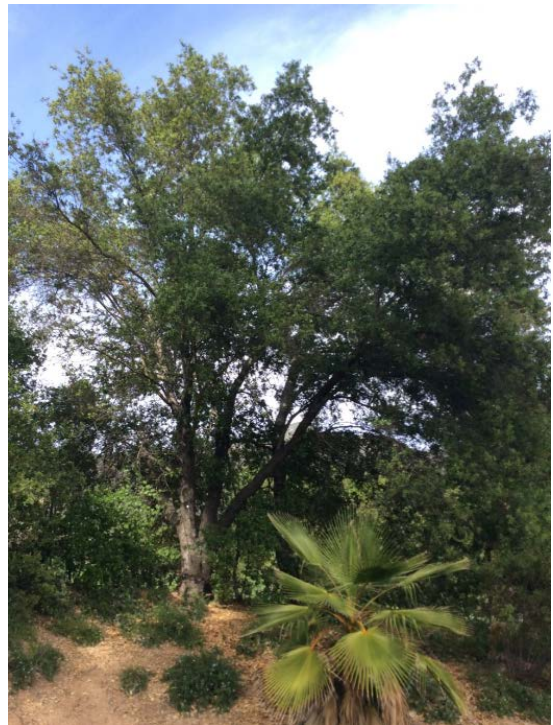
Tree Number	435
Species:	Coast Live Oak – <i>Quercus agrifolia</i>
Number of Trunks:	1
Girth at 54":	86"
Height	35'
Dripline	35'
Observations:	Located just north of fence, 5' west of tree 434
Overall Health:	Good
Project Impact:	None
Recommendations:	Install fence around dripline + 5' = 40' during construction, mulch

Condition reflects the health and structural integrity of the tree. The tree is in a rural portion of the camp that is seldom unused. The health of the tree is good.

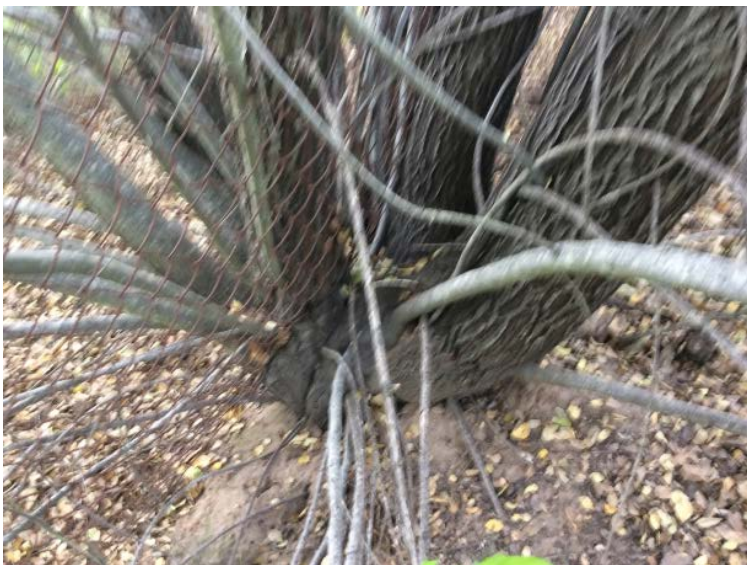
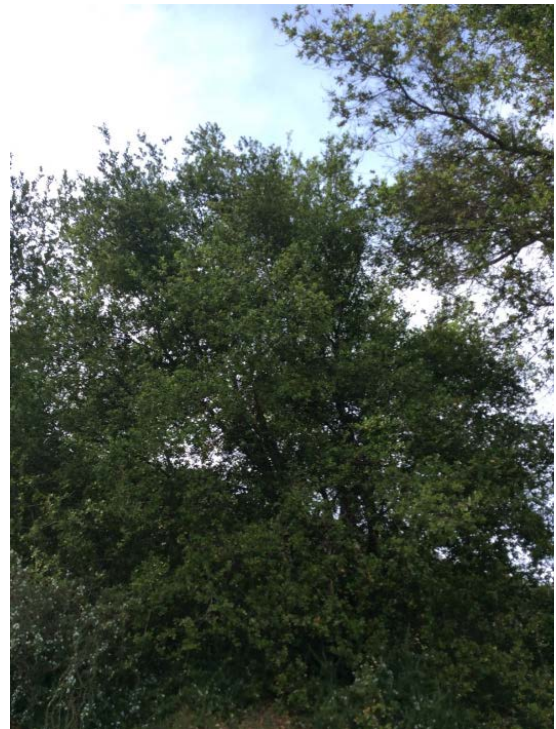
Tree Number	436
Species:	Coast Live Oak – <i>Quercus agrifolia</i>
Number of Trunks:	7
Girth at 54":	56"
Height	25'
Dripline	25'
Observations:	Located on fence line, 15' west of tree 435
Overall Health:	Good
Project Impact:	Approximately 10% CRZ impact from driveway construction north of tree. See TPP.
Recommendations:	Install fence around dripline + 5' = 30' during construction, mulch.

Condition reflects the health and structural integrity of the tree. The tree is in a rural portion of the camp that is seldom unused. The health of the tree is good.

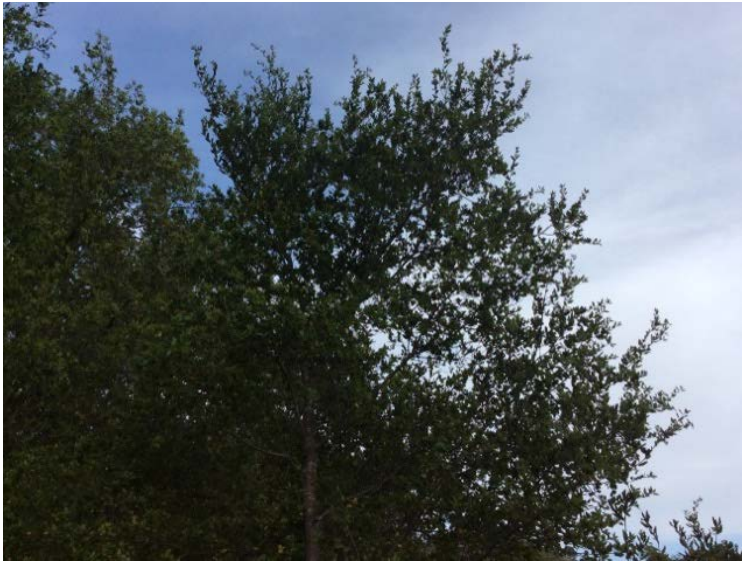
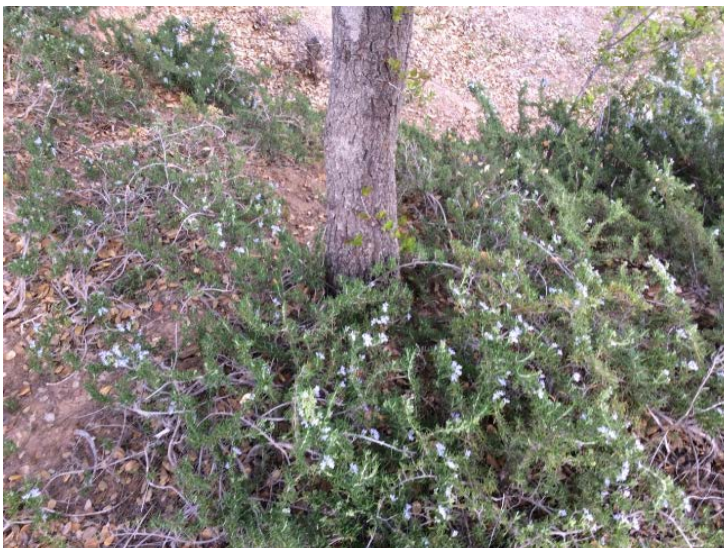
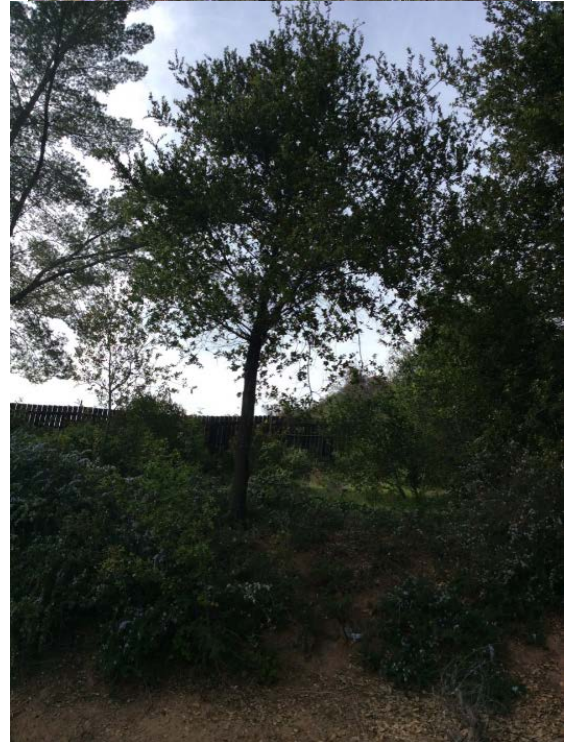
Tree Number	437
Species:	Coast Live Oak – <i>Quercus agrifolia</i>
Number of Trunks:	1
Girth at 54":	15"
Height	20'
Dripline	22'
Observations:	Located 21" south of fence and 5' east of service road
Overall Health:	Good
Project Impact:	Likely to be removed due to road widening
Recommendations:	Remove and mitigate with planting of ten 15-gallon Coast Live Oaks.

Condition reflects the health and structural integrity of the tree. There are minor root issues in relation to the health of the tree, mostly due to compaction of the area around the roots as a portion of its root system is under impermeable surfaces (paved access road) and compacted surfaces (soccer field). The health of the tree is good,

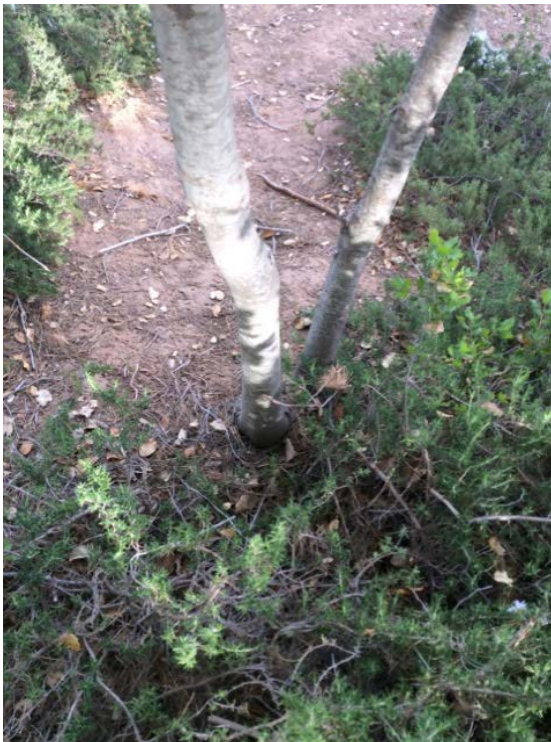
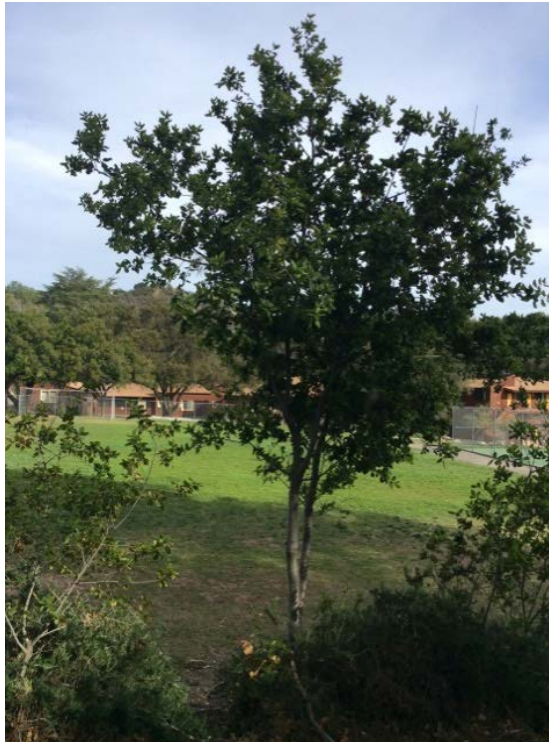
Tree Number	438
Species:	Coast Live Oak – <i>Quercus agrifolia</i>
Number of Trunks:	2
Girth at 54":	7" and 7" = 17"
Height	15'
Dripline	15'
Observations:	Located 9' south of goal and 5' east of service road
Overall Health:	Good
Project Impact:	Likely to be removed if access road widened on the east side
Recommendations:	Remove and replace with ten 15-gallon Coast Live Oaks

Condition reflects the health and structural integrity of the tree. There are minor root issues in relation to the health of the tree, mostly due to compaction of the area around the roots as a portion of its root system is under impermeable surfaces (paved access road) and compacted surfaces (soccer field). The health of the tree is good,

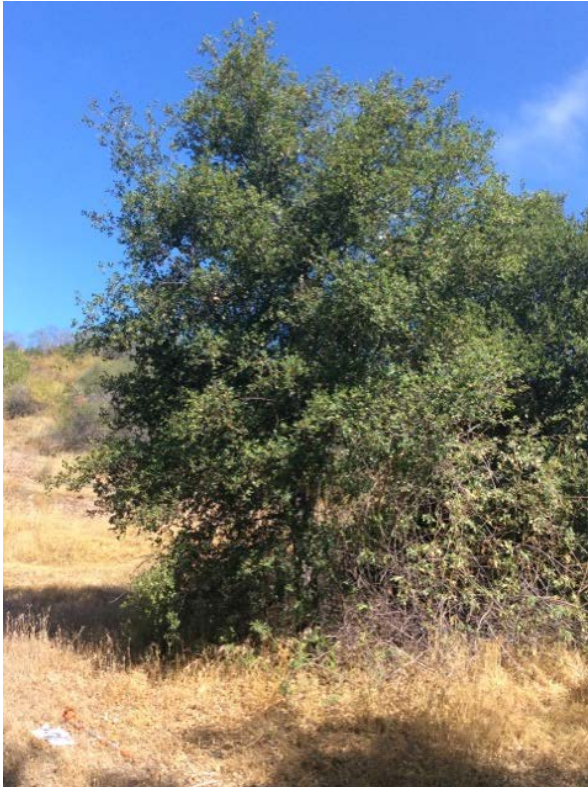
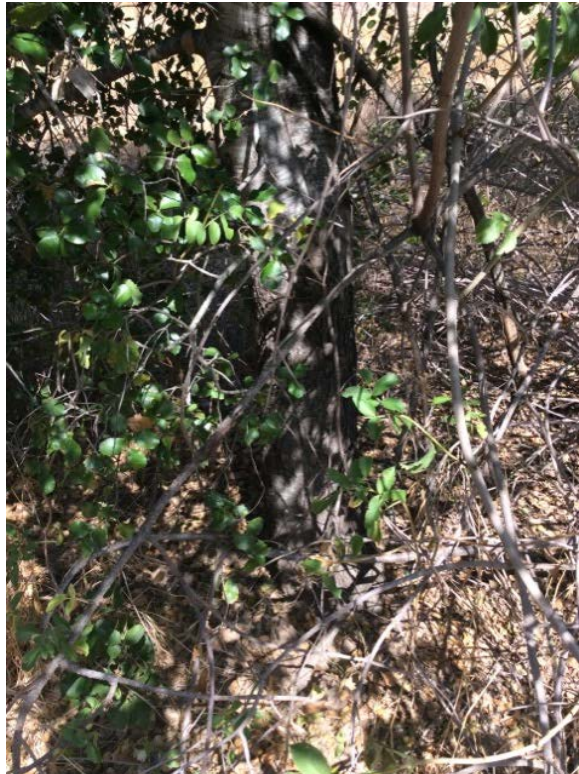
Tree Number 476
Species: Coast Live Oak – *Quercus agrifolia*
Number of Trunks: 1
Girth at 54": 37" (12" DBH)
Height 25'
Dripline 25"
Observations: 55' north of fence, north of tree 432
Overall Health: Destroyed
Project Impact: Tree destroyed during the Thomas Fire by firefighters cutting firebreaks.
Recommendations: None

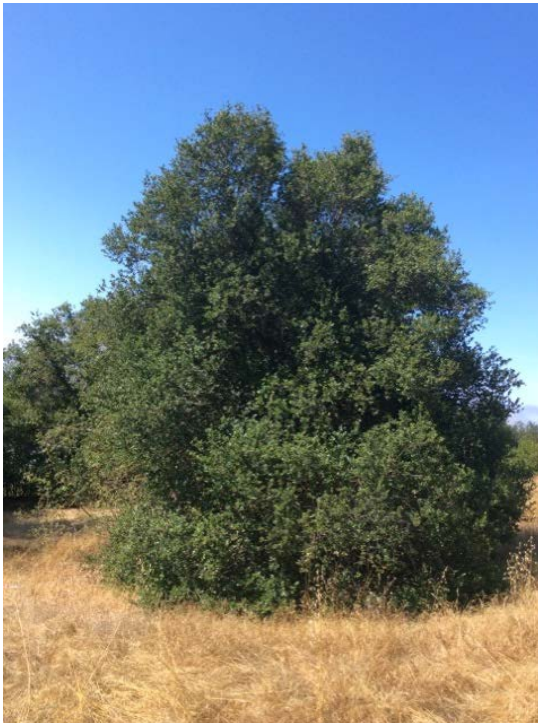
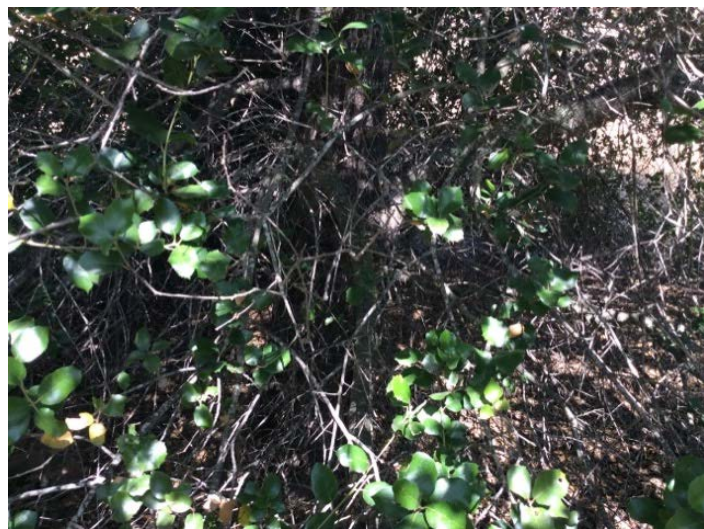
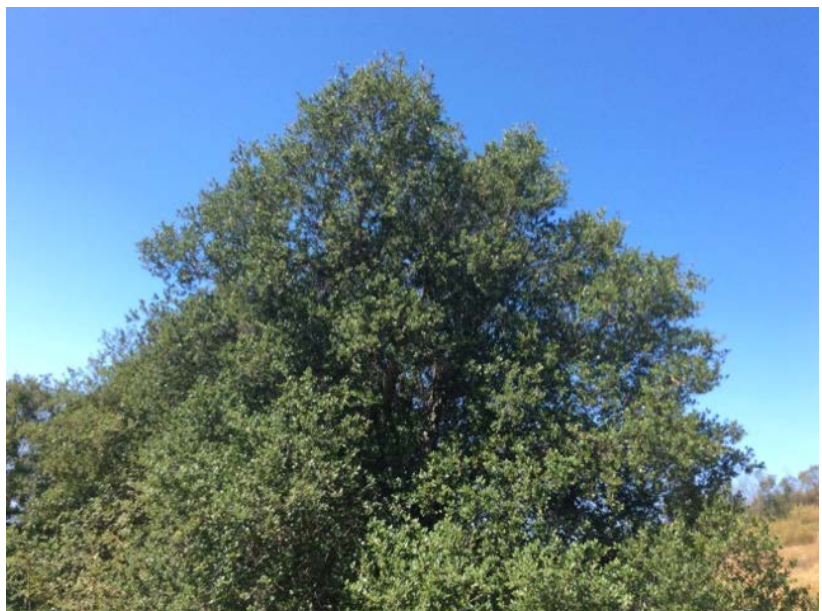
Tree Number 477
Species: Coast Live Oak – *Quercus agrifolia*
Number of Trunks: 1
Girth at 54": 39" (13" DBH)
Height 20'
Dripline 35"
Observations: 73' north of fence, 18' north of tree 476
Overall Health: Destroyed
Project Impact: Tree destroyed by firefighters creating firebreak during Thomas Fire
Recommendations: none

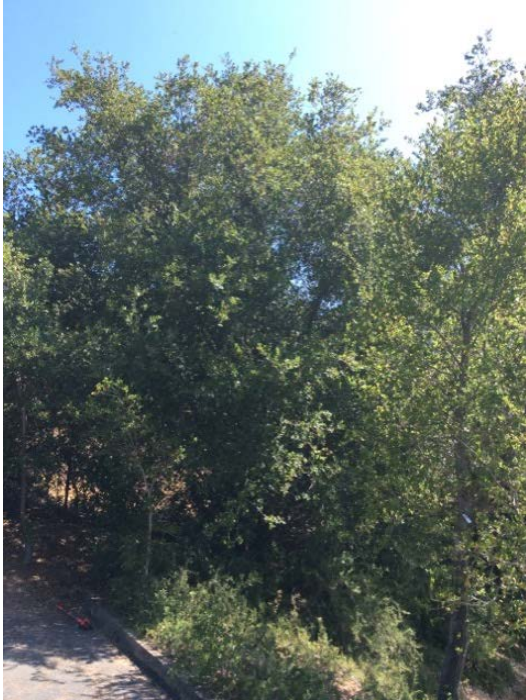
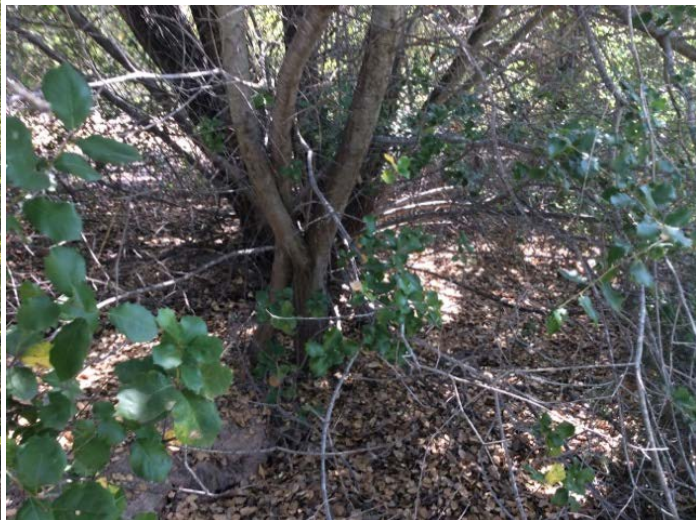
Tree Number	478
Species:	Coast Live Oak – <i>Quercus agrifolia</i>
Number of Trunks:	9
Girth at 54":	10.5" (3" DBH)
Height	15'
Dripline	15"
Observations:	2' south of fence, 5' southwest of tree 436
Overall Health:	Good
Project Impact:	Likely to be removed as part of road widening project
Recommendations:	Remove and replace with ten 15-gallon Coast Live Oaks

Condition reflects the health and structural integrity of the tree. There are minor root issues in relation to the health of the tree, mostly due to compaction of the area around the roots as a portion of its root system is under impermeable surfaces (paved access road) and compacted surfaces (soccer field). The health of the tree is good,

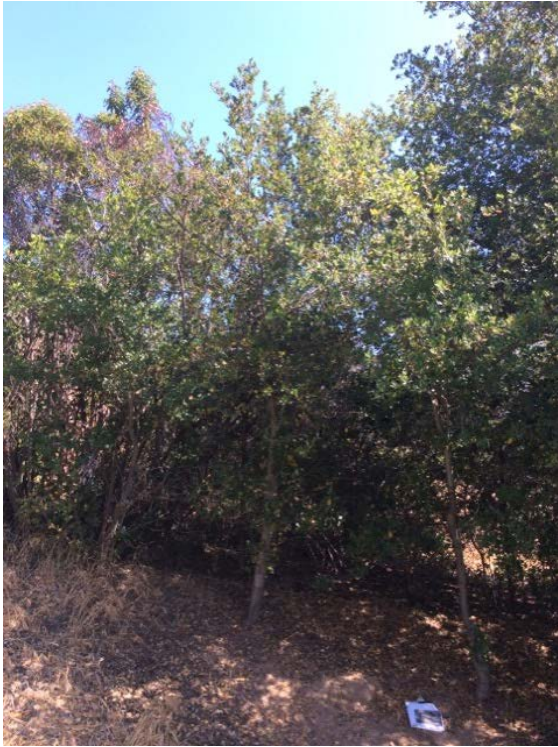
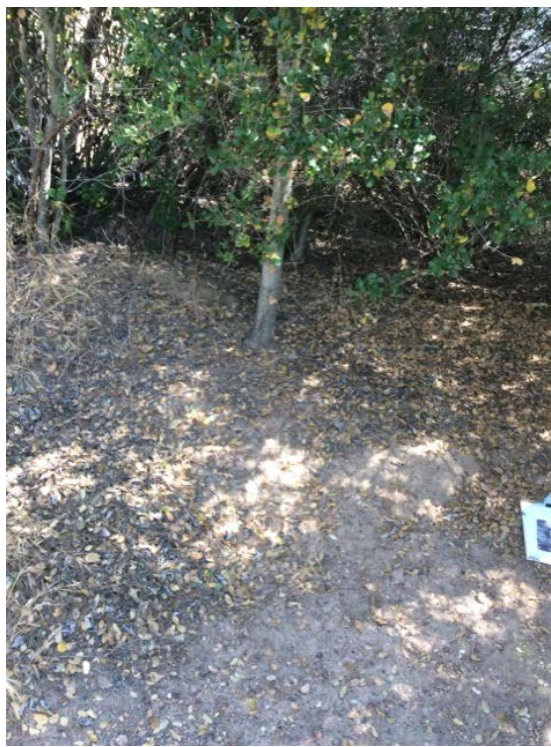
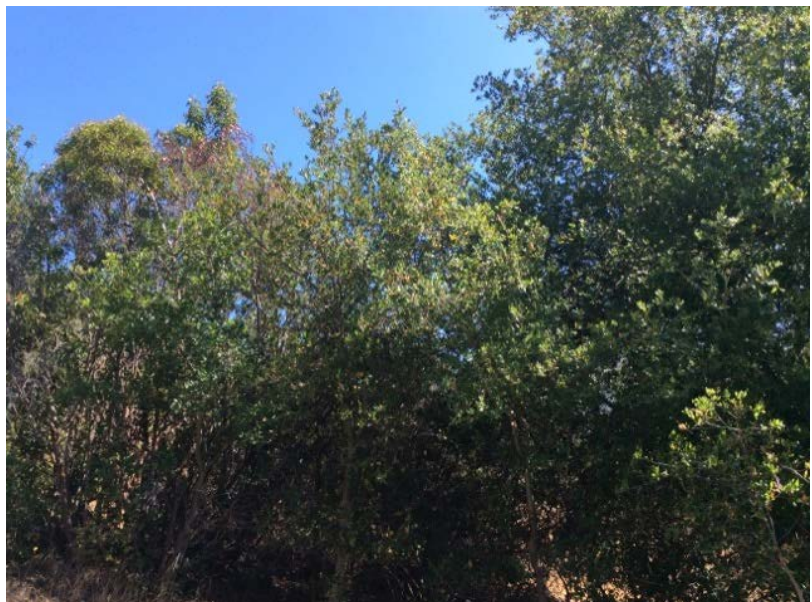
Tree Number 479
Species: Coast Live Oak – *Quercus agrifolia*
Number of Trunks: 1
Girth at 54": 10.5" (3" DBH)
Height 15'
Dripline 15"
Observations: 3' south of fence, 8' west of edge of road at north end
Overall Health: Destroyed by firefighters creating fire break during Thomas Fire
Project Impact: None
Recommendations: None

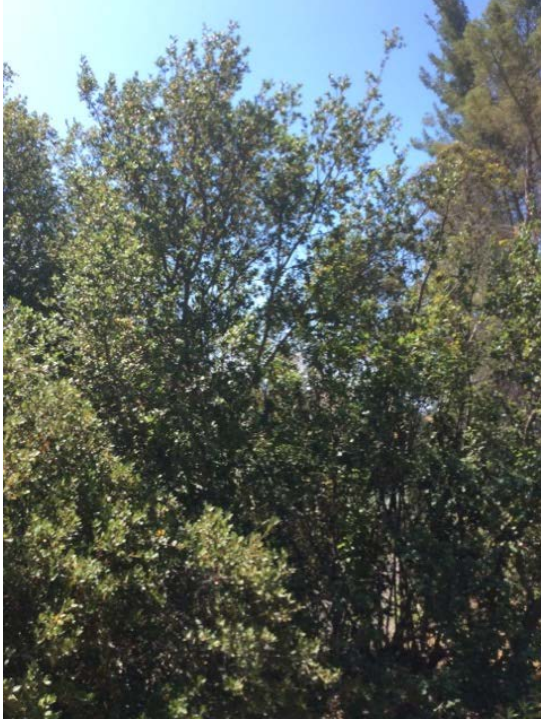
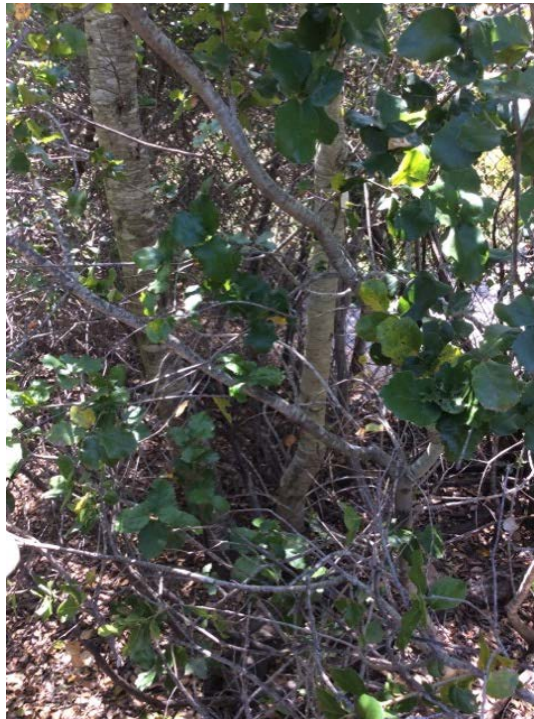
Tree Number	480
Species:	Coast Live Oak – <i>Quercus agrifolia</i>
Number of Trunks:	2
Girth at 54":	10" + 12" = 22" (7.5" DBH)
Height	20'
Dripline	15"
Observations:	3' north of fence,
Overall Health:	Good
Project Impact:	Possible if road widened
Recommendations:	Remove and replace with ten 15-gallon Coast Live Oaks

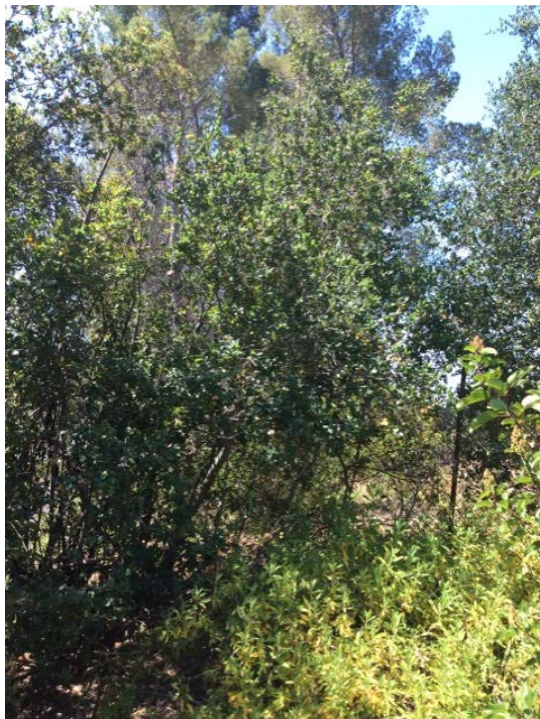
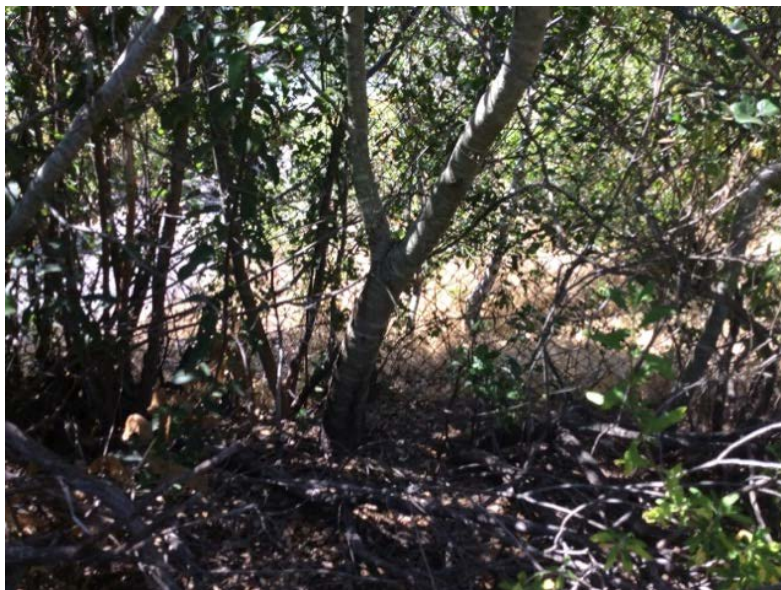
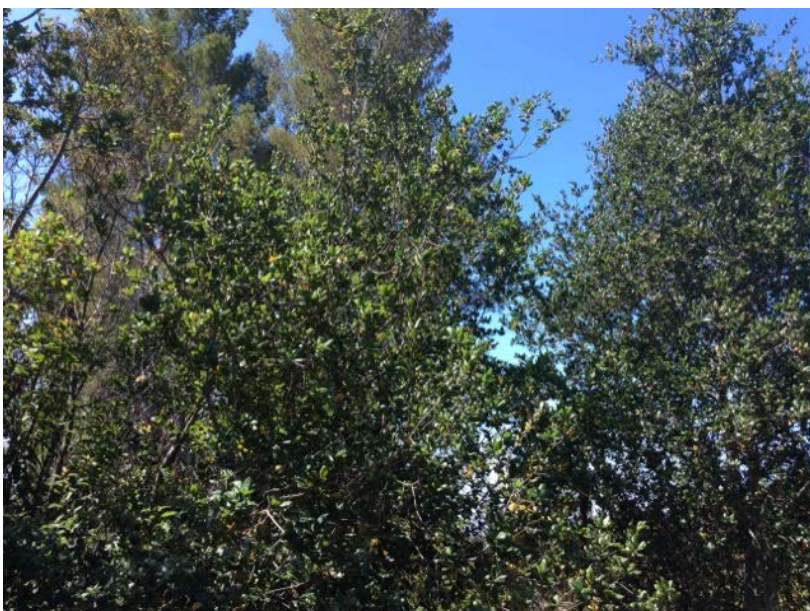
Tree Number 481
Species: Coast Live Oak – *Quercus agrifolia*
Number of Trunks: 2
Girth at 54": $10'' + 7'' = 17''$ (5.5" DBH)
Height 20'
Dripline 15"
Observations: 1' north of fence,
Overall Health: Good
Project Impact: Potential impact to 20% of CRZ. See TPP
Recommendations: Install fence around dripline + 5' = 20' during construction, mulch

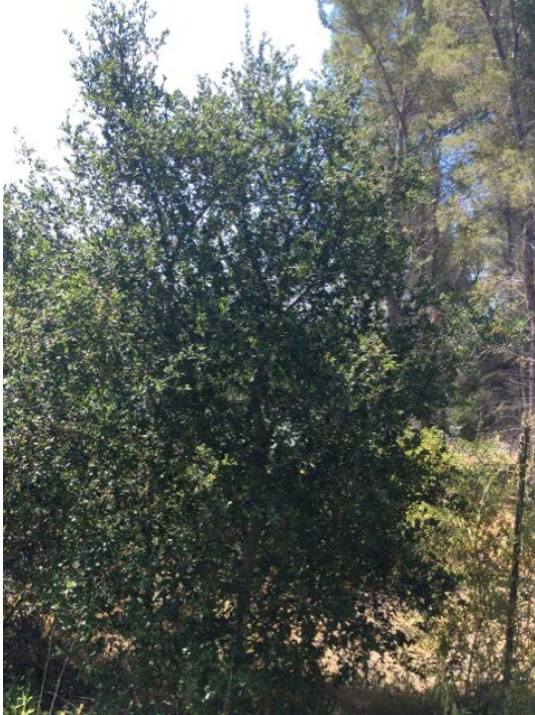
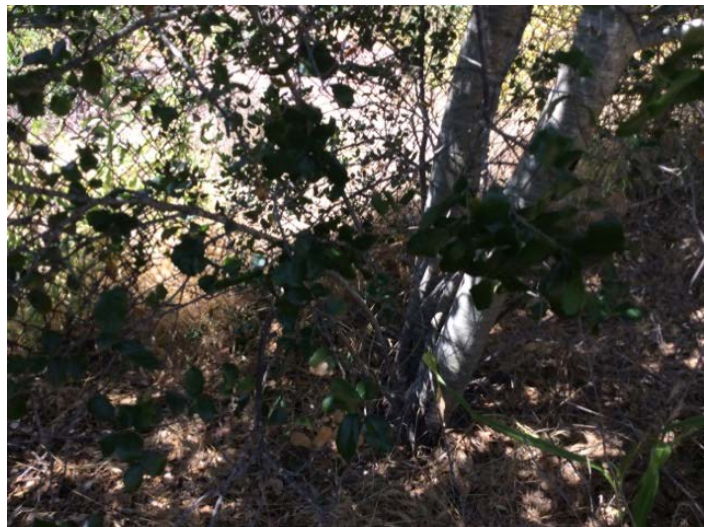
Tree Number 482
Species: Coast Live Oak – *Quercus agrifolia*
Number of Trunks: 2
Girth at 54": 10" + 12" = 22" (7.5" DBH)
Height 15'
Dripline 15"
Observations: 2' north of fence,
Overall Health: Good
Project Impact: None
Recommendations: Install fence around dripline + 5' = 20' during construction, mulch

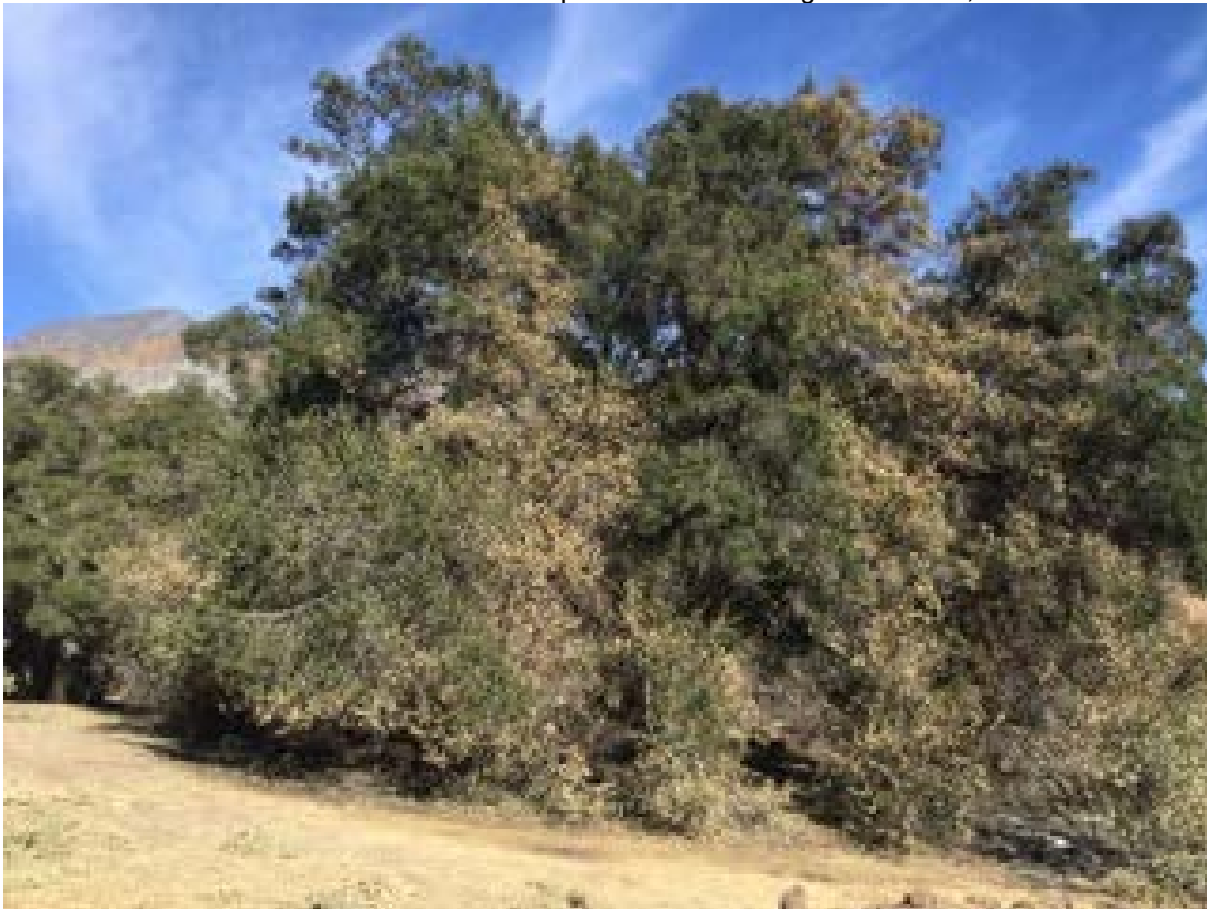
Tree Number 598
Species: Coast Live Oak – *Quercus agrifolia*
Number of Trunks: 1
Girth at 54": 164" (52.5" DBH)
Height 35'
Dripline 45"
Observations: 5th trunk failed, 40% foliage burns from Thomas Fire
Overall Health: Fair - Recovering well from fire
Project Impact: Located 28' from northern most new cabin impacting about 20% of CRZ. See TPP.
Recommendations: Install fence around dripline + 5' = 50' during construction, mulch

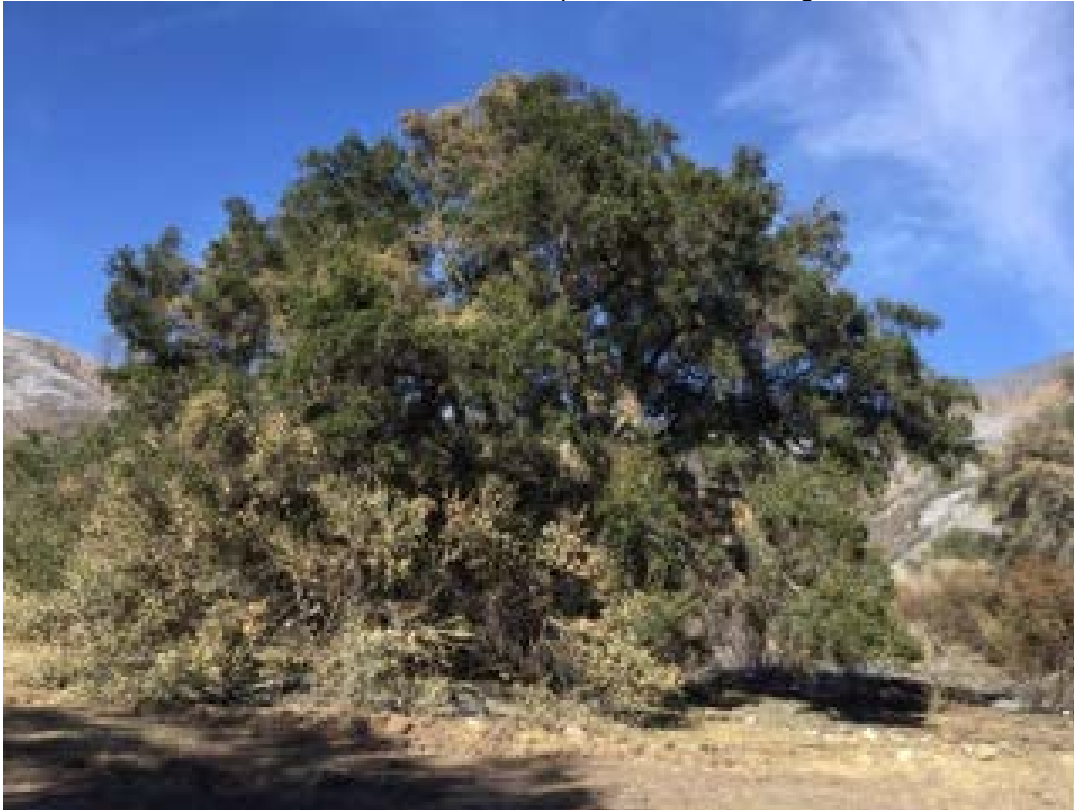
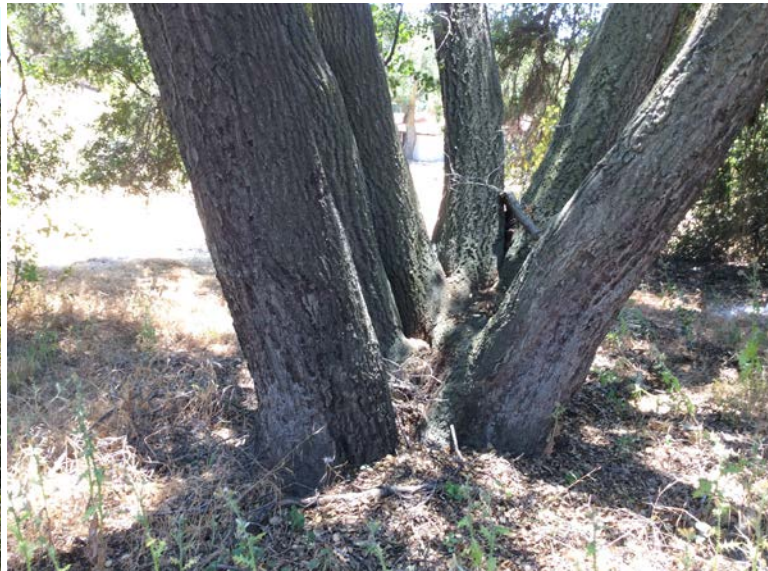
Tree Number	599
Species:	Coast Live Oak – <i>Quercus agrifolia</i>
Number of Trunks:	2
Girth at 54":	$7.5 + 4.5 = 12"$ (4" DBH)
Height	35'
Dripline	45"
Observations:	30% foliage scorched during Thomas Fire
Overall Health:	Fair -Recovering well from fire
Project Impact:	Located 28' from northern most new cabin impacting about 20% of CRZ. See TPP
Recommendations:	Install fence around dripline + 5' = 50' during construction, mulch
