NORFLEET CONSULTANTS

January 15, 2018

Proj. No. 131882.3

RE: Geologic/Slope Review
Ojai Quarry
Ojai, CA

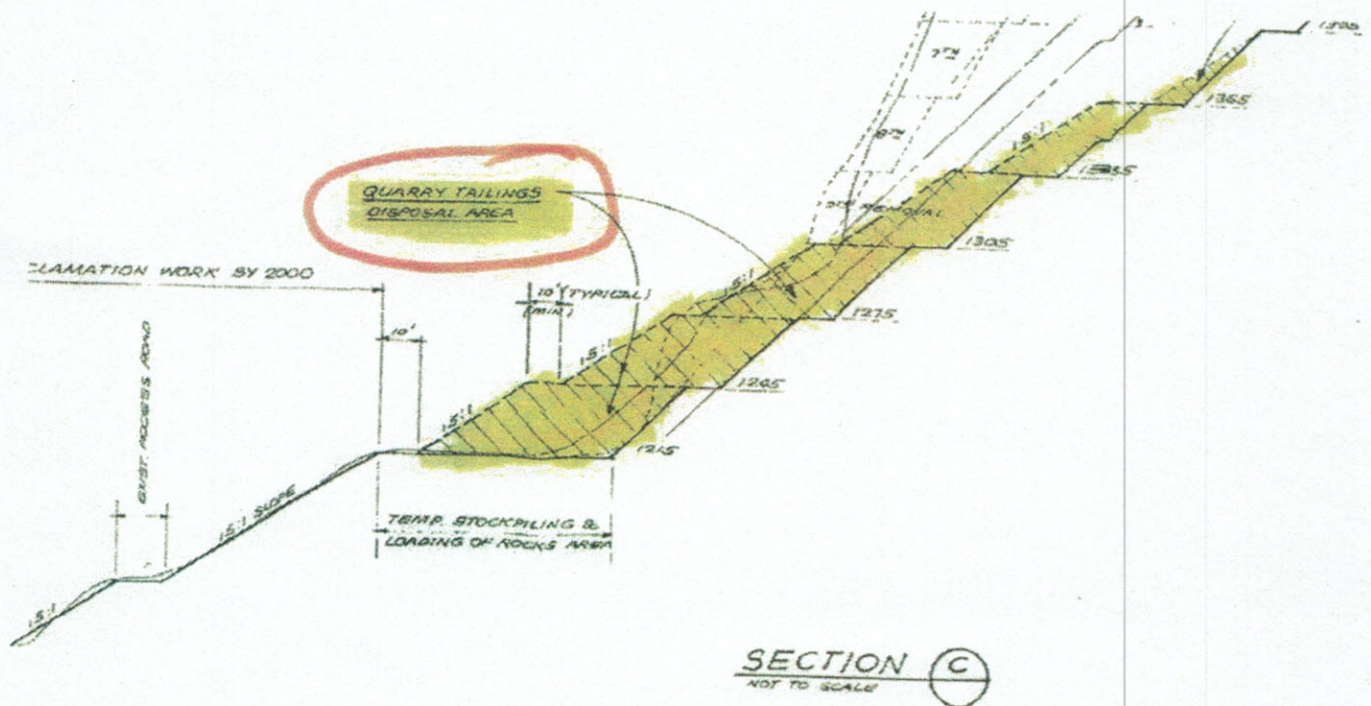
A point of contention between the operator and the County is the meaning of notes on the proposed cross-section (C) in the original reclamation plans (Hovell and Piloarski Engineering, September, 1994?), Figure 1. One note read "Quarry Tailings Disposal Area." Below, another note read "Temp. Stockpiling & Loading of Rocks Area." Both notes had arrows pointing to newly cut benches. There no indication that the notes refer to the final, reclaimed slope configuration. The operator believes that the notes allow the temporary storage of tailings on an as needed basis to a maximum depth specified in the notes during mining. The County believes that these notes specify the final, reclaimed configuration of the quarry slope. They believe that all benches must eventually be filled with engineered fill to the configuration shown in the notes.
