ARBORISTS FIELD REPORT - RE: 8120 Puesta Del Sol, Rincon Pt, CA

March 5, 2021

County of Ventura Planning Commission Hearing PL21-0035 Exhibit 9 - Arborist Field Report dated March 5, 2021, and Amended on August 6, 2021
--

August 6, 2021

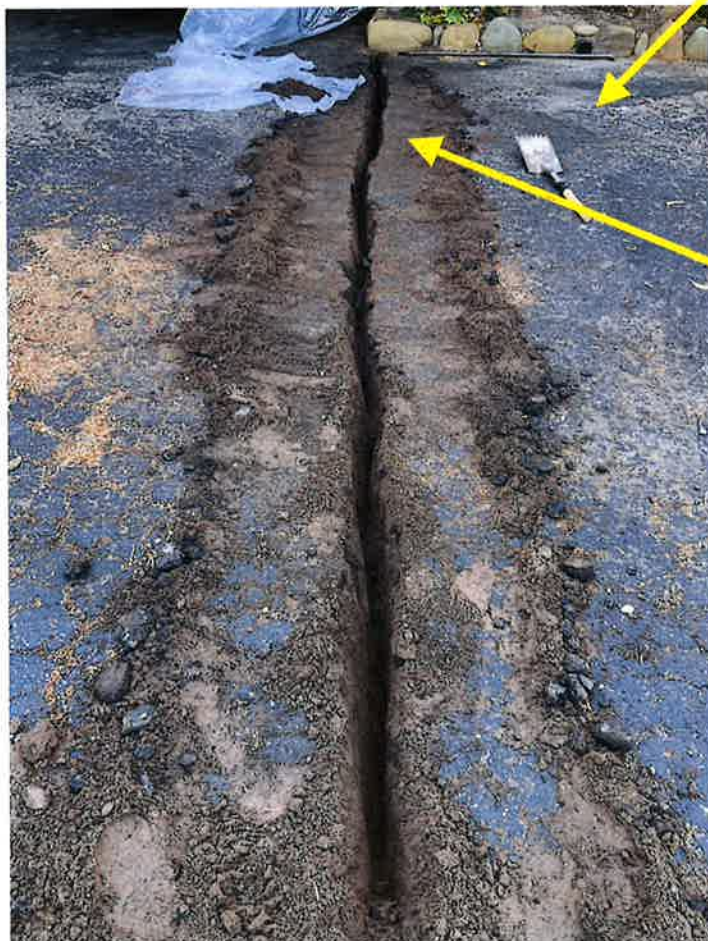
First trench 27' to east of property line.

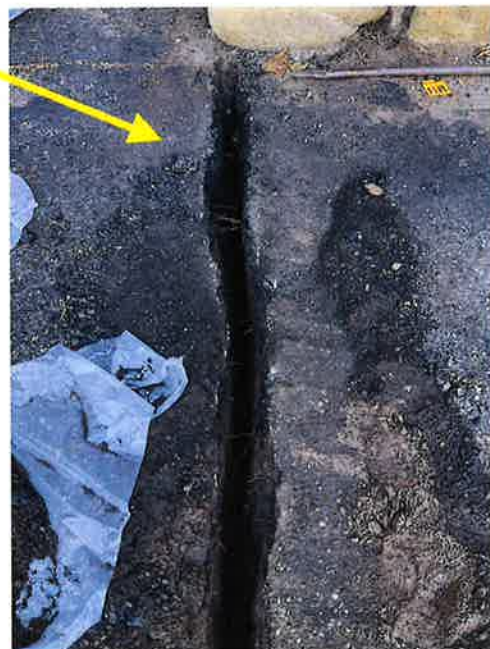
Second trench 11' to east of property line.

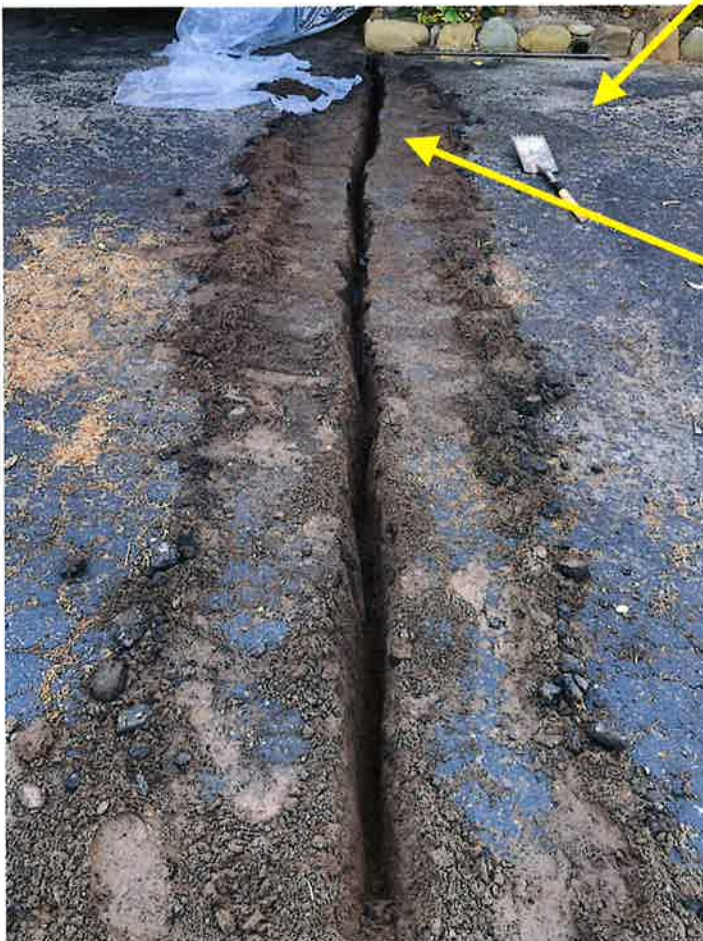
First trench 27' to east of property line.

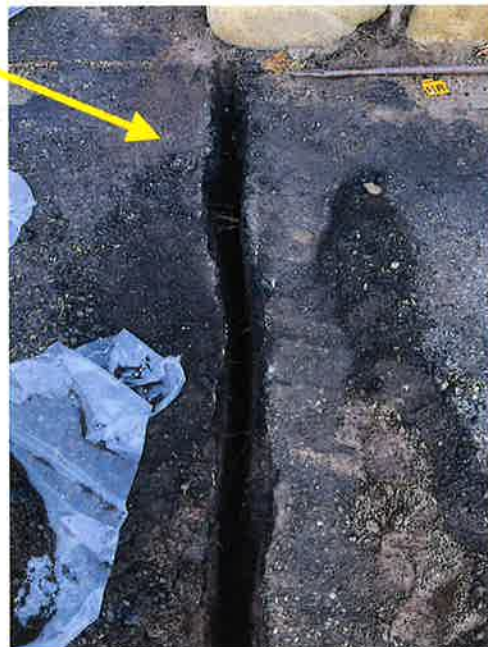
Second trench 11' to east of property line.
