### **ARBORISTS FIELD REPORT - RE: 8120 Puesta Del Sol, Rincon Pt, CA**

March 5, 2021

August 6, 2021

## ARBORIST'S MEMO-RE: Greg and Michelle Elliot 8120 Puesta Del Sol

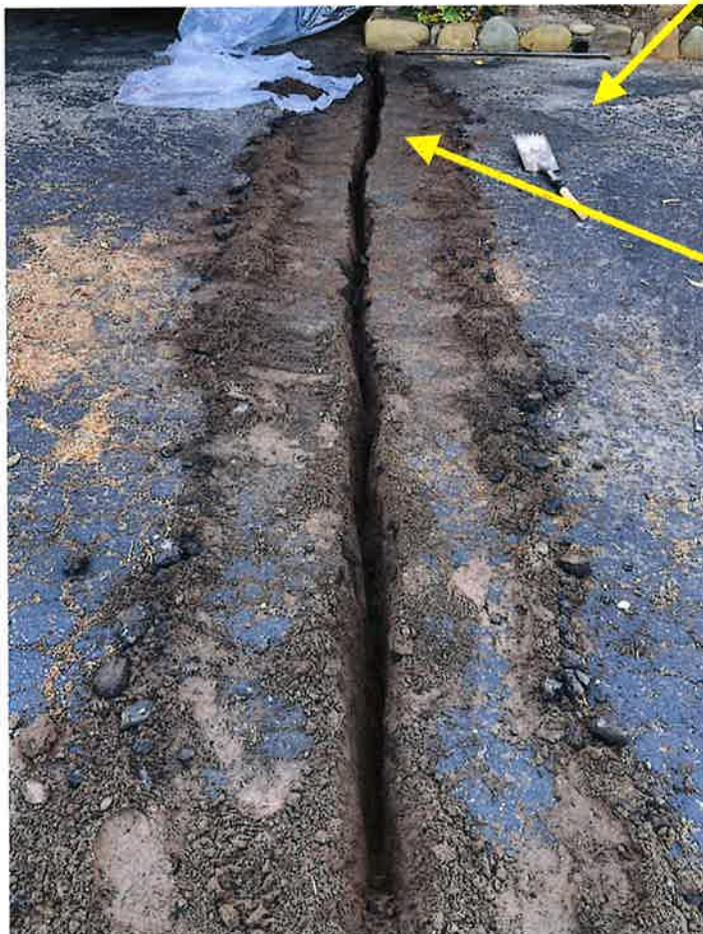
First trench 27' to east of property line.

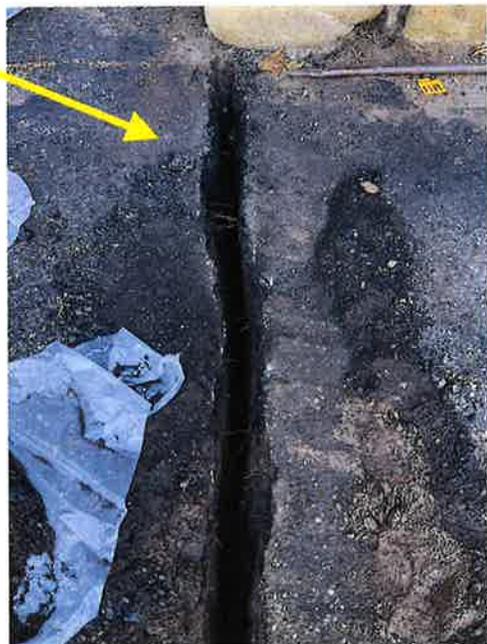
Second trench 11' to east of property line.

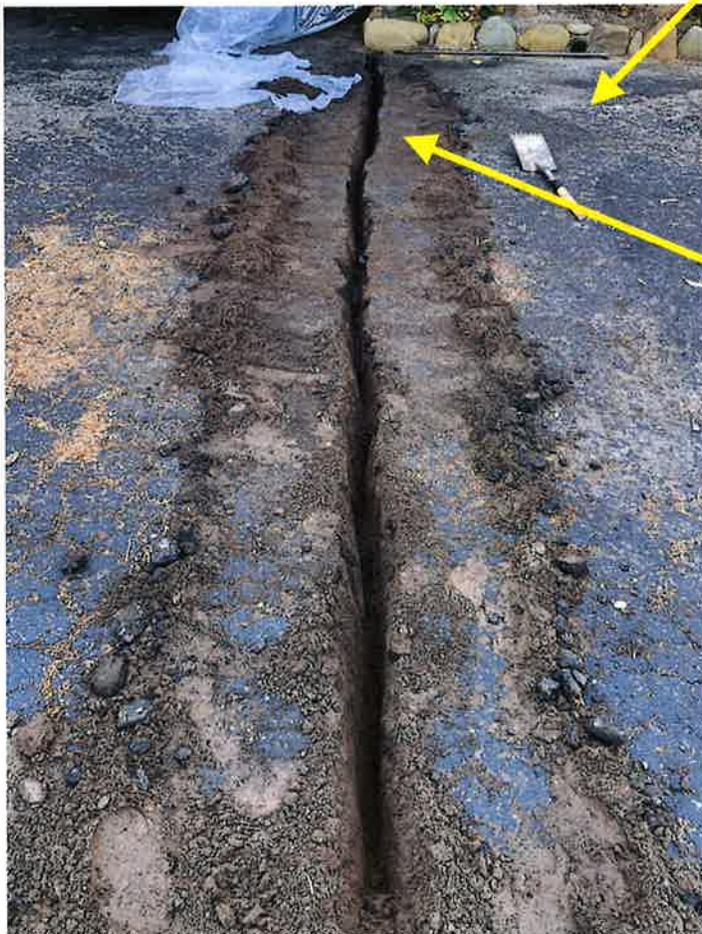
First trench 27' to east of property line.

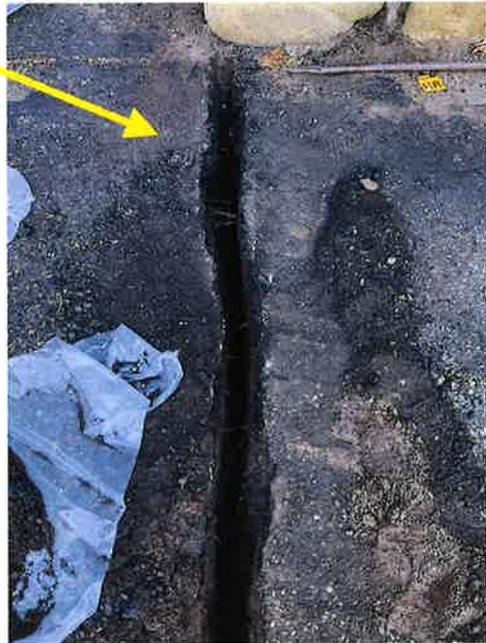
Second trench 11' to east of property line.
