**Draft Least Environmentally Damaging Alternatives Analysis
Camp Hess Kramer and Gindling Hilltop Camps (PL21-0051)
11495 & 11677 Pacific Coast Highway, Unincorporated Ventura County**

LITTLE SYCAMORE CANYON CREEK WILSHIRE BOULEVARD TEMPLE CAMPS

Geomorphic Assessment and Recommendations

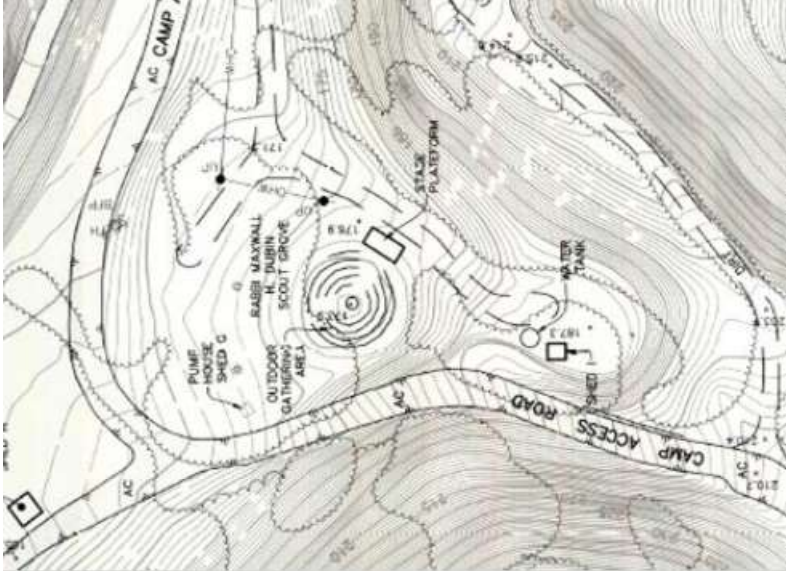
Scout's Grove as depicted on the
CUP-approved plans
(not to scale)

The site plan comparison for the changes to Scout's Grove are shown in the figure on the following page.

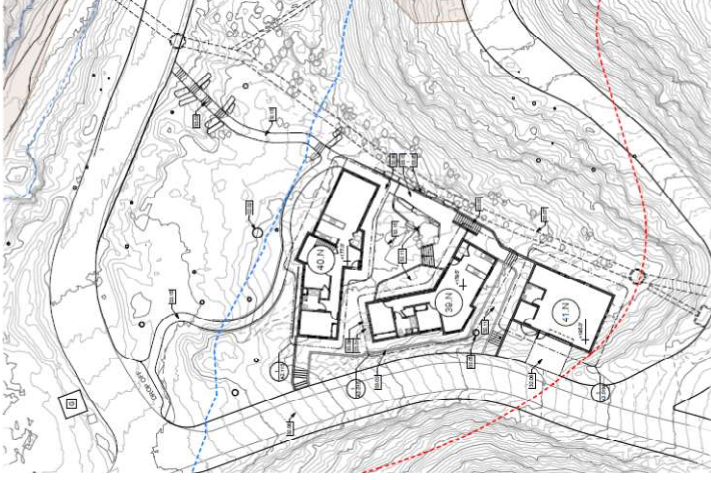
Alternative 2

Scout's Grove as Proposed May 2021

Blue line indicates 100 feet from top of bank
of Little Sycamore Creek

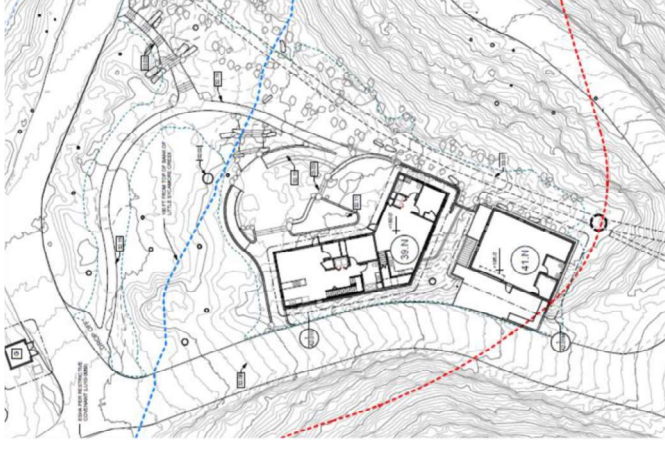
Alternative 3

Scout's Grove as Proposed October 2022

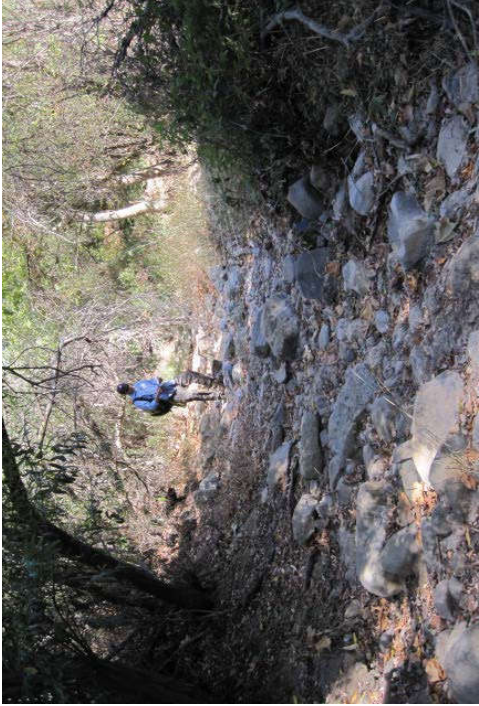
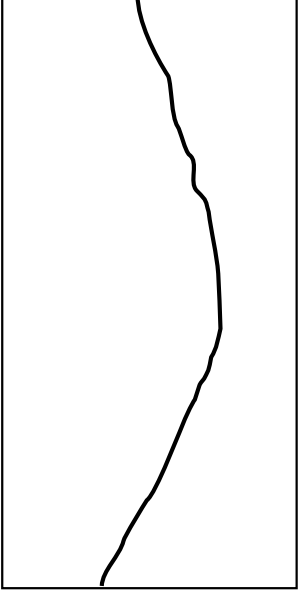
- Low confinement reaches have a relatively high width:depth ratio so that as runoff volume increases during a storm the flow tends to spread out laterally rather than become deeper. This allows erosive energy to be dissipated on the bed and low floodplain of the creek rather than attacking the banks. Creek sections with a high width:depth ratio also tend to support more riparian habitat on low floodplain benches that are frequently inundated. Low confinement reaches are considered to be stable; they should support high quality and more diverse habitat and should have relatively low rates of erosion.

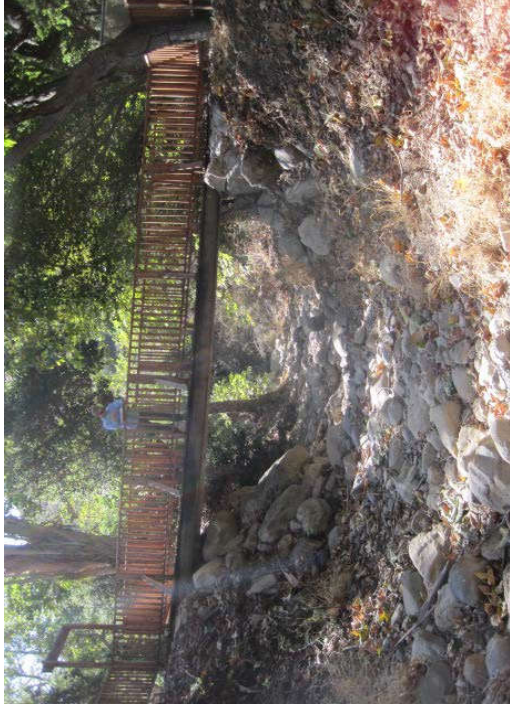
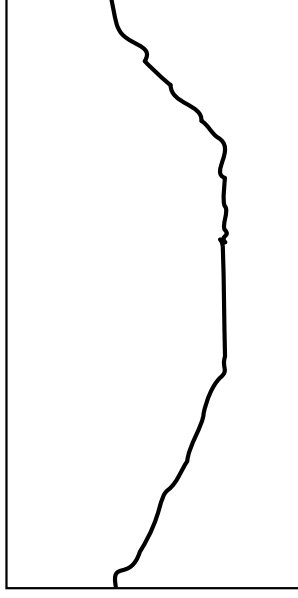
- Medium confinement reaches have a lower width:depth ratio, so increases in runoff volume are expressed more as increases in flow depth than width. This condition increases the erosive energy, focuses energy more directly on the creek banks, and has steeper banks that may not support riparian vegetation as much as Low confinement reaches. Medium confinement reaches are considered to be unstable, with active erosion and limited habitat.

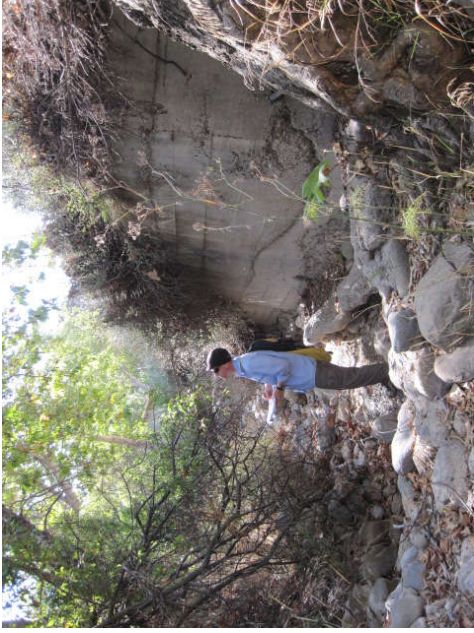
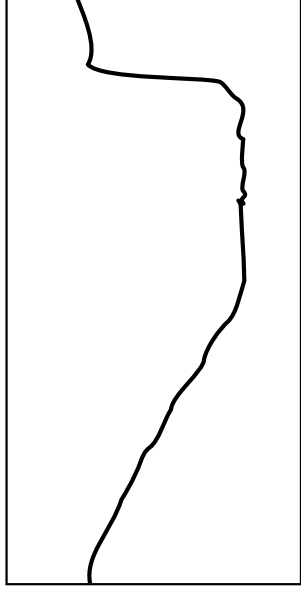
- High confinement reaches have the lowest width:depth ratios found in Little Sycamore Canyon Creek and are deeply entrenched. The banks are almost vertical, often actively eroding, and support few riparian trees. High confinement reaches are highly unstable, characterized by major bank failures, channel incision and/or potential damage to adjacent infrastructure during flood events.

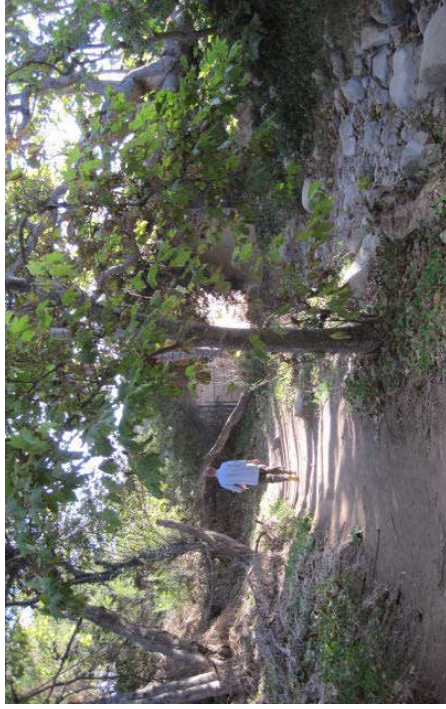
Medium confined section just upstream of the Pacific Coast Highway crossing and beach, STA 0+50

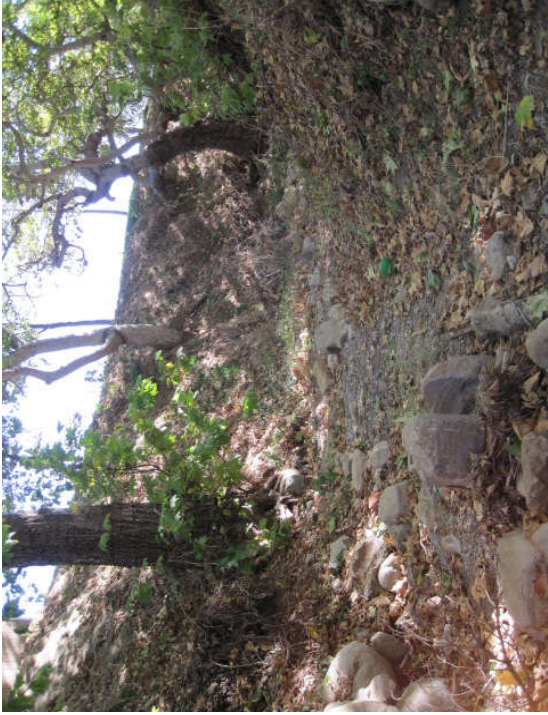
High confinement area and outside bend erosion adjacent to playing fields, STA. 4+00

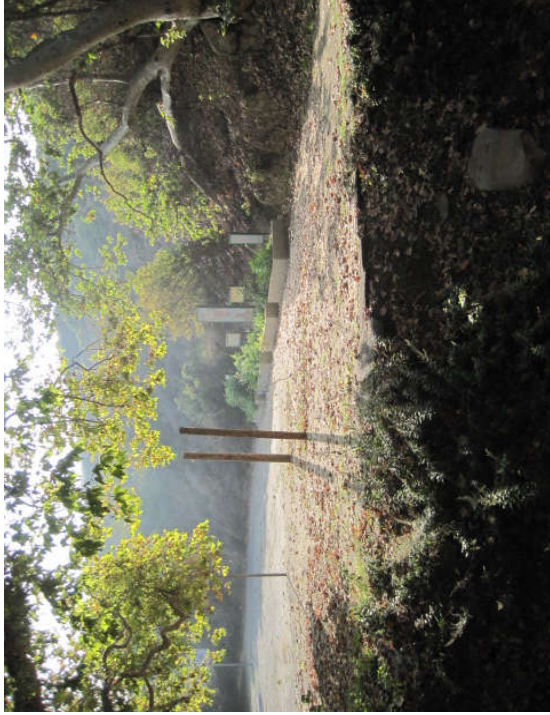
Asphalt basketball court (STA 1+50 to STA 3+50)

Potential Actions: remove asphalt surface, excavate and grade a lower area to create an active floodplain bench

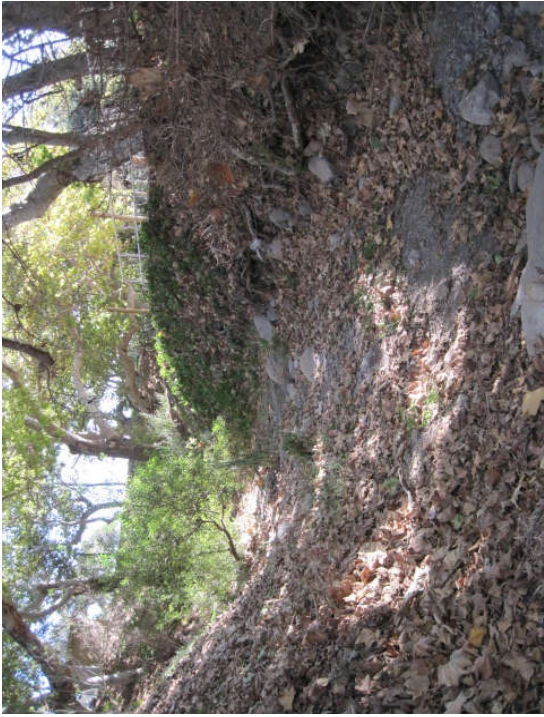
Medium confinement between playing fields and asphalt basketball court (~STA 5+00, Cross section 1A).

Potential Actions: remove dumped material on left bank, remove asphalt trail and lower ground on right bank, preserve sycamores

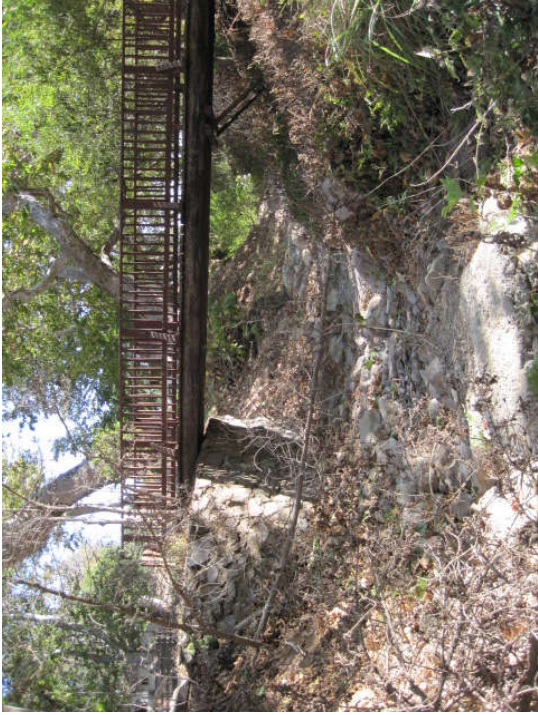
Medium confinement between 1st road bridge and footbridge
(~STA. 7+00)

Potential Actions: remove asphalt surface, excavate and grade a lower area to create an active floodplain bench

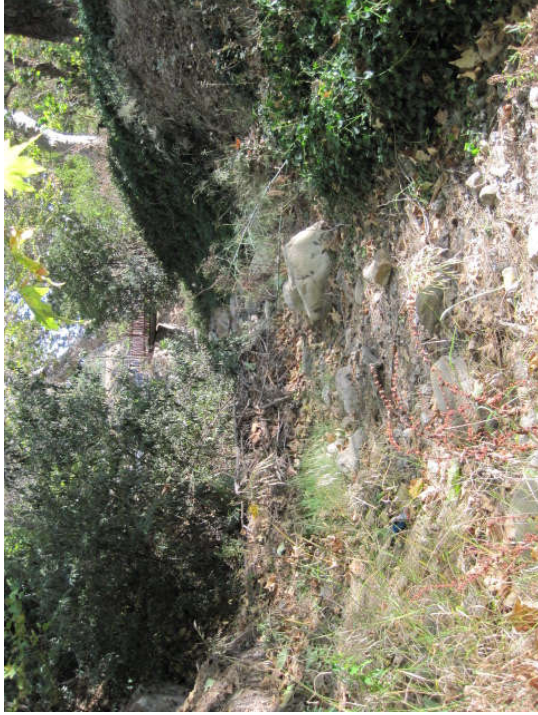
High confinement extending 50-80 feet downstream of road bridge at STA. 9+00

Potential Actions: remove non-native plant species (ivy) and replant with native tree and plant species

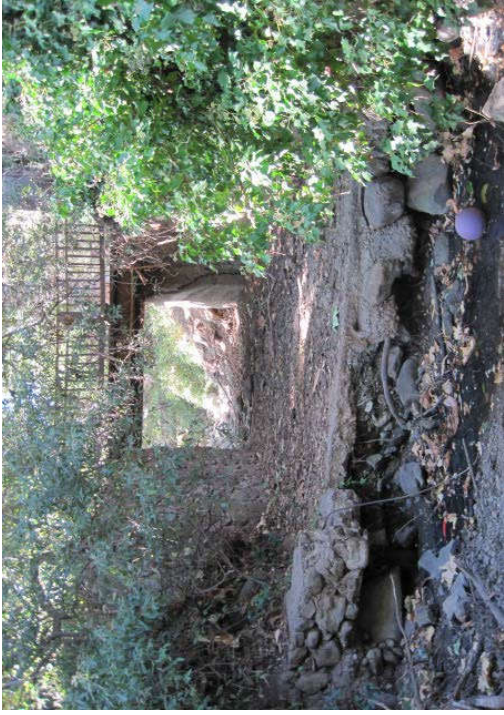
High confinement and bed erosion downstream of the 1st road bridge at STA. 9+00

Potential actions: widen or replace bridge, stabilize eroded knickpoint with rock ramp, manage/remove non-native vegetation

- (CE) Widen the 1st road bridge to reduce flow constrictions and associated flooding and erosion.
- (CS) Remove dumped debris and restore banks with native vegetation
- (CE/S)) Remove bridge remnants on right bank between Breuer Lawn and parking lot and stabilize drop structure with boulder step-pool or rock ramp
- (S) Lay back and stabilize the steep outer bend (right bank) opposite Breuer Lawn

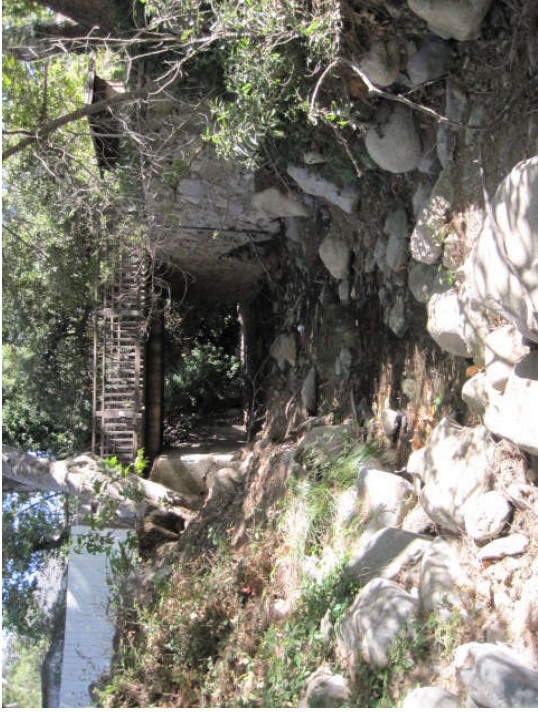
Highly confined conditions upstream of the 1st road bridge at STA 9+00

Potential Actions: widen or stabilize existing bridge

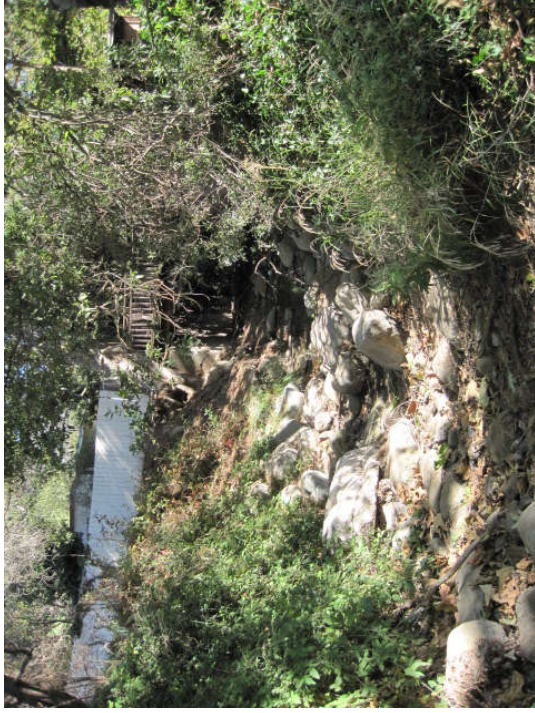
Medium confinement through the maintenance area to the road bridge

Potential Actions: remove dumped debris from left bank, vegetation management

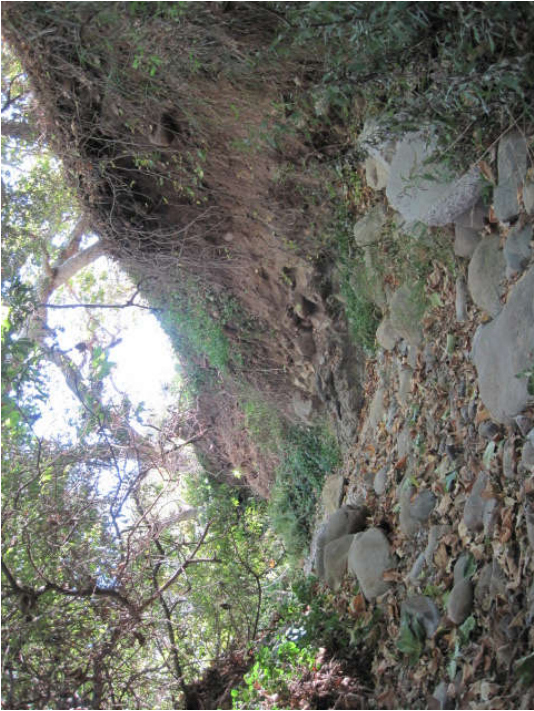
Local severe bank erosion opposite
Breuer Lawn

Potential Actions: lay back and stabilize
banks while preserving mature
Sycamores and Oaks

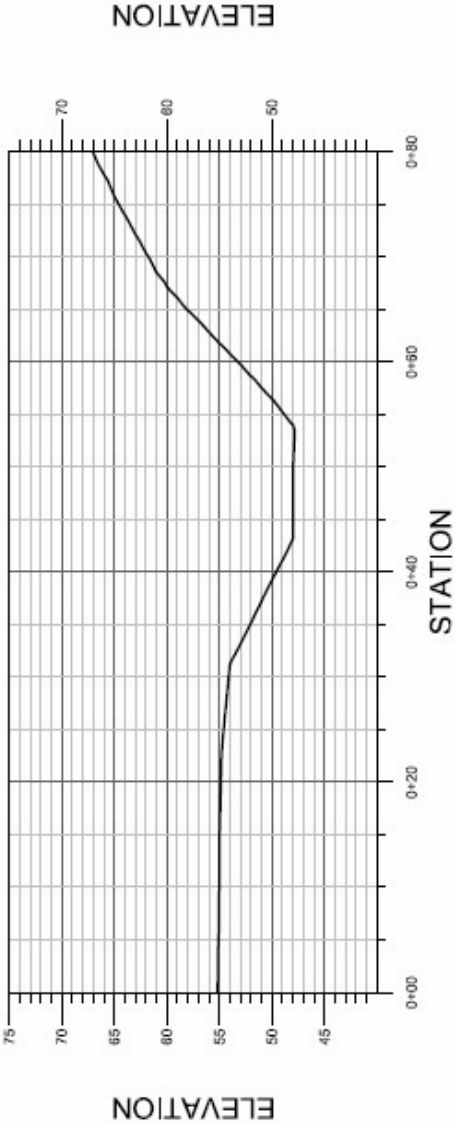
Typical cross section in Reach 2 (Cross section 2A)

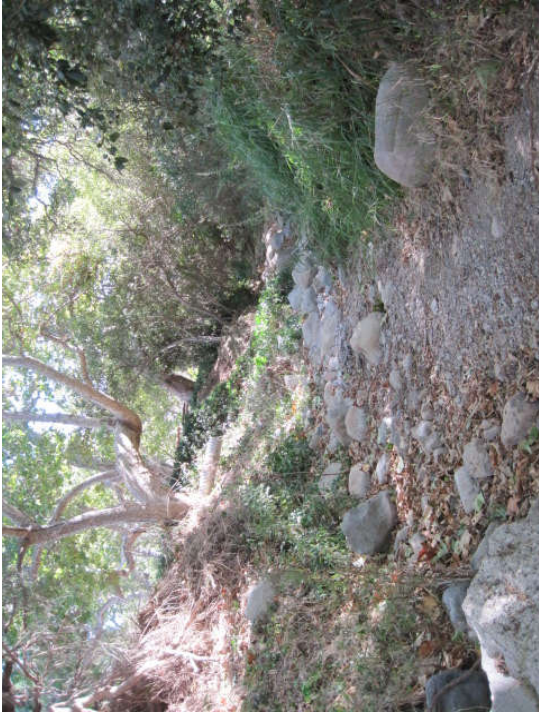
Medium confinement typical of conditions throughout the parking lot area (Cross section 2B)

Potential Actions: cut floodplain bench on left bank while preserving trees, regrade and stabilize right bank, shorten and install erosion control for stormwater culvert on right bank

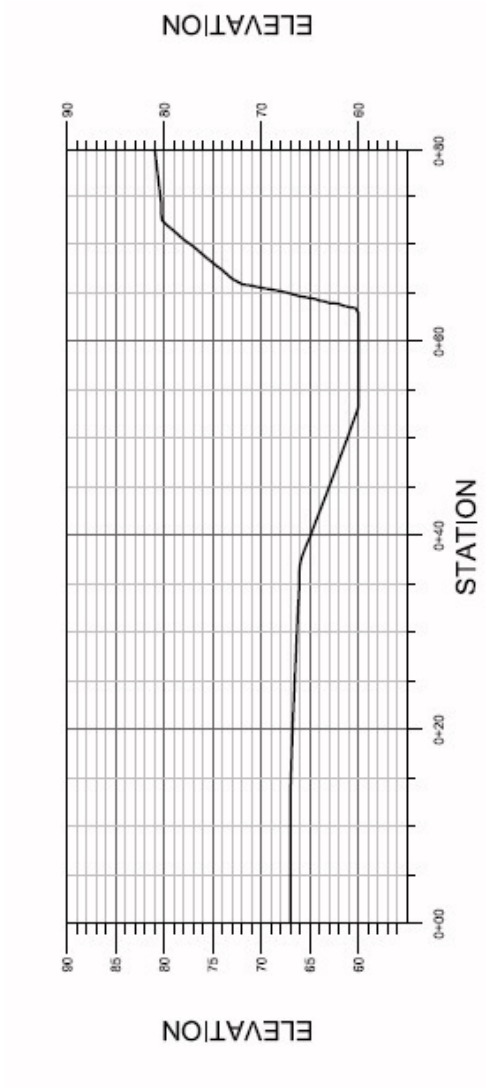
Cross section in Reach 2, STA. 9+50

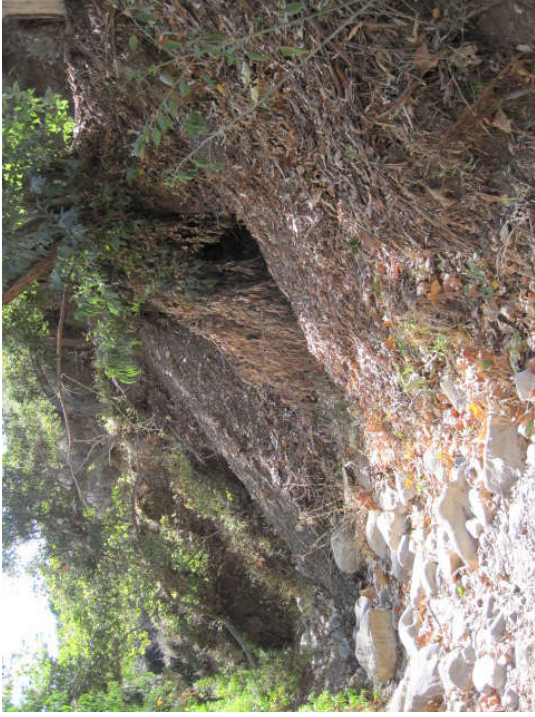
Earth and organic matter dumped on banks downstream of road bridge at STA 15+60

Potential Actions: remove dumped material and revegetate banks, replace or widen bridge

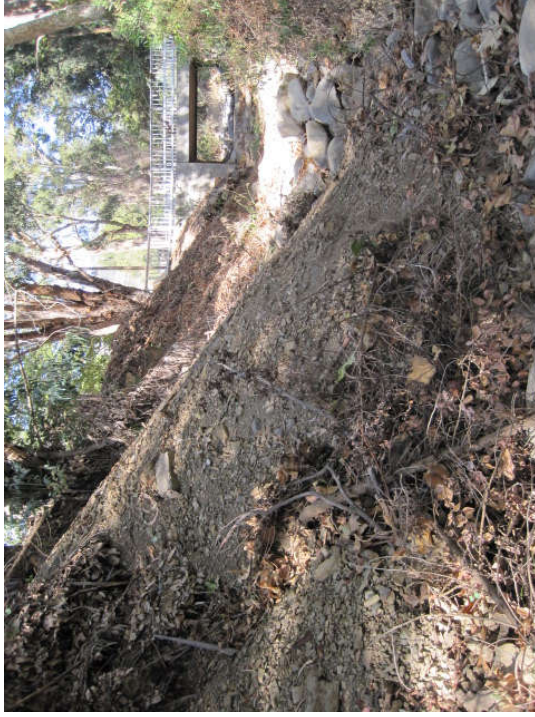
Earth and organic matter dumped on banks downstream of road bridge at STA 15+60

Potential Actions: remove dumped material and revegetate banks, replace or widen bridge

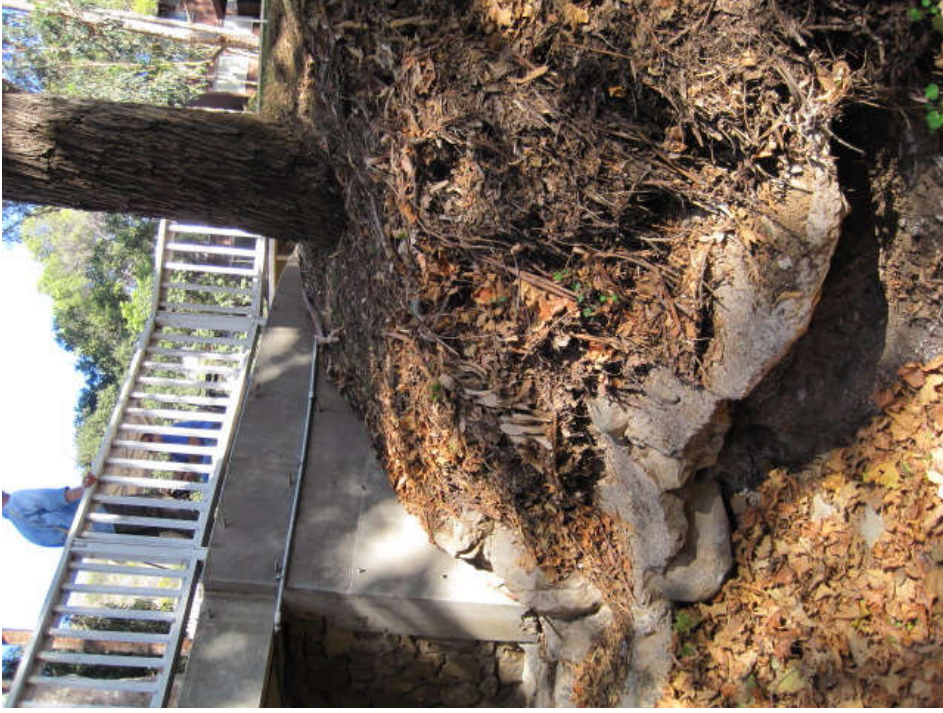
Undercut grade control at 2nd road crossing

Potential Actions: replace or widen bridge and stabilize bed with a boulder step-pool structure or rock ramp

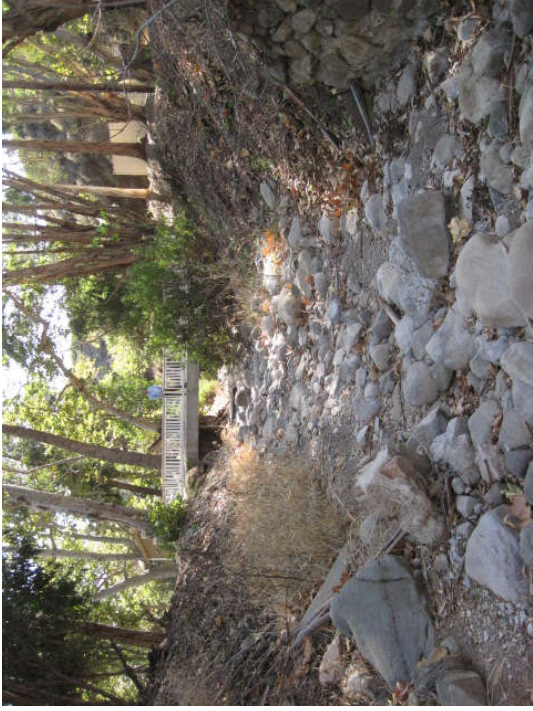
Medium confinement around rope course

Potential Actions: remove dumped debris

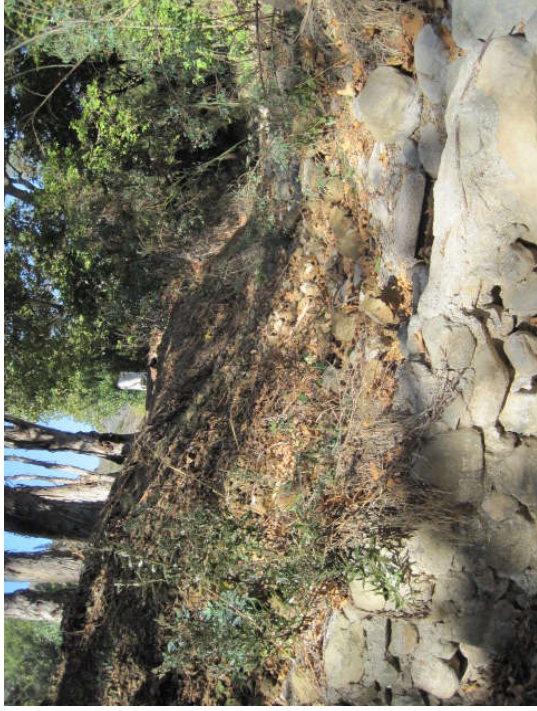
Earth dumping above grade control structure adjacent to the rope course (looking upstream). Reach is classified as Medium confinement.

Potential Actions: remove dumped debris

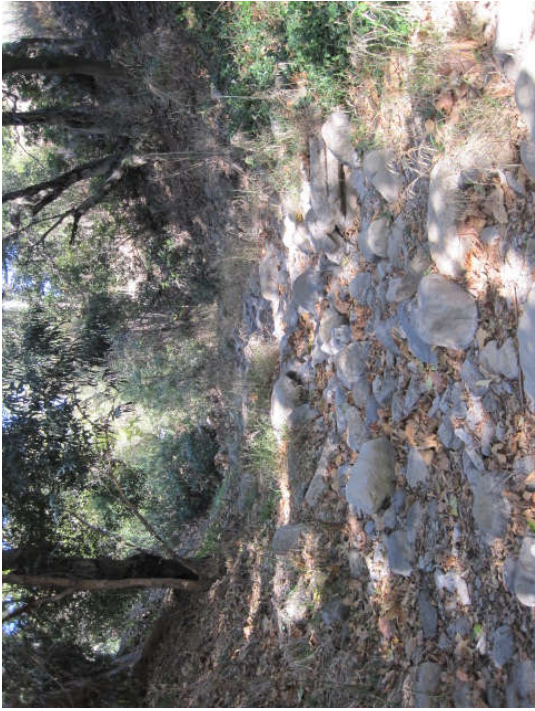
30-foot sub reach of Low confinement in a mostly Medium reach opposite Baruh Hall

Potential Actions: remove non-native hedge between Baruh Hall and the creek

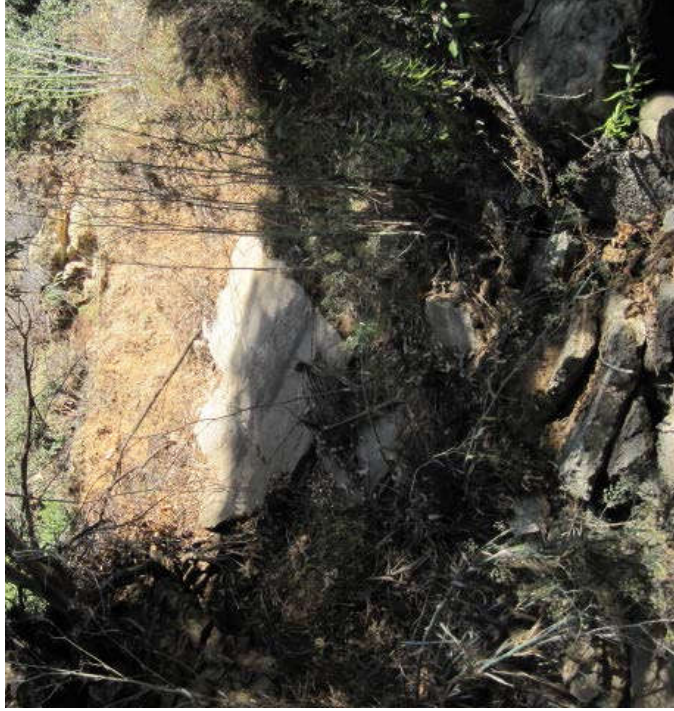
Failing grade control structure adjacent to the landslide

Looking south (left) onto the toe of the landslide where flow impinges

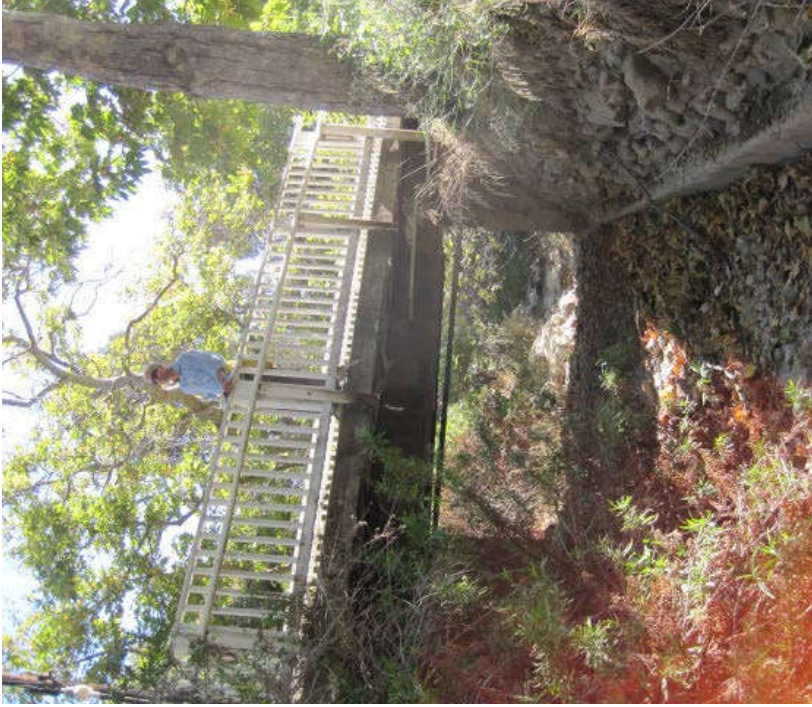
Highly confined reach upstream of bridge, adjacent to pool. This artificially straightened reach causes flow to concentrate and impinge on the toe of the landslide immediately downstream of the 3rd road bridge (left side below bridge in photo).

Potential actions: Widen bridge, lay back left bank (removing road) or buttress left bank (reconstructing road), stabilize landslide toe with vegetated rock, stabilize failing drop structure.

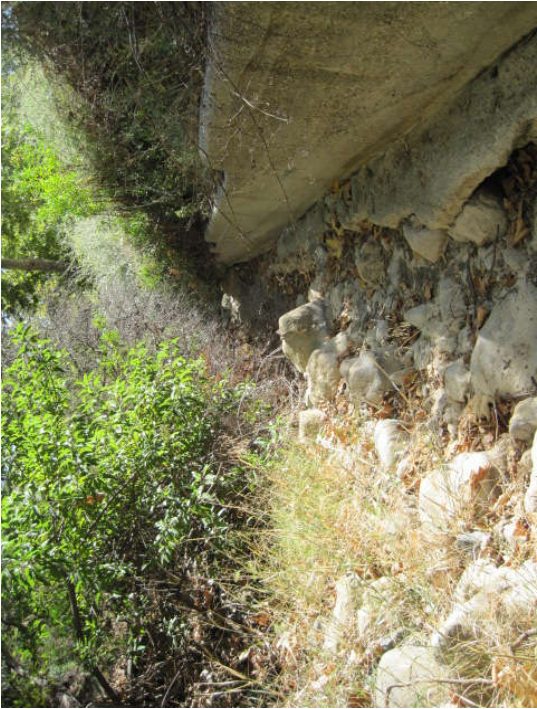
High confinement in the concrete-lined, straightened reach upstream of the swimming pool. Note undercutting of concrete retaining wall. Cross section 3A.

Potential Actions: repair failing sections of bank

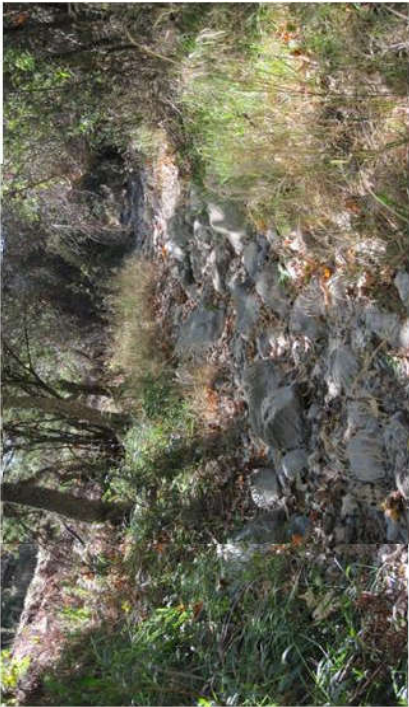
Low confinement area downstream of the archery bridge, upstream of the dance stage. This reach is one of the least disturbed areas of Little Sycamore Creek and shows how much of the remaining creek may have appeared prior to development. Cross section 3B.

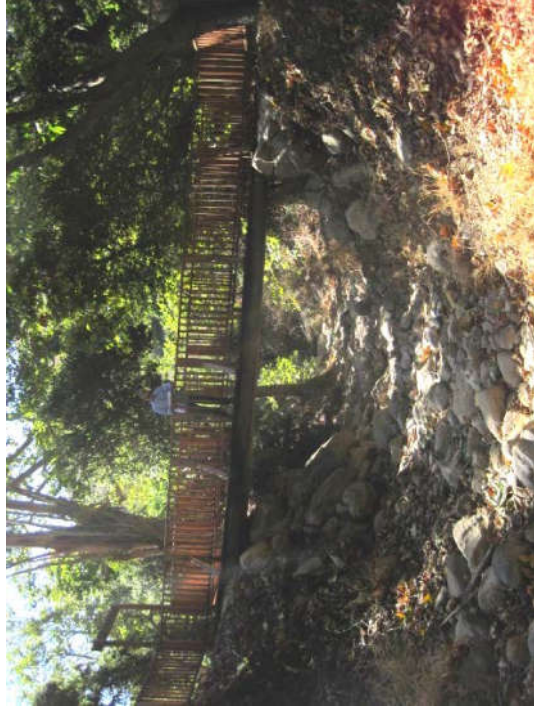
Medium confinement around the archery footbridge

Potential Actions: No recommended actions

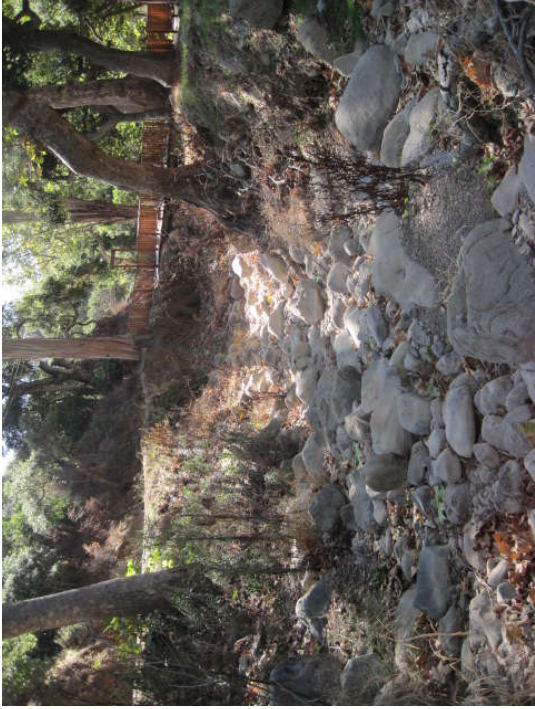
Transition to medium confinement near the archery area

Potential Actions: No recommended actions

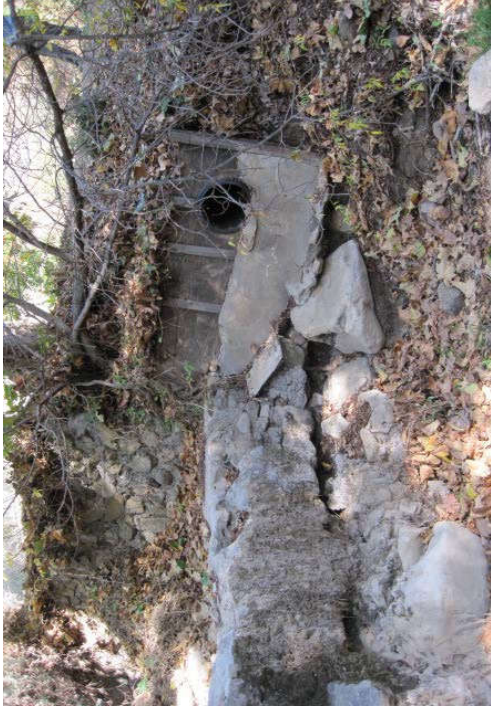
Failing drop structure by stormwater discharge pipe at STA 26+40

Potential Actions: replace failing drop structures with boulder step-pool or ramps

- (S) Repair failing grouted drop structures and replace with boulder drop-pools
- (CE) Remove tire bank stabilization structures and replace with rock and biotechnical stabilization

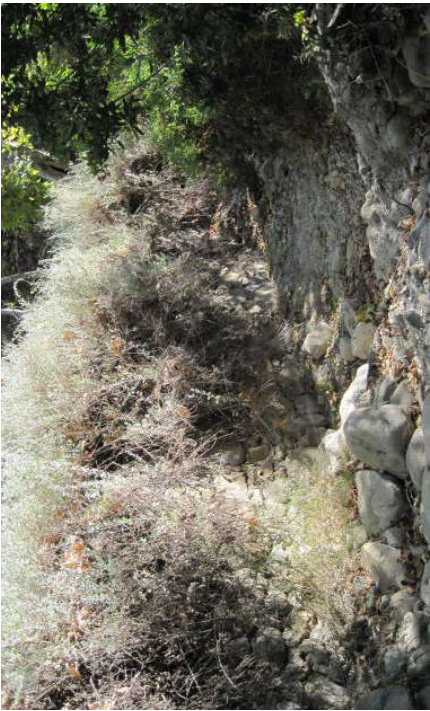
Deeply confined reach downstream of chapel. Cross section 4.

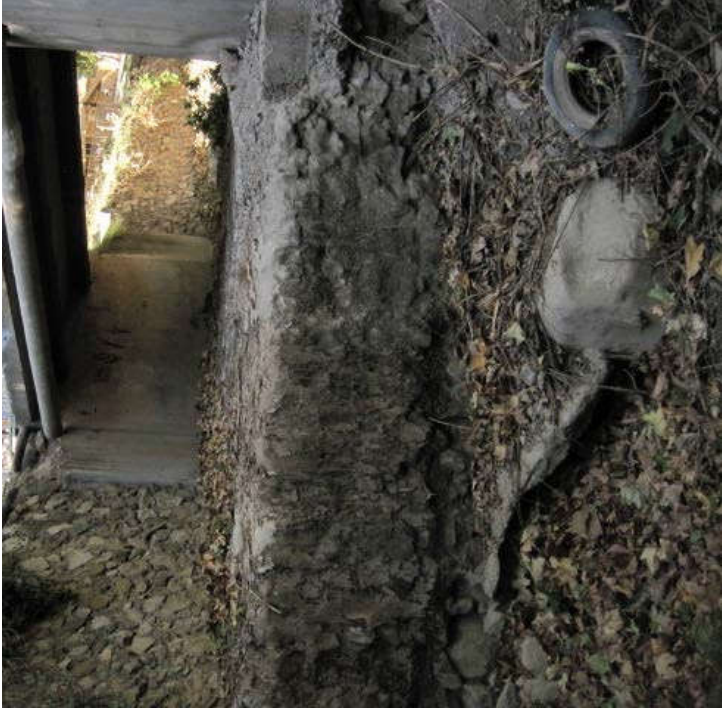
Looking upstream at road bridge (STA 29+10) showing channel incision on the downstream end.

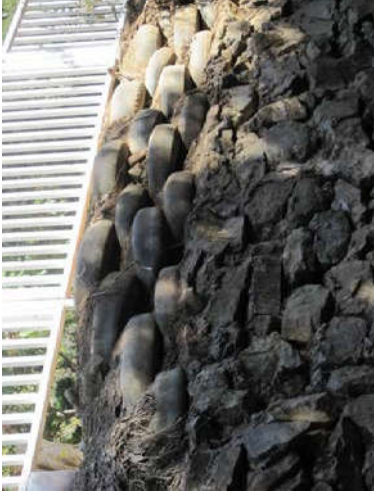
Close up of tire bank stabilization

Potential Actions: remove tires and replace with biotechnical bank stabilization

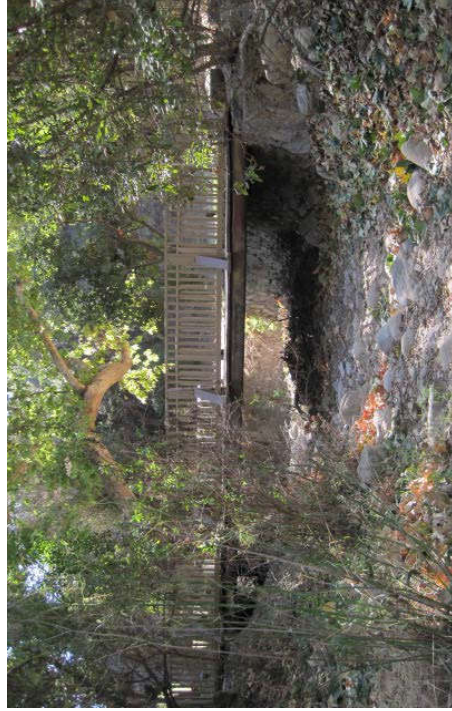
Medium confinement looking downstream towards 3rd road bridge

Potential Actions: No recommended actions

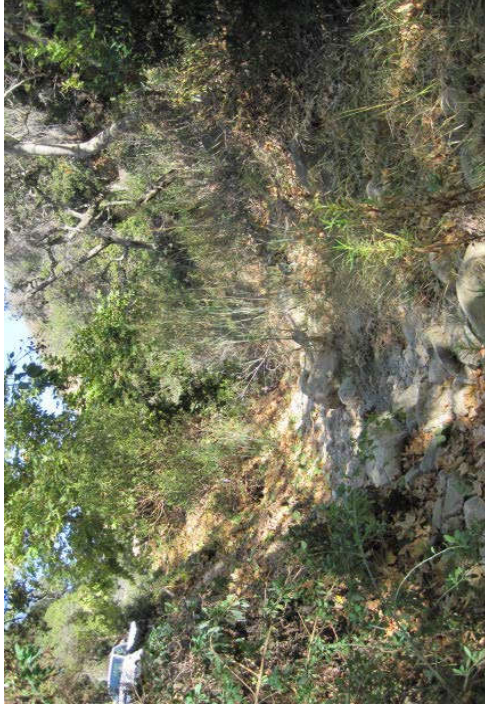
Typical view of 'Medium' level confinement in Reach 5.
(Note: image is looking upstream while cross section is oriented looking downstream.) Cross section 5.

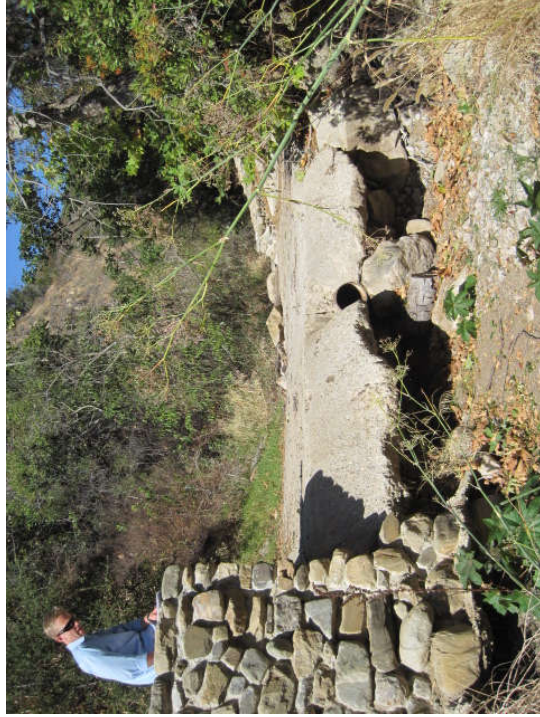
Grade control structure at ford on upstream property boundary. Note undercutting of road crossing.

Potential Actions: replace ford with bridge, stabilize drop with boulder step-pool

- (CS) Remove dumped debris from north bank
- (S) Replace ford at upstream boundary with bridge for all-season access
- (S) Stabilize undercut drop structure at upstream boundary
- (SM) Formalize and control surface runoff from hillslope currently passing down road

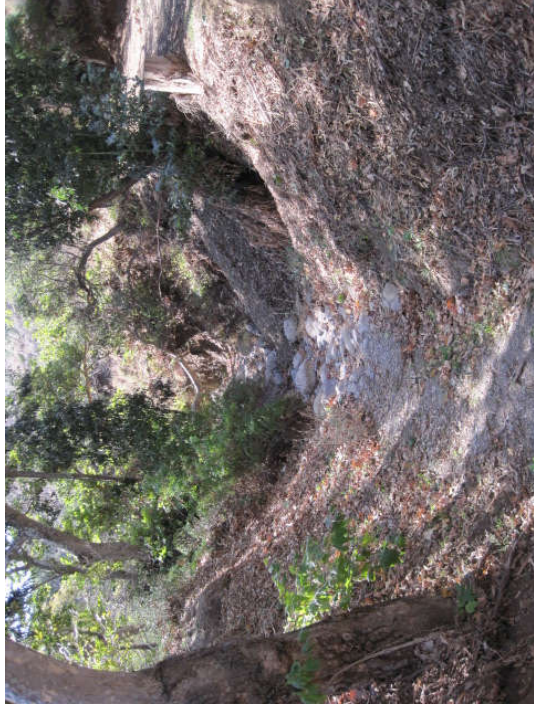
Example of a reach where dumped debris has confined the creek cross section and created steep, unvegetated banks

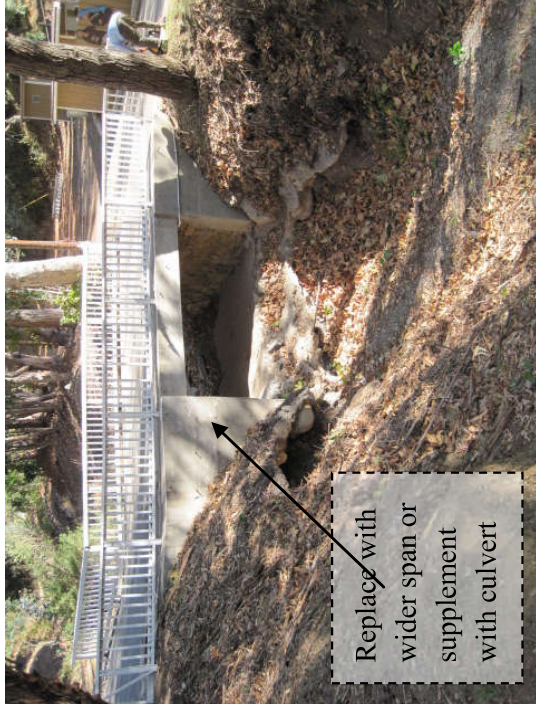
Road bridge #2 is undersized for the channel and flows resulting in channel incision and flooding.

- Replace bridges with wider spans or retrofit the existing bridges with box culverts to increase conveyance capacity. The highest priority bridges for replacement are road bridges 2 and 3. Road bridge 1 would also benefit from widening, though this is not as high a priority.
- Remove berms, widen portions of creek and lay back eroding and slumping banks to a more gentle angle to create low flow floodplains and benches, and to reduce flooding and erosion

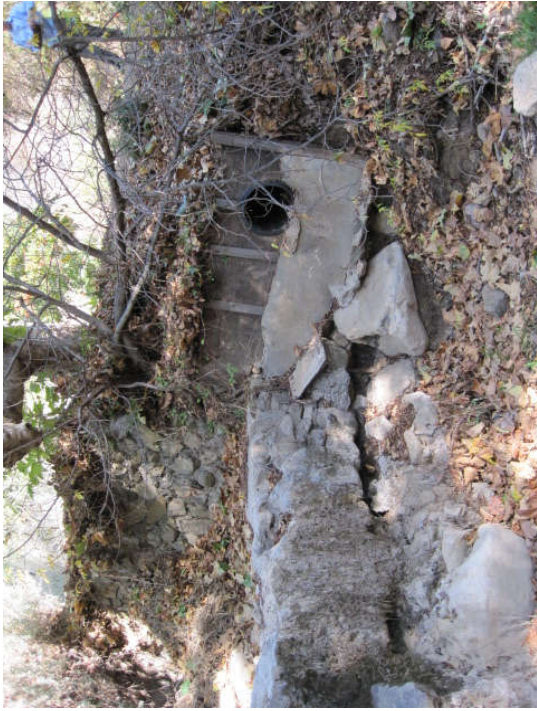
Example of a failing concrete drop structure.

- Stabilize failing grade control structures by retrofitting/replacing them with loose (not grouted) boulder step-pools or roughened rock ramps.
- Stabilize the landslide in Reach 3. This would involve either laying back (excavating) the existing left bank (eliminating the failed road section) or reconstructing the bank on a stabilized toe structure (allowing the road/trail to be reincorporated). In both cases a rock toe would be required to prevent future bank erosion. It should be noted that although stabilizing the bank toe will increase slope stability compared to current conditions, it will not be sufficient in itself to prevent some future movements in the landslide.

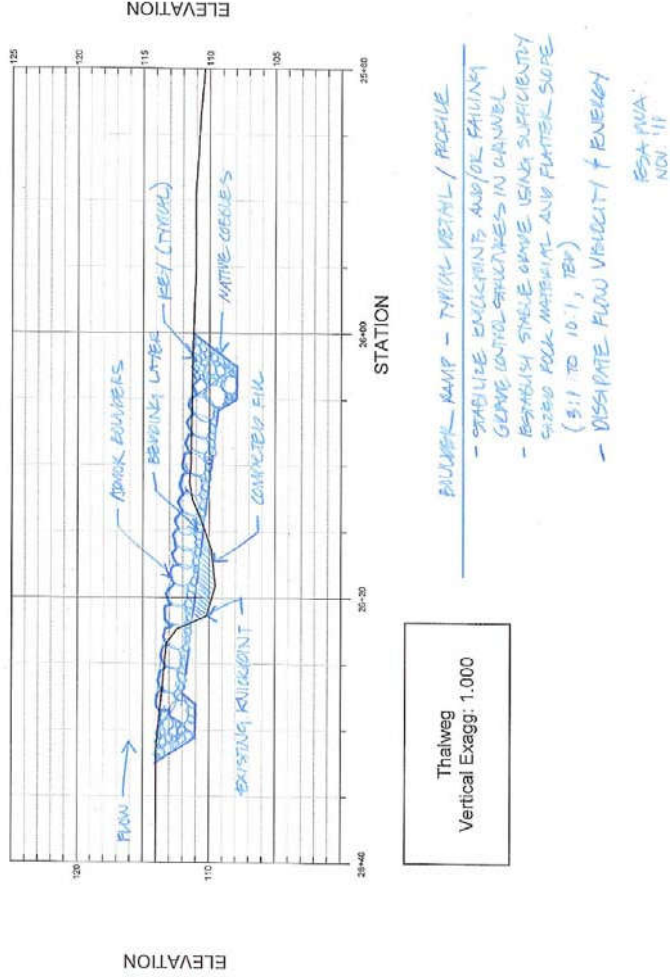
Conceptual Sketch of Channel Stabilization Structure (Boulder Ramp)

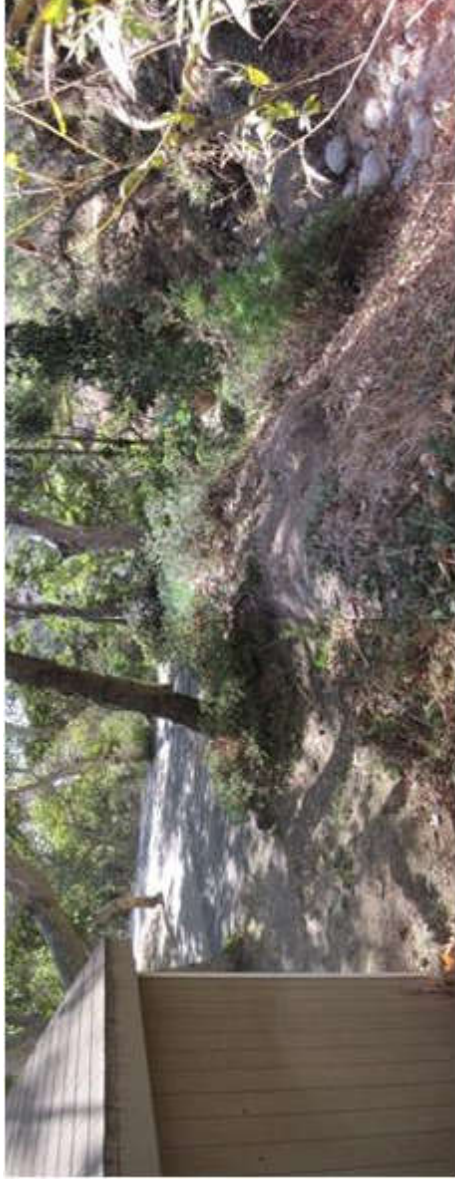
A potential floodplain grading site (by the lower camp parking lot). Actions would include removing the shed and berm on the left, and lowering the terrace by approximately 6 feet to form a floodplain area next to the creek. The mature sycamores in the background would be preserved on a linear island between the creek and the floodplain.

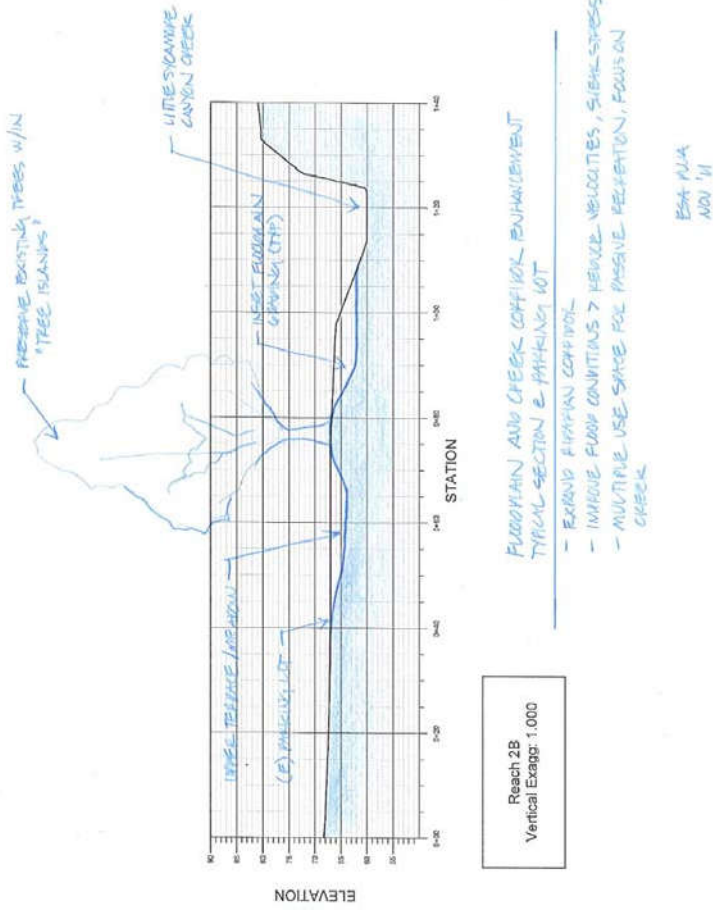
Conceptual Sketch of Floodplain Bench

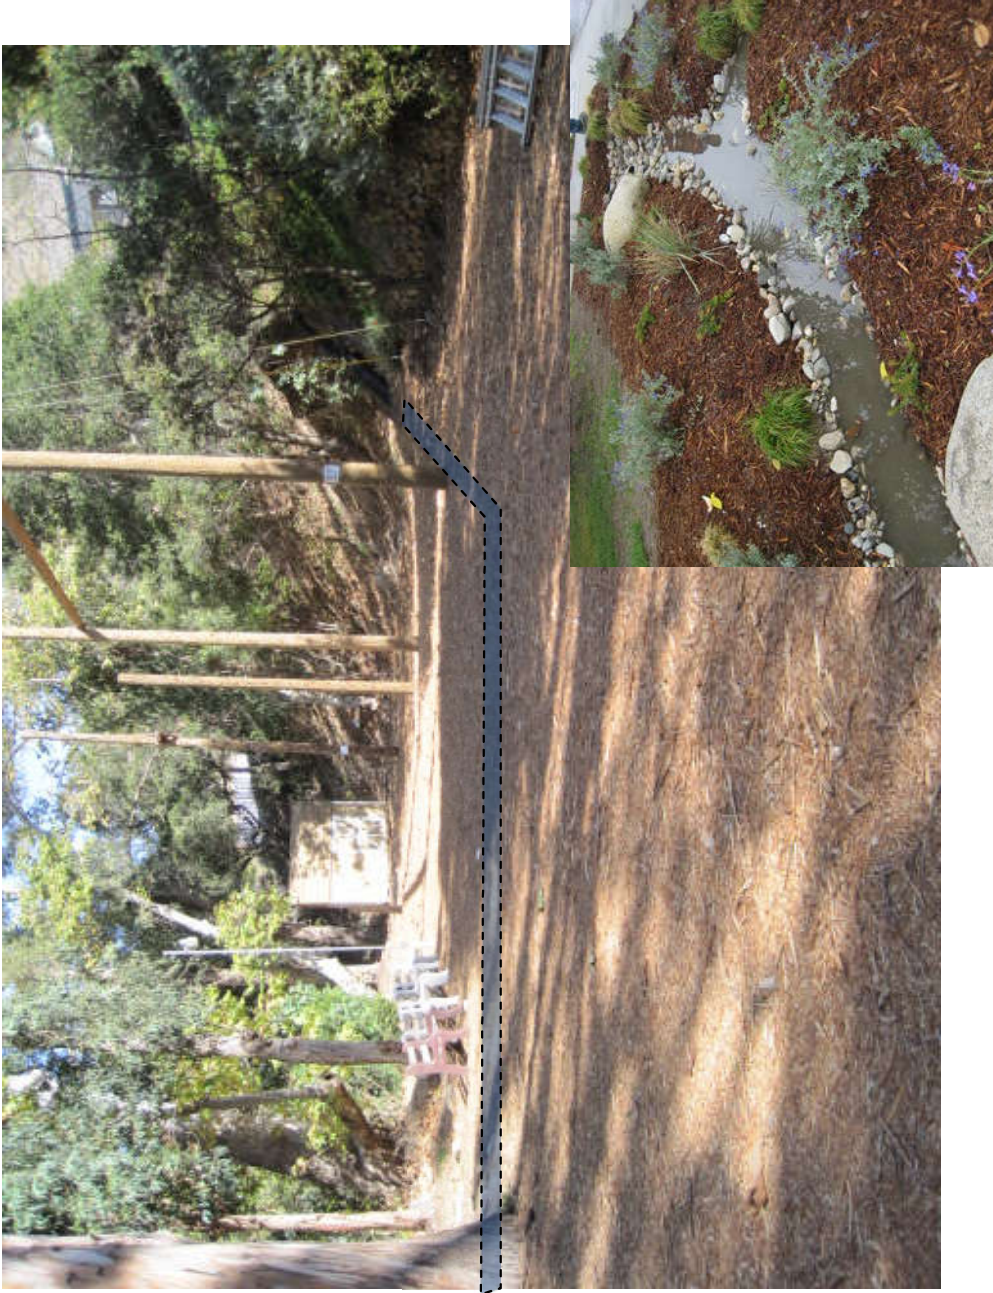
Rope course showing the existing stormwater pipeline alignment (dashed line). Insert shows example of a bioswale infiltrating stormwater.

- Remove asphalt areas and replace with pervious surfaces
- Redirect concentrated runoff (roofs, driveways, parking areas, etc) to vegetated bioswales, planted detention basins, etc
- Retrofit the culverts entering the creek opposite the rope course and detain/infiltrate the runoff through a bioswale
