**Draft Least Environmentally Damaging Alternatives Analysis
Camp Hess Kramer and Gindling Hilltop Camps (PL21-0051)
11495 & 11677 Pacific Coast Highway, Unincorporated Ventura County**

LITTLE SYCAMORE CANYON CREEK WILSHIRE BOULEVARD TEMPLE CAMPS

Geomorphic Assessment and Recommendations

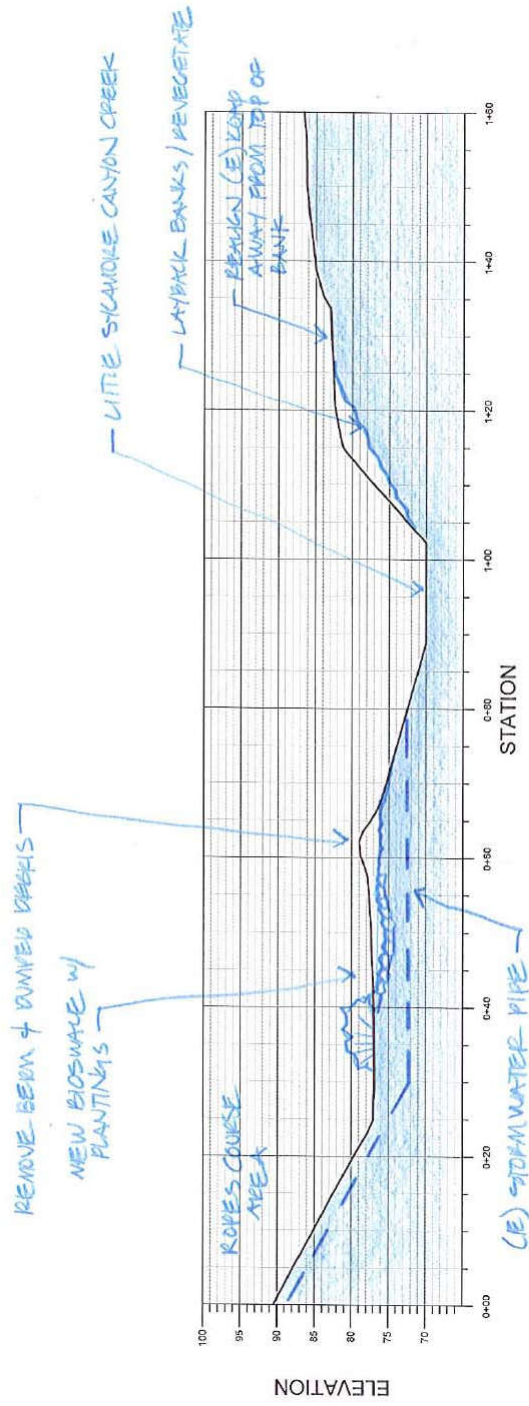
BANK STABILIZATION AND STORMWATER IMPROVEMENTS TYPICAL SECTION & CONFIDENCE BUILDING AREA

- LAY BACK OVER-STEEPENED BANKS, REALIGN ROAD
- REMOVE BERM AND DUMPED DEBRIS
- REASON & CONNECT STORMWATER PIPE TO VEGETATED BIOSWALE / ABANDON FROM CREEK
- MAINTAIN ROPES COURSE

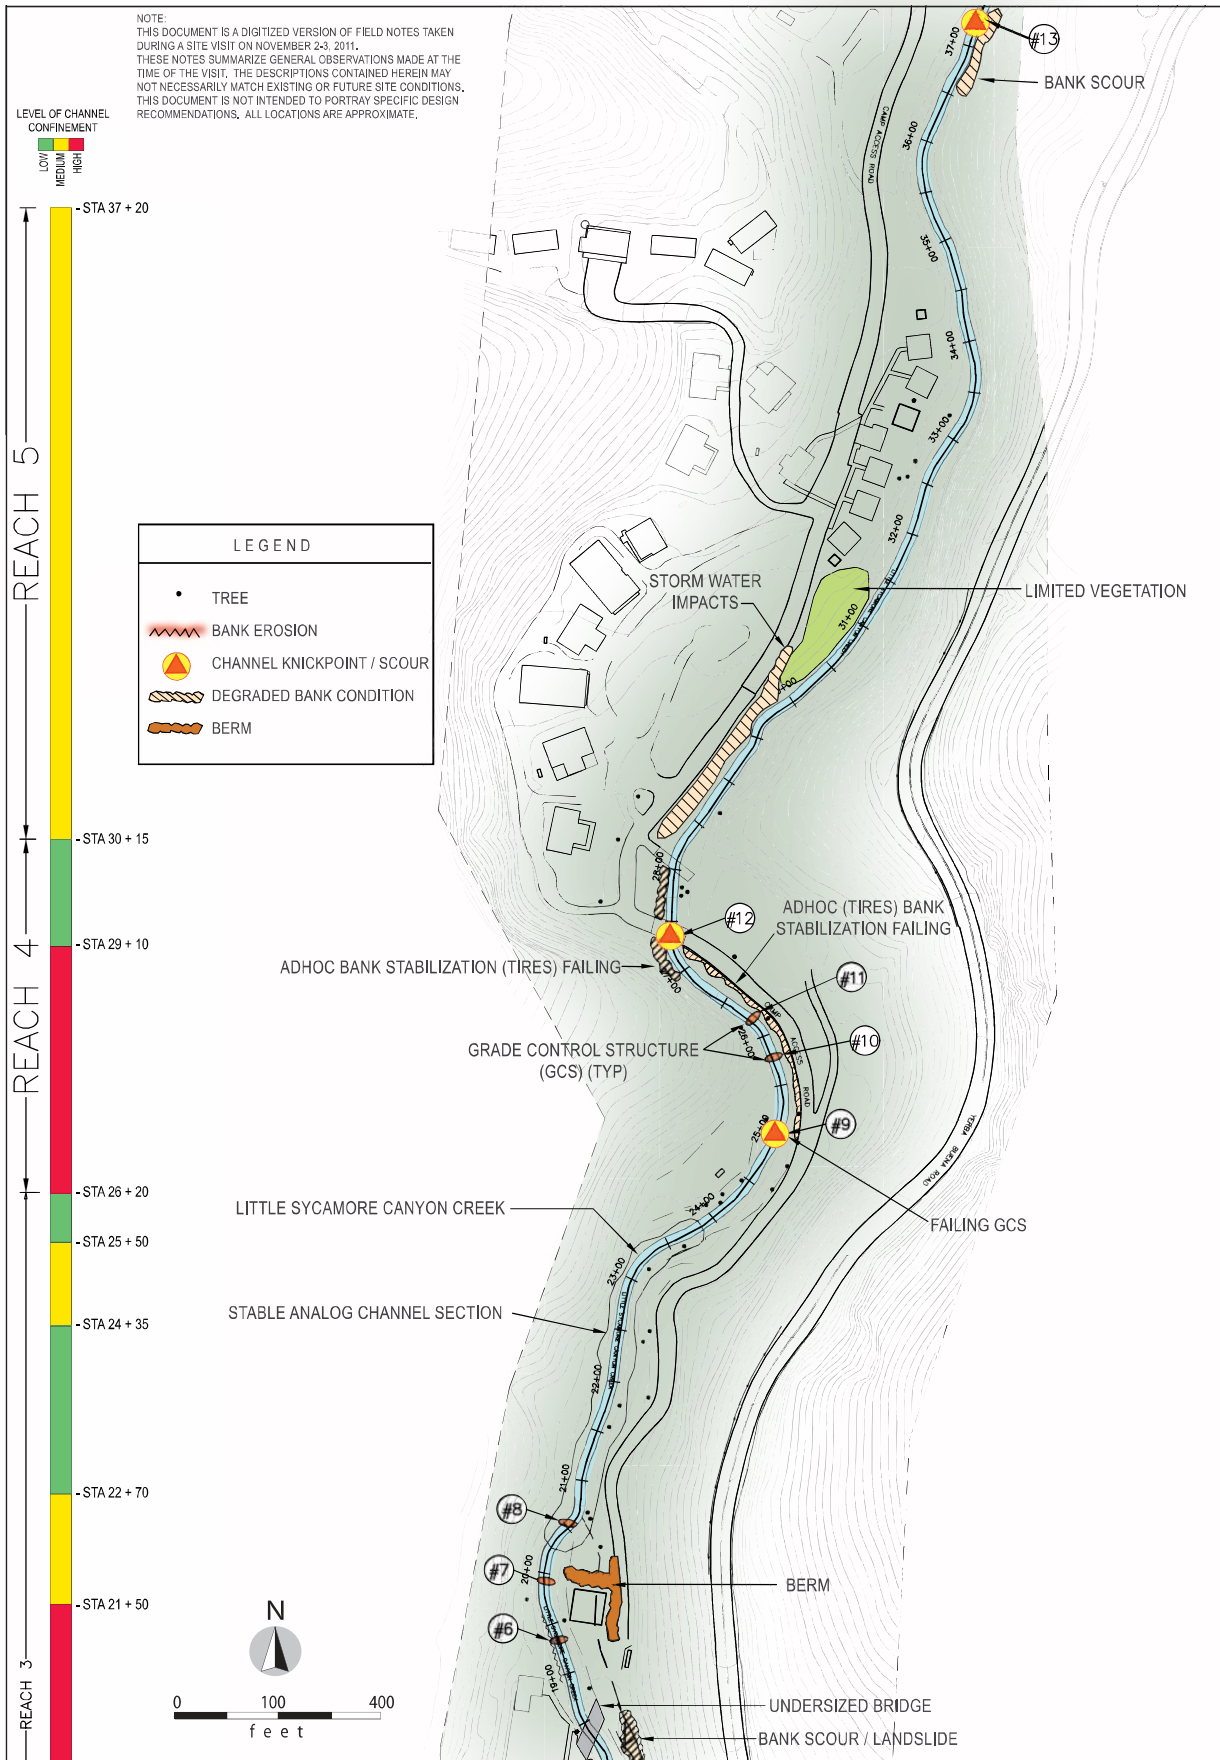
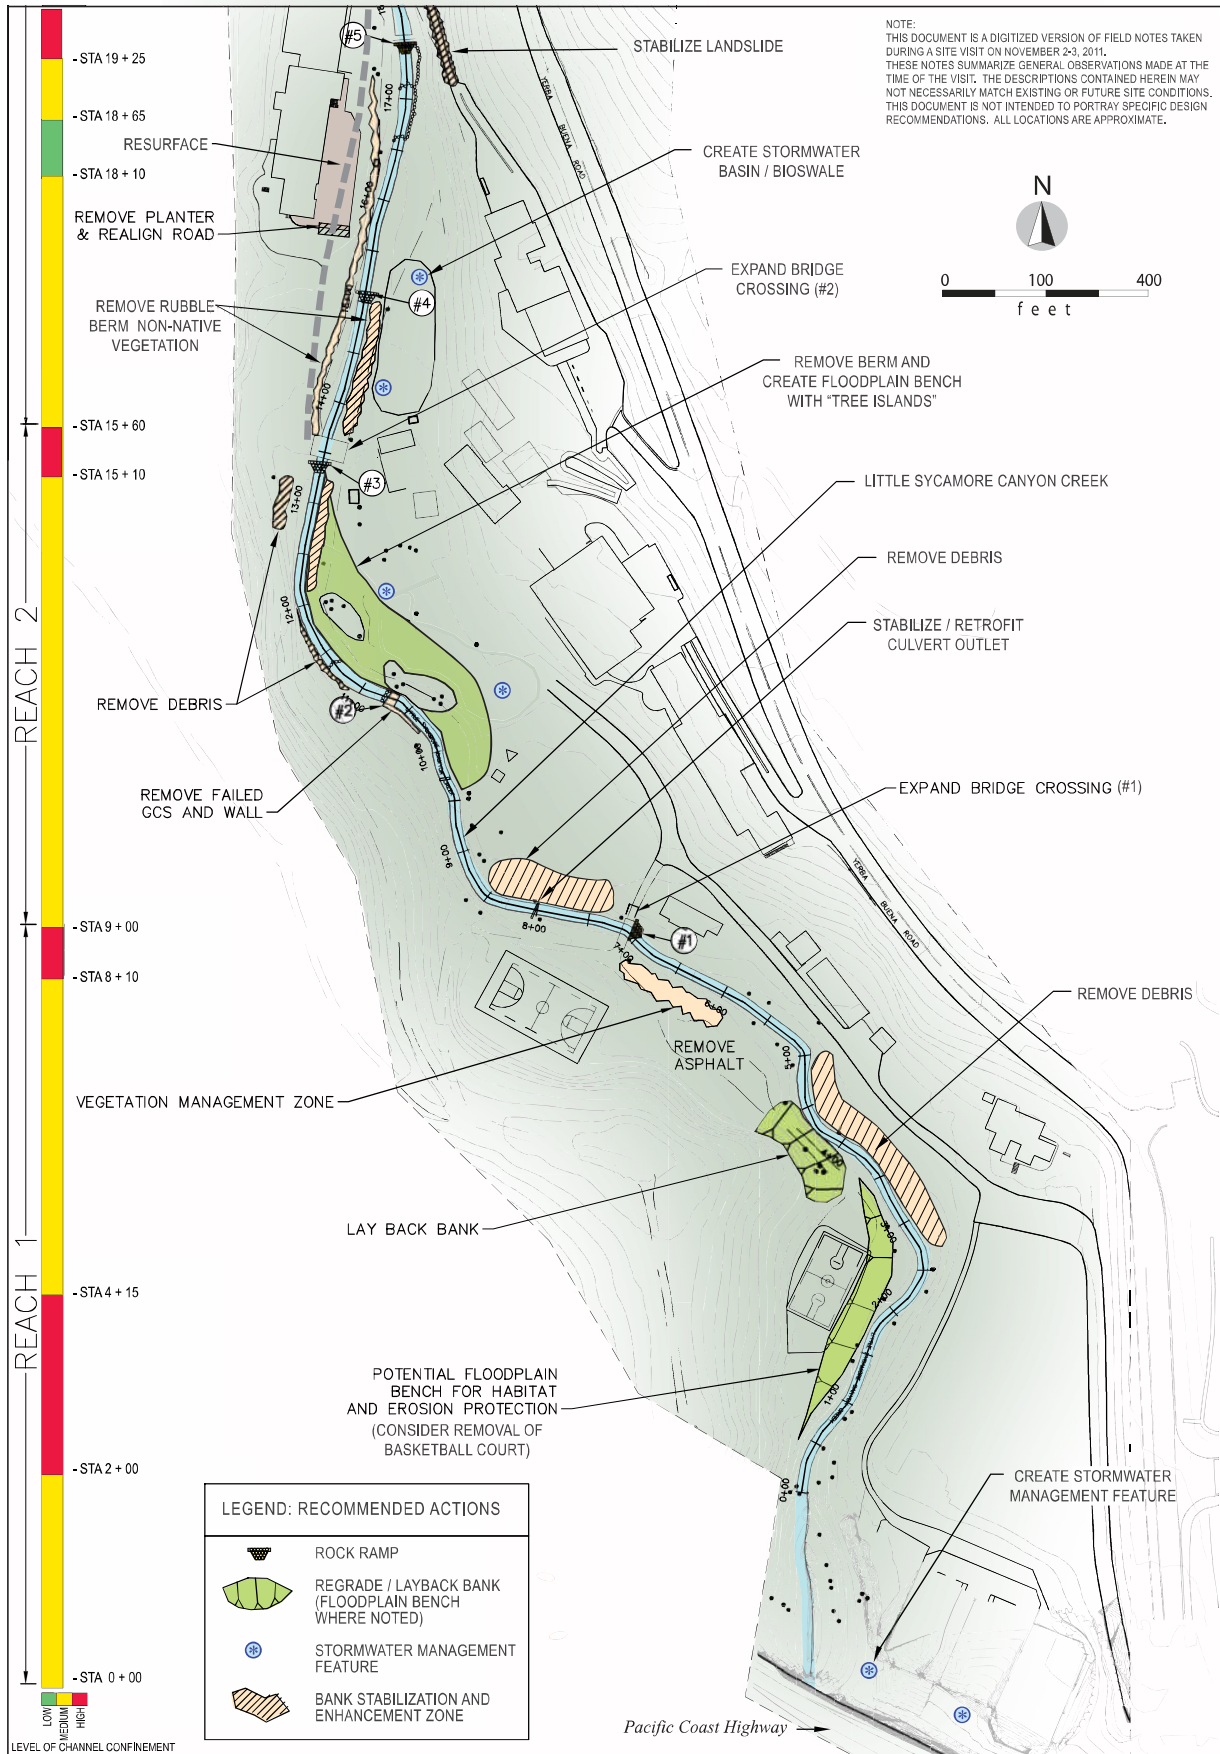
Figure 2A Map of Recommended Creek Improvement Actions

Figure 2B Map of Recommended Creek Improvement Actions
