OPERATION AND MAINTENANCE PLAN
Ferro Channel, Beardsley Watershed
Ventura County, CA

Description of the Project:

This project consists of the construction of approximately 1,700 linear feet of a widened and deepened rock lined channel that will replace the existing earthen trapezoidal Ferro Ditch. The new channel also includes a floodgate that will be placed between the adjacent field and the box culvert that conveys storm water flows from the field ditch to the Los Angeles Avenue Drain.

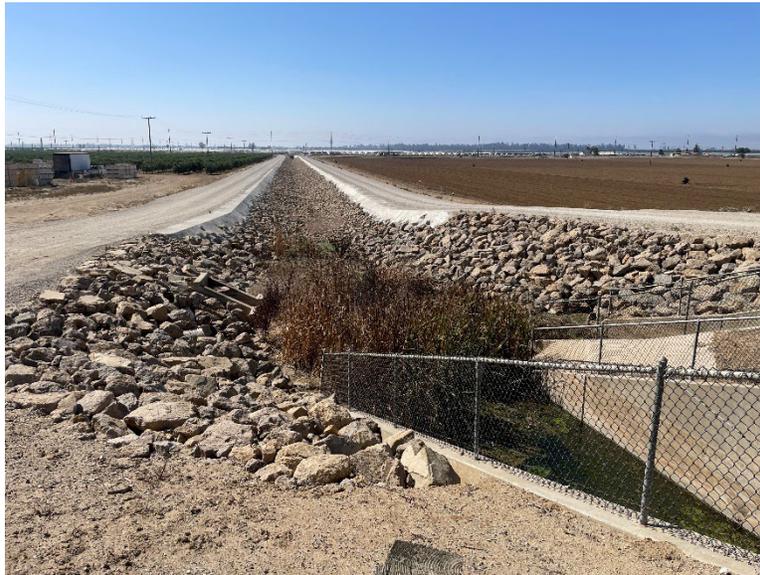
Figure 1: Stilling Basin and Rock Lined Channel with 2 Vehicle Access Routes (looking downstream)

1. Stilling Basin: Rock Riprap Lined (approximately 80' x 60')
2. Stilling Basin Outfall: Concrete Cut-Off Wall
3. Rock Riprap Lined Trapezoidal Channel: approximately 1500 LF; includes a 6" Thick Concrete Cap

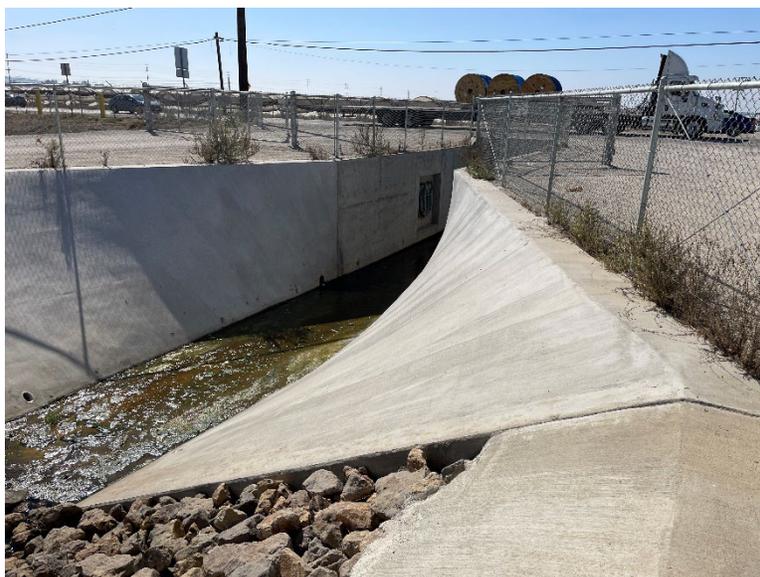
Figure 2: Concrete Transition and Box Conduit (downstream end of Ferro Channel at State Route 118)

4. Concrete Transition Structure (downstream of Rock Lined Section): 30 LF of Reinforced Concrete
5. Concrete Rectangular Channel (downstream of Transition Structure): 35 LF of Reinforced Concrete
6. Concrete Flared End Section (between Transition Structure and Box Conduit): a 36" Flap gate and Reinforced Concrete section that outfalls into the RC Rectangular Channel.
7. Concrete Box Conduit (at S.R. 118): 15 LF of Reinforced Concrete
8. Flood Wall (along S.R. 118): 40' Long x 6' Tall with a 3' x 4' Flap Gate and a 12" Diameter Flap Gate.
9. 2 x Vehicle Access Routes: approx. 3,600 Total LF. 16' Wide x 6" Thick Crushed Miscellaneous Base (CMB)
10. Safety Fence: 5' Tall Chain link with 2-18' Wide Gated Entrances.

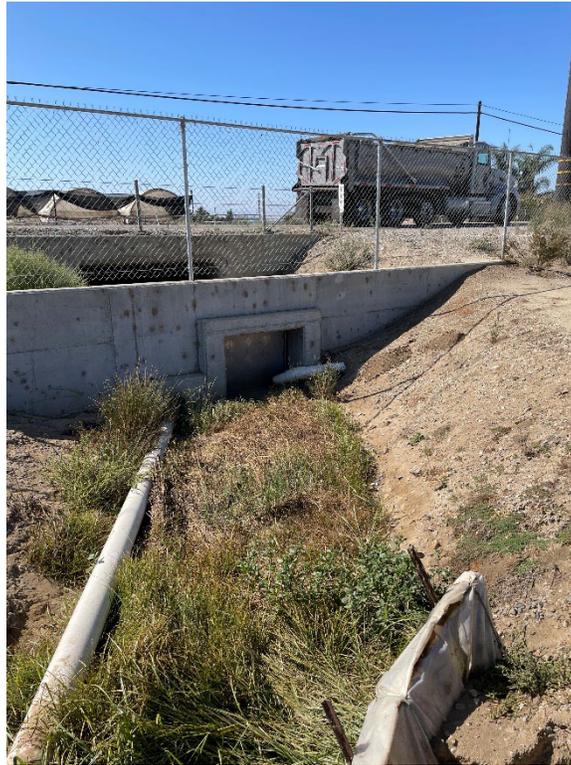
Figure 3: Flood Wall with Flap Gates (along State Route 118)
