EXHIBIT 5 – DRAFT CONDITIONS OF APPROVAL FOR MODIFIED CONDITIONAL USE PERMIT (CUP) AND MITIGATION MONITORING AND REPORTING PROGRAM FOR CASE NO. PL17-0012 AND DISCRETIONARY TREE PERMIT CASE NO. PL23-0040.

RESOURCE MANAGEMENT AGENCY (RMA)

Planning Division Conditions

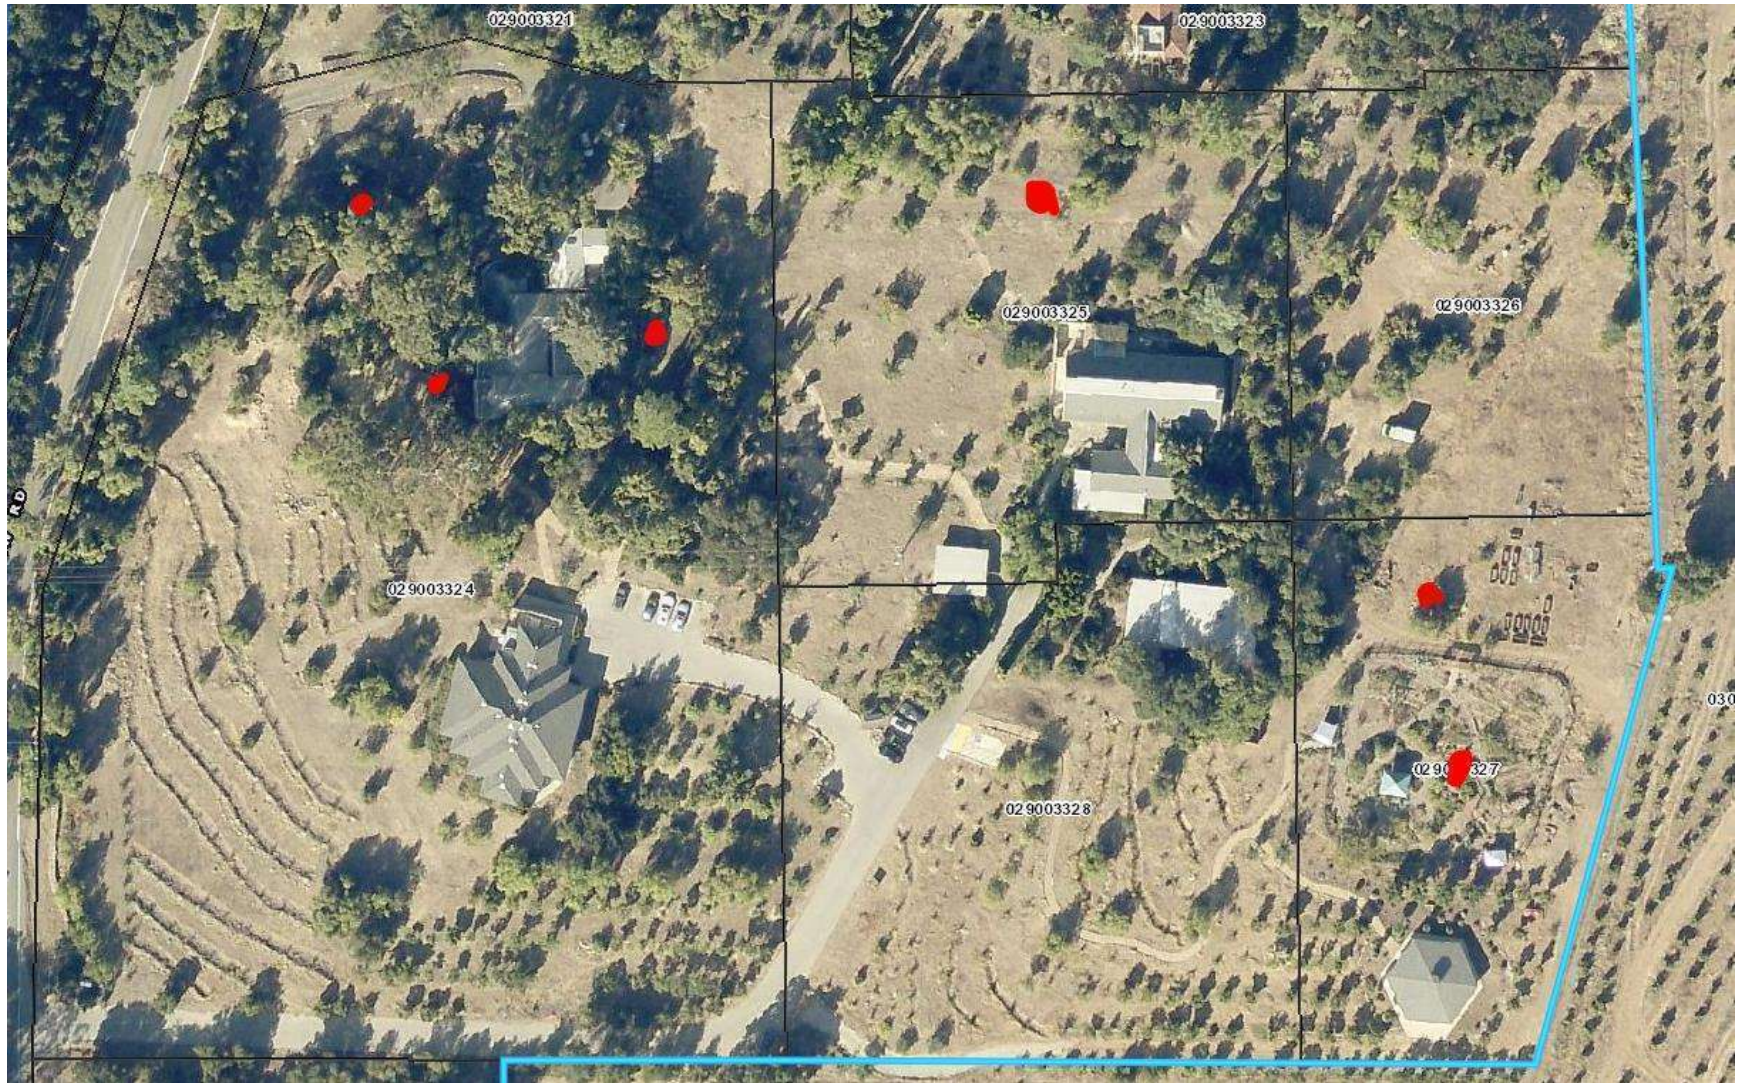
● = Location of Midweek Programs and Dialogues
