# Santa Paula Creek Hydrology & Floodplain Research

## Ferndale Lease, Ojai Oil Field – Drill Site No. 7

Prepared by:  
Blue Tomorrow, LLC

County of Ventura  
Planning Commission Hearing  
PL13-0150  
Exhibit A - Santa Paula Creek Report

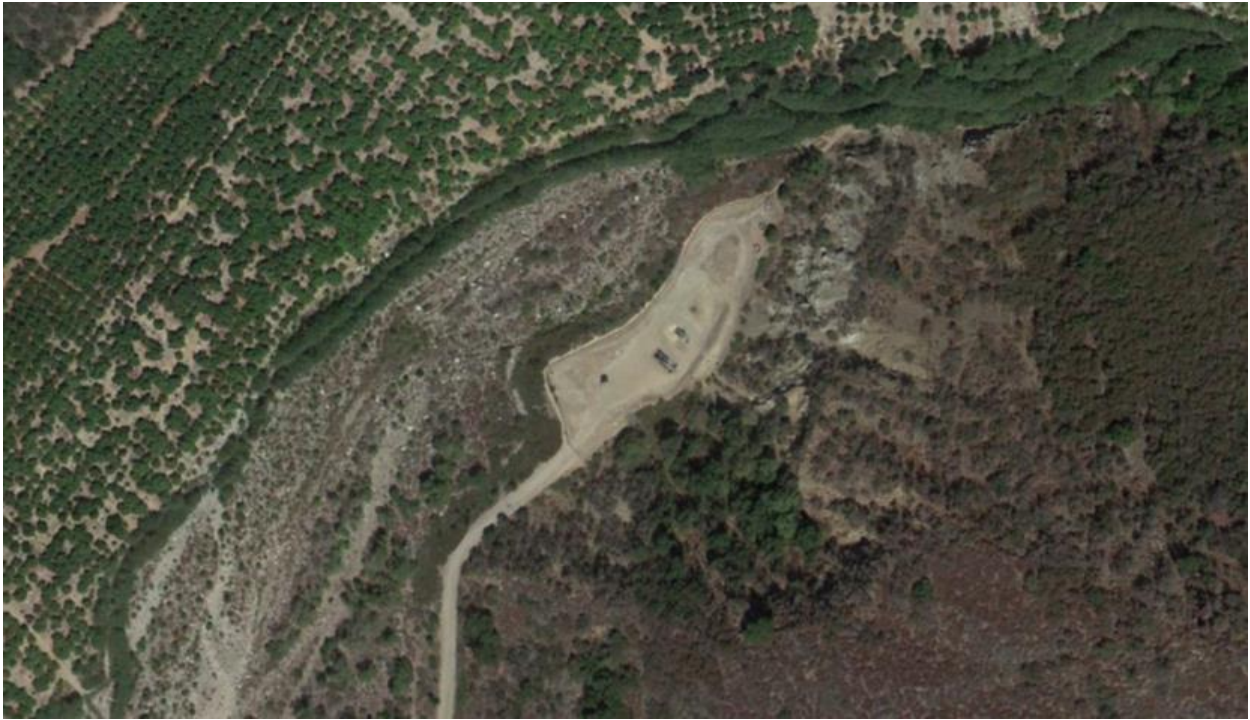
*The cover photo was taken on August 28, 2012, and shows the Santa Paula Creek that encompasses the study reach with Drill Site No. 7 and the avocado orchard on opposite sides of the channel (Source: Google Earth). Figure 1 shows the location of Drill Site No. 7 in the Santa Paula Creek watershed and Ventura County.*

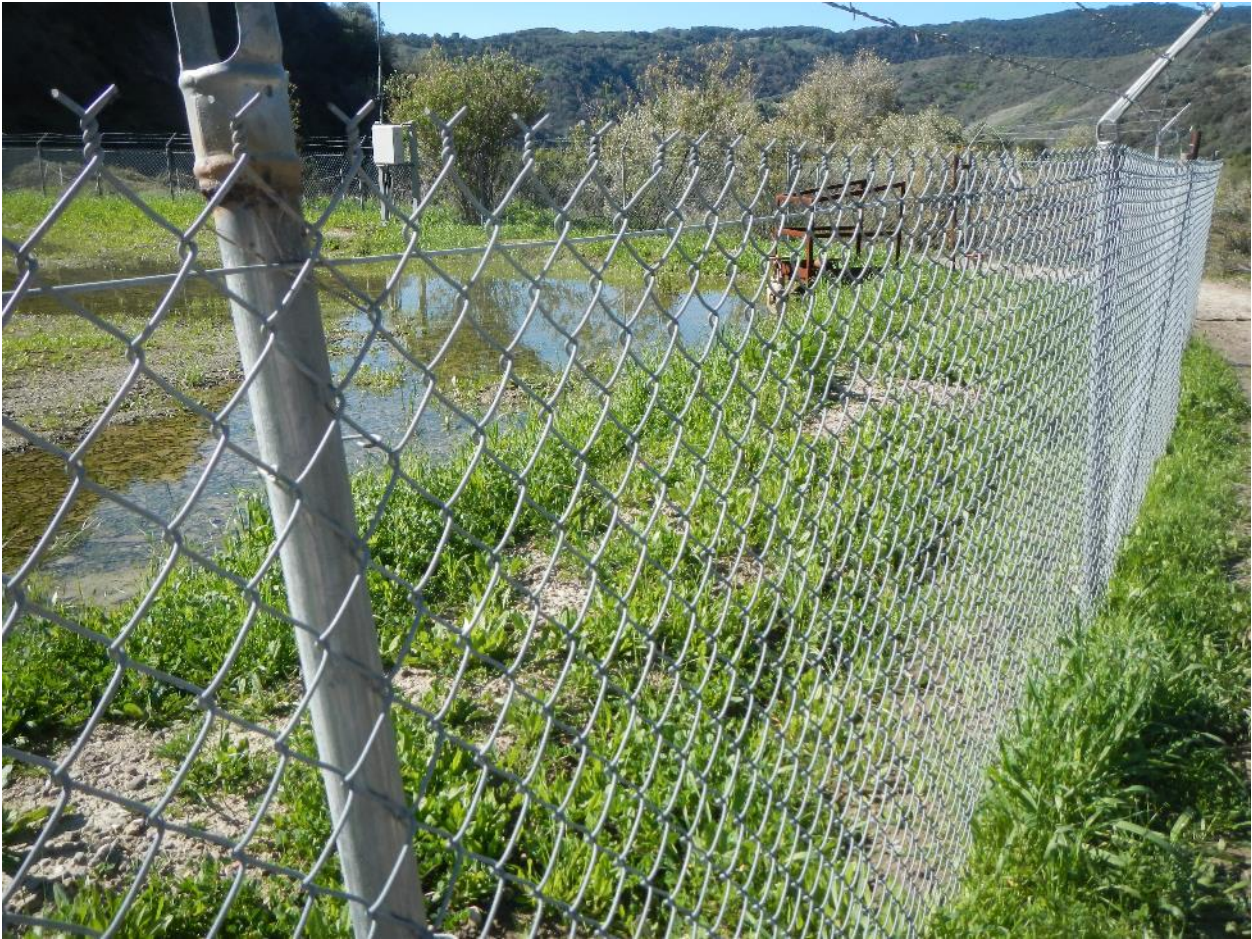
***Picture 2*** – Western edge of Drill Site No. 7 facing the drain. Ponding from previous storm event. Picture taken on March 6, 2015 at 10:00 am.

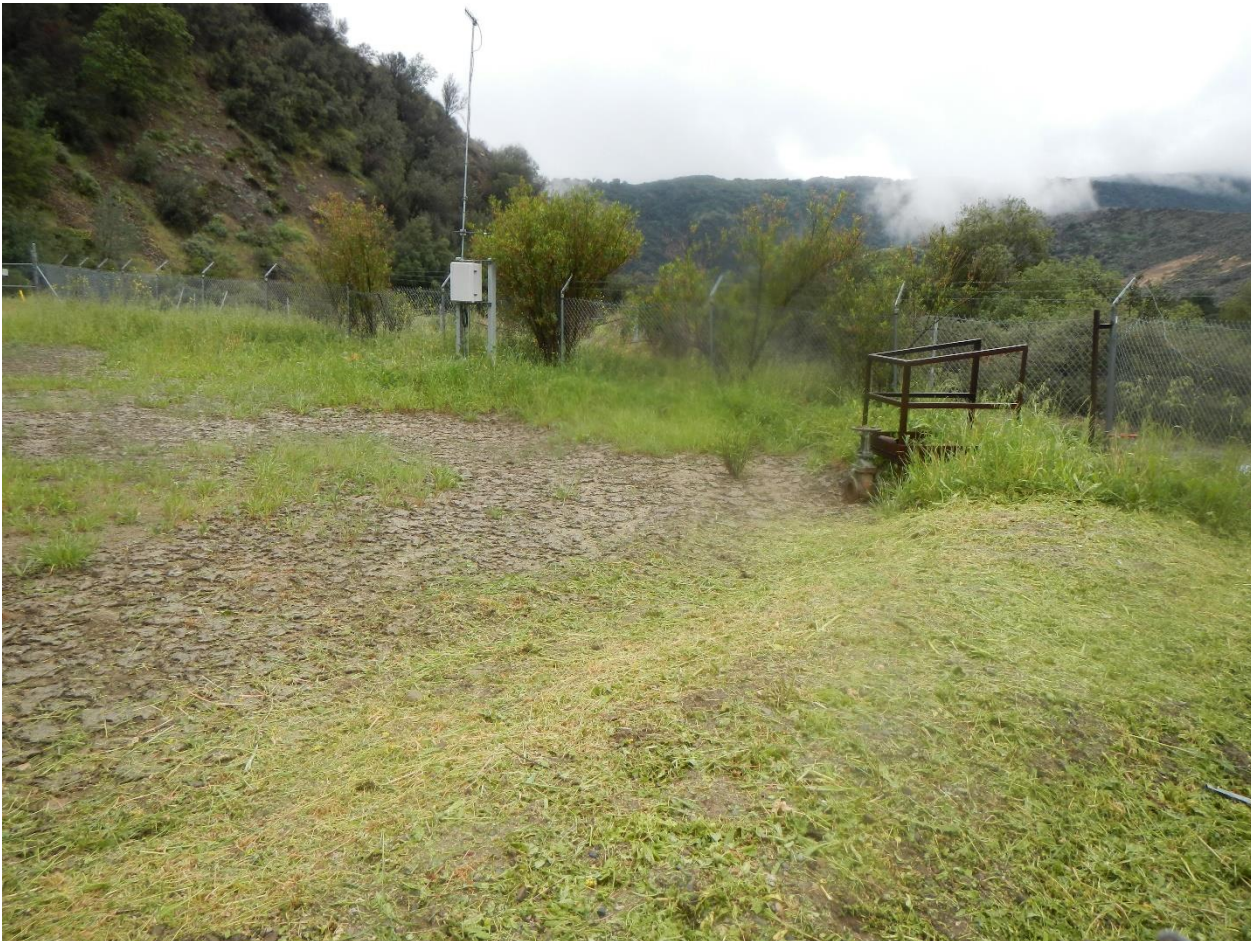
**Picture 3** – Western edge of Drill Site No. 7 facing the drain. No ponding near the drain. Silts and clays appear cracked from swelling and shrinking due to moisture accumulation and evaporation. Picture taken on April 7, 2015 at 4:12 pm

As seen in Picture 3 there is what appears to be clays and silts depositing near the drain pipe on DS7 (seen dried and cracked on the surface). These silts and clays are potentially being transported during storm events when surface runoff is occurring from the un-vegetated and disturbed areas closer to the wells (seen in Picture 4). Organic pollutants generated on well pads such as DS7 are carcinogenic and can bound and be carried with these fine sediments when surface runoff occurs.

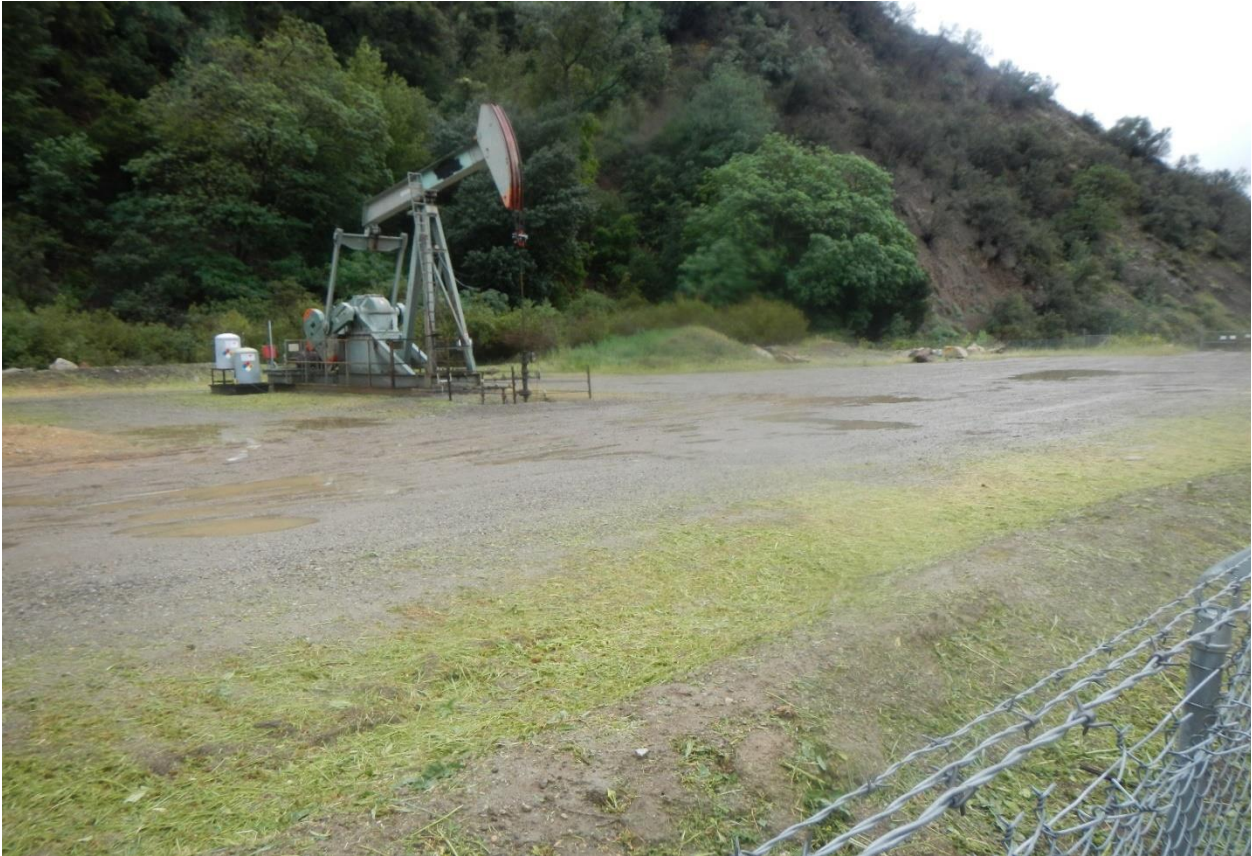
**Picture 4** – Edge of Drill Site No. 7 at XS-C, facing well #717. Ponding visible on the graveled area of the well pad, around the wells, and towards the gated entrance of the well pad. Picture taken on April 7, 2015 at 4:10 pm

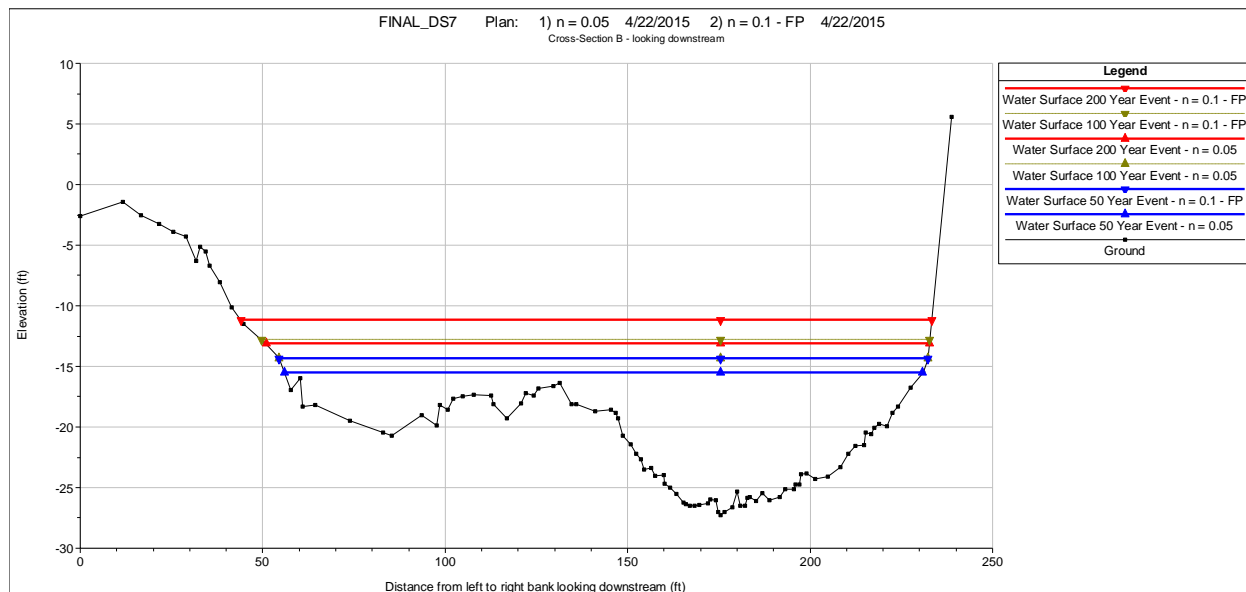
**Figure 10** - HEC-RAS calculated water surface results for the 50, 100, and 200 year events at cross-section B with a low ( $n=0.05$  across channel) and high ( $n=0.05$  in channel and  $0.1$  in floodplain) roughness senerio. Depicted facing downstream, this is the middle of three cross-sections in the modeled reach.

The following profiles depicts low and high roughness scenarios used to gage the sensitivity of the flood stage to various Manning's  $n$  coefficients, and demonstrate the uncertainty associated with estimating stream hydraulics in this reach. Refer to Section 2.0 and 3.0 for more about these estimates.

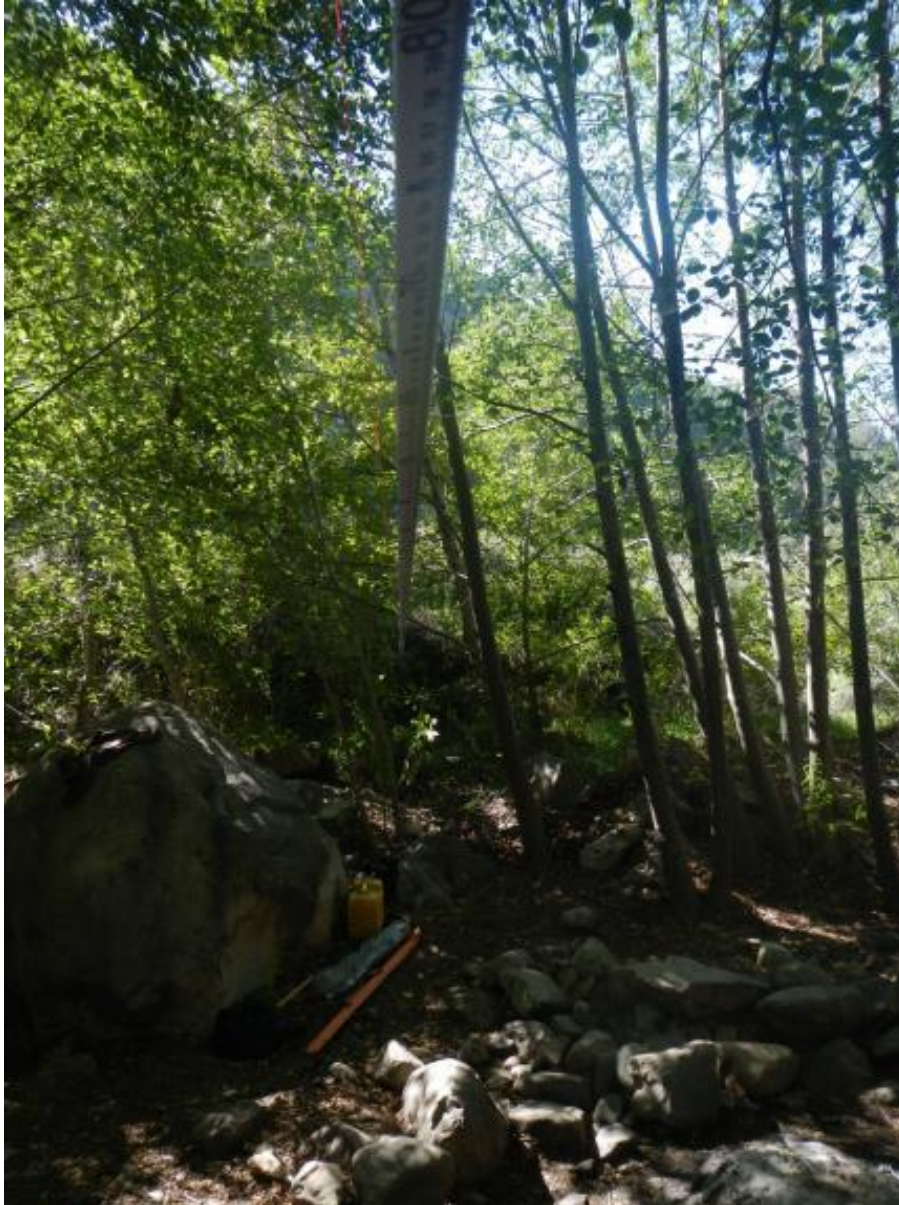
*Picture 5* – Standing in channel facing left bank looking along cross-section A.

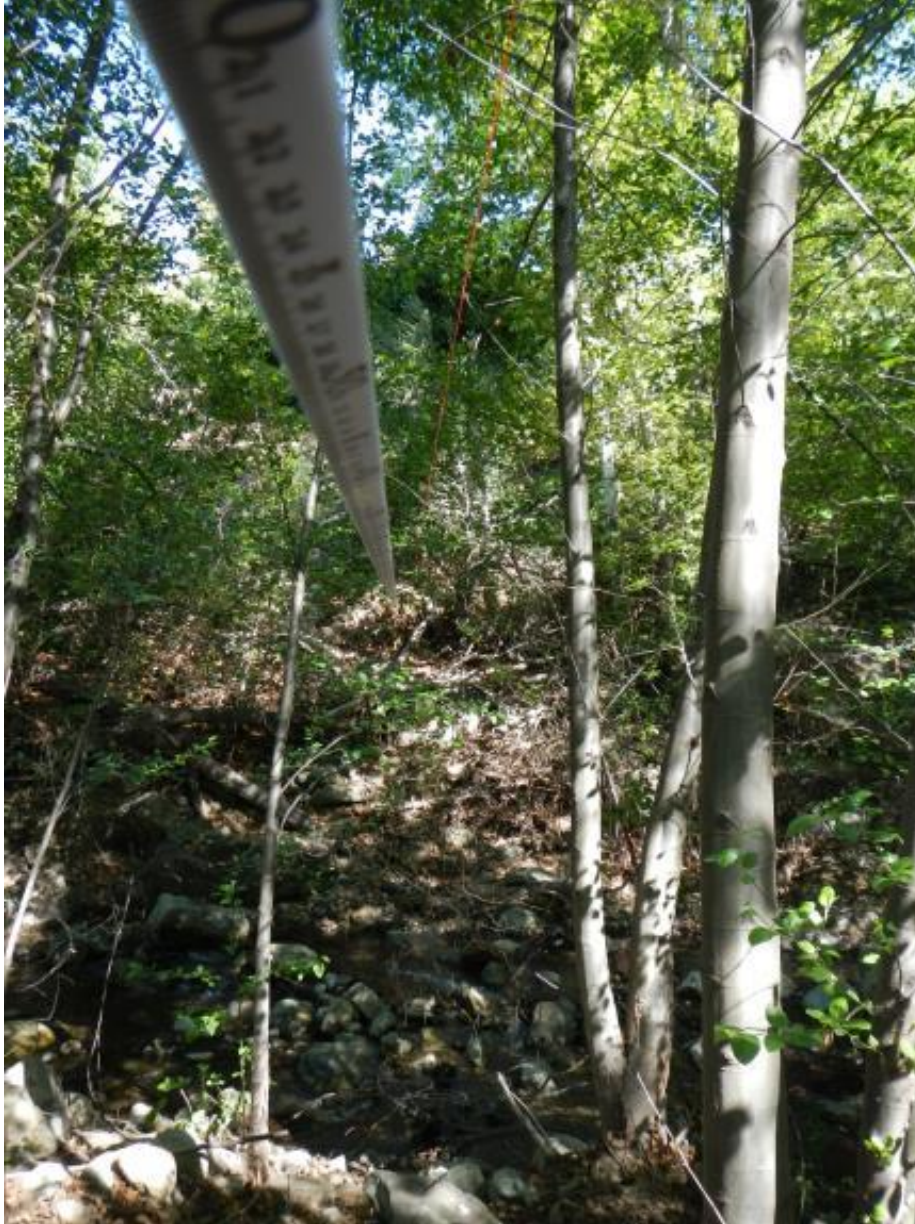
*Picture 6* – Standing in channel facing right bank looking along cross-section A.

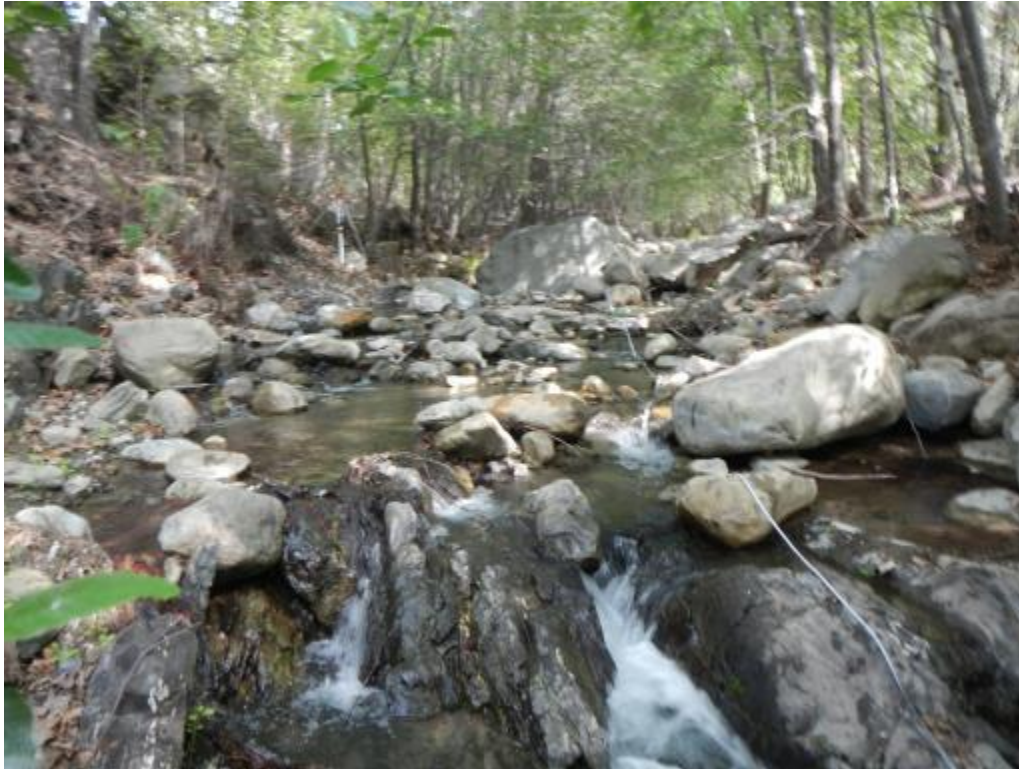
*Picture 7* – Standing in channel at cross-section A facing upstream.

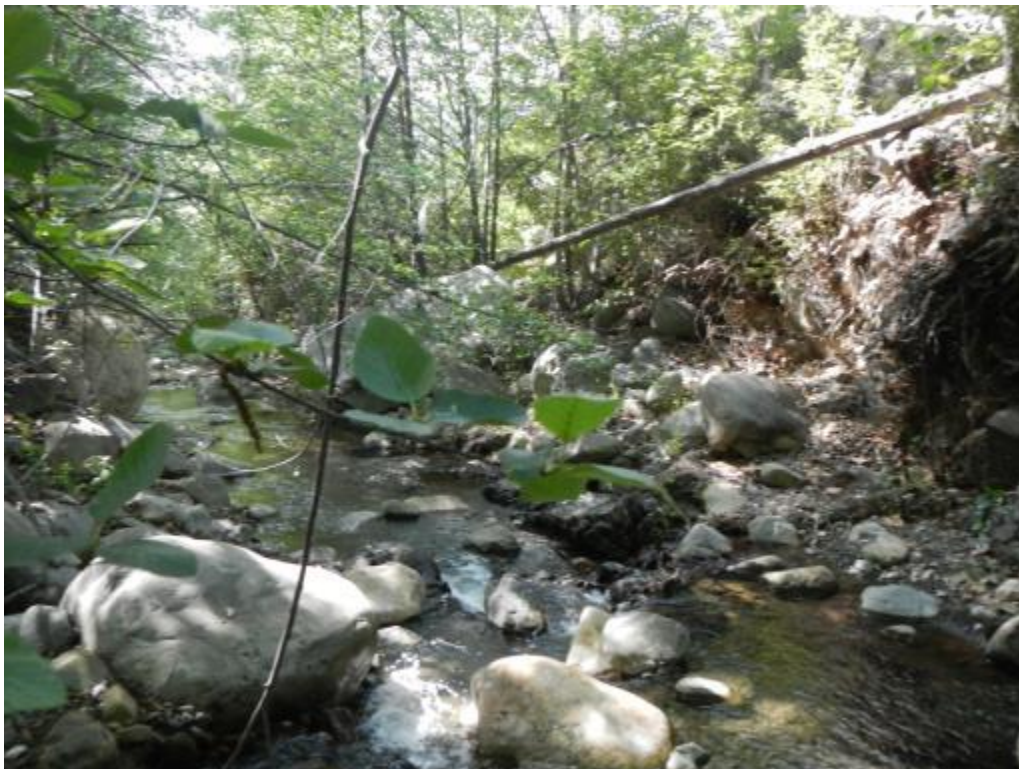
*Picture 8* – Standing at waters-edge-left-bank at cross-section A facing downstream.

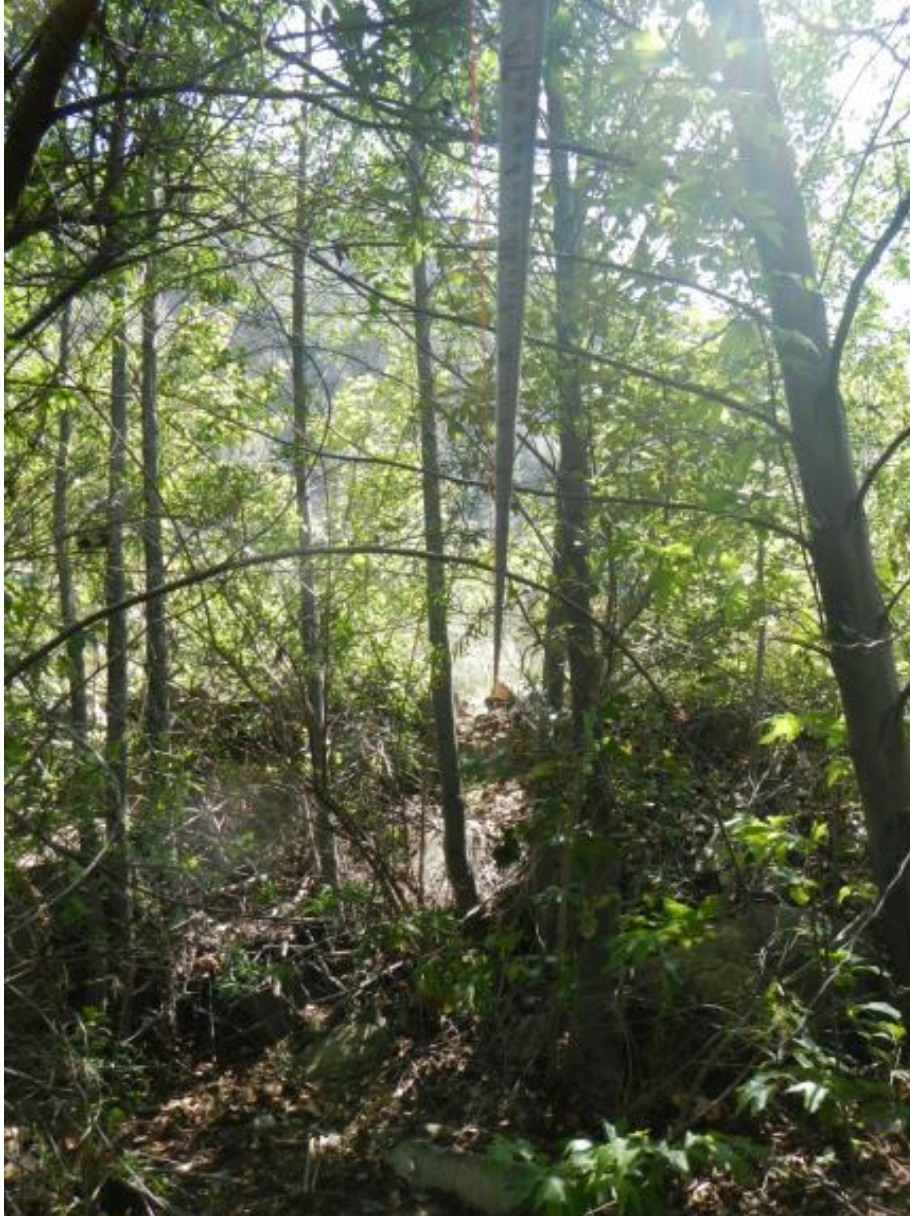
*Picture 9* – Standing in channel facing left-bank looking along cross-section B.

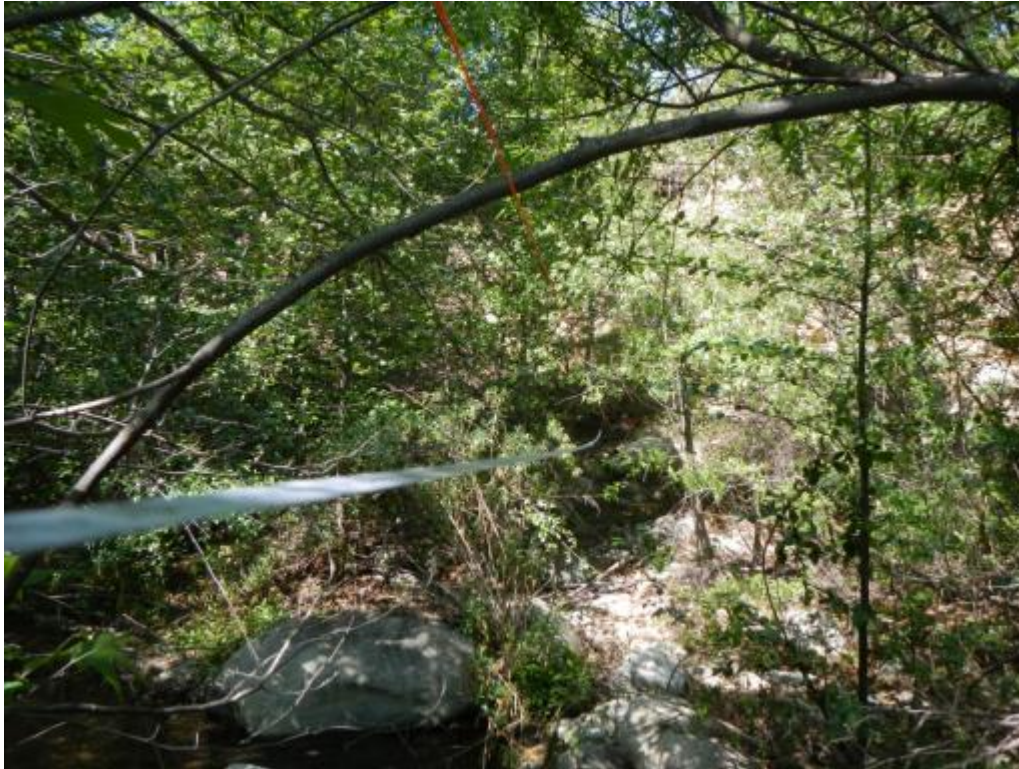
*Picture 10* – Standing in channel facing right-bank looking along cross-section B.

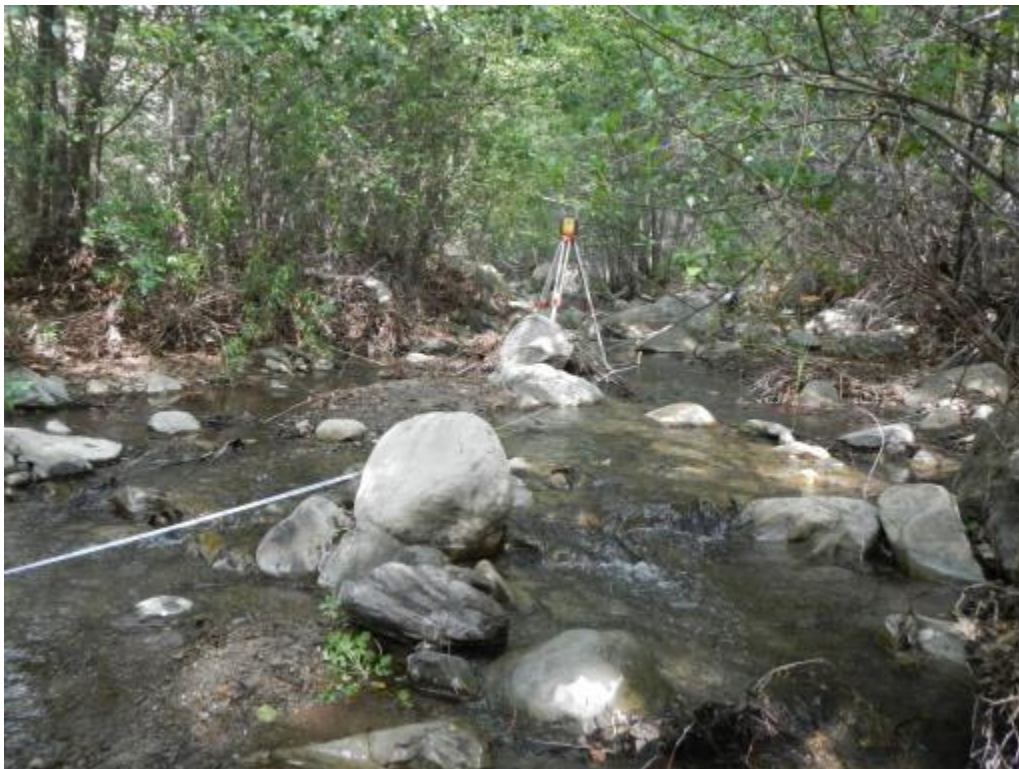
*Picture 11* – Standing in channel at cross-section B facing upstream.

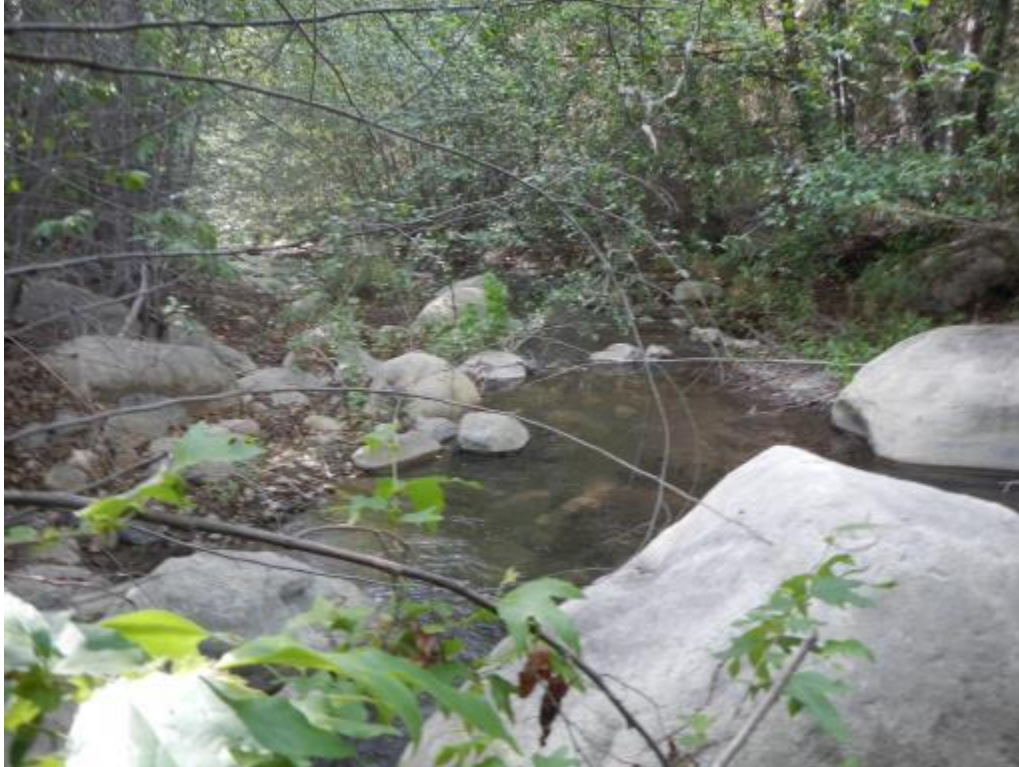
*Picture 12* – Standing at waters-edge-left-bank at cross-section B facing downstream.

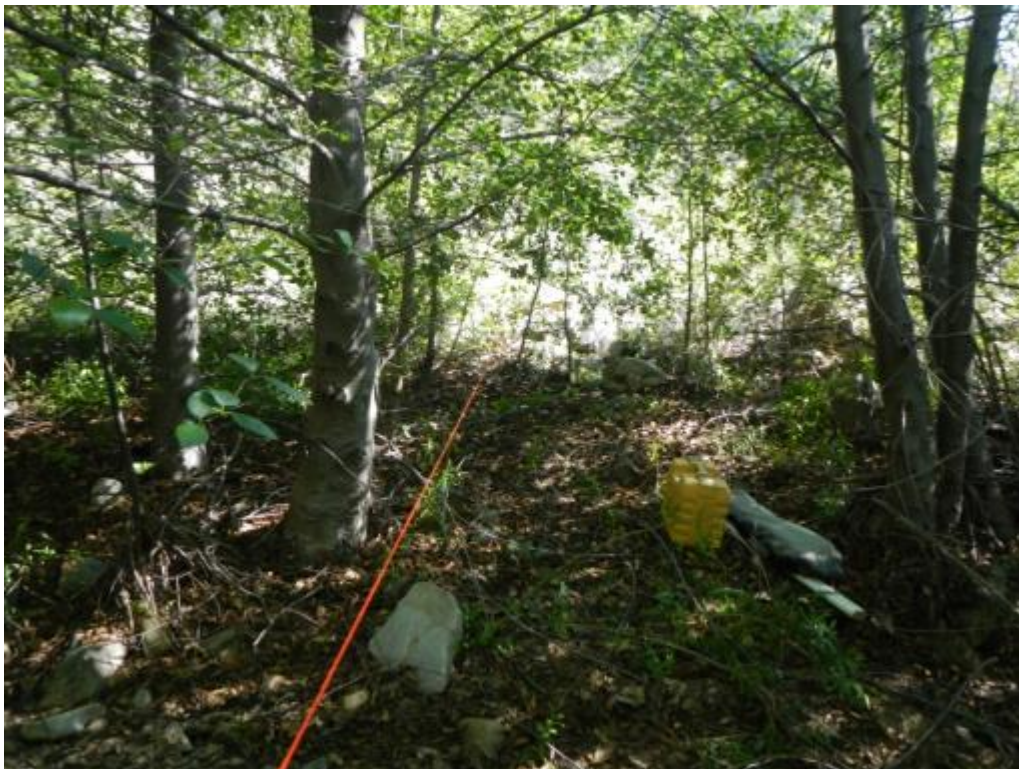
*Picture 13* – Standing in channel facing left-bank looking along cross-section C.

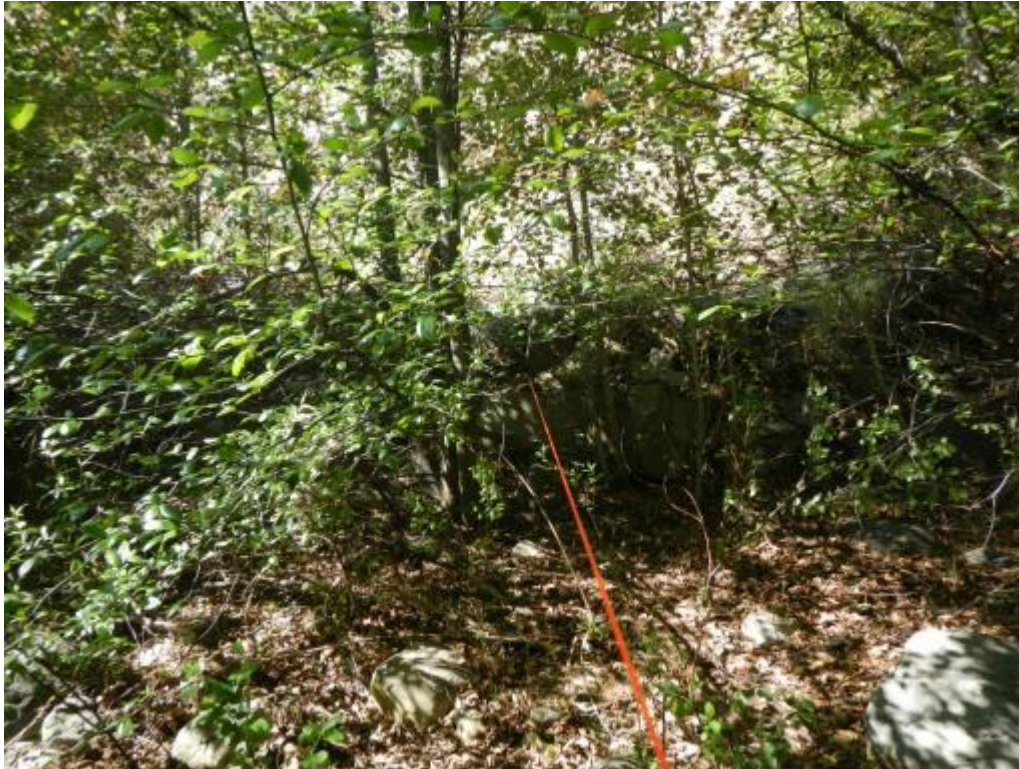
*Picture 14* - Standing in channel facing right-bank looking along cross-section C.

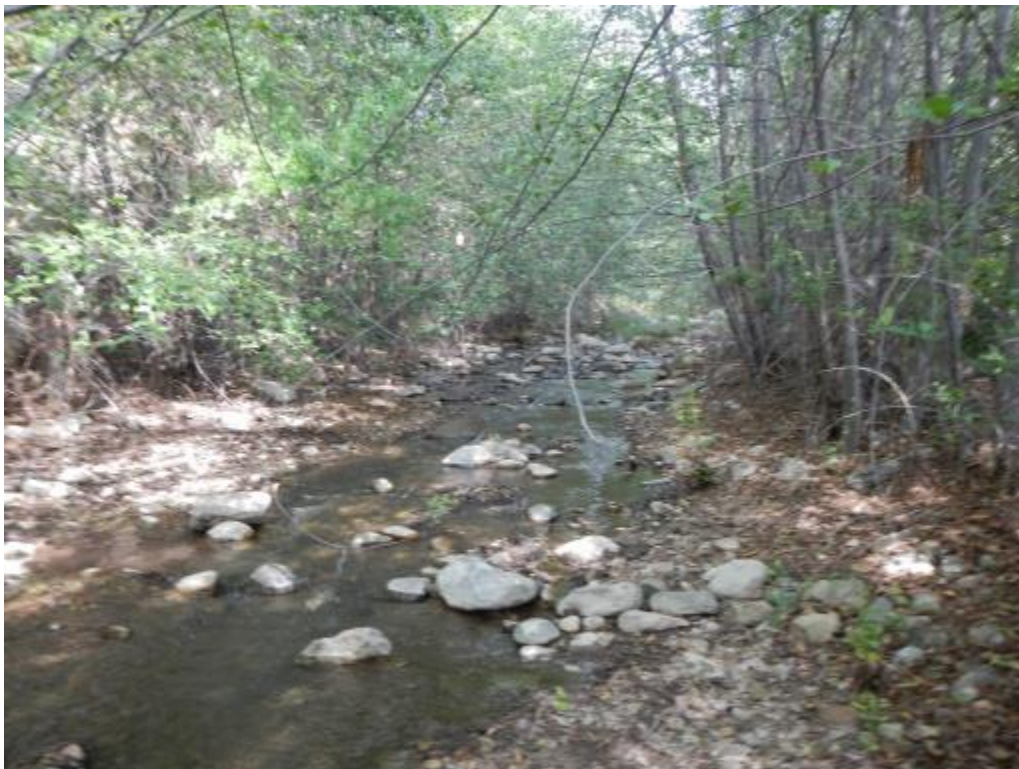
*Picture 15* – Standing at waters-edge-left-bank at cross-section C facing upstream.

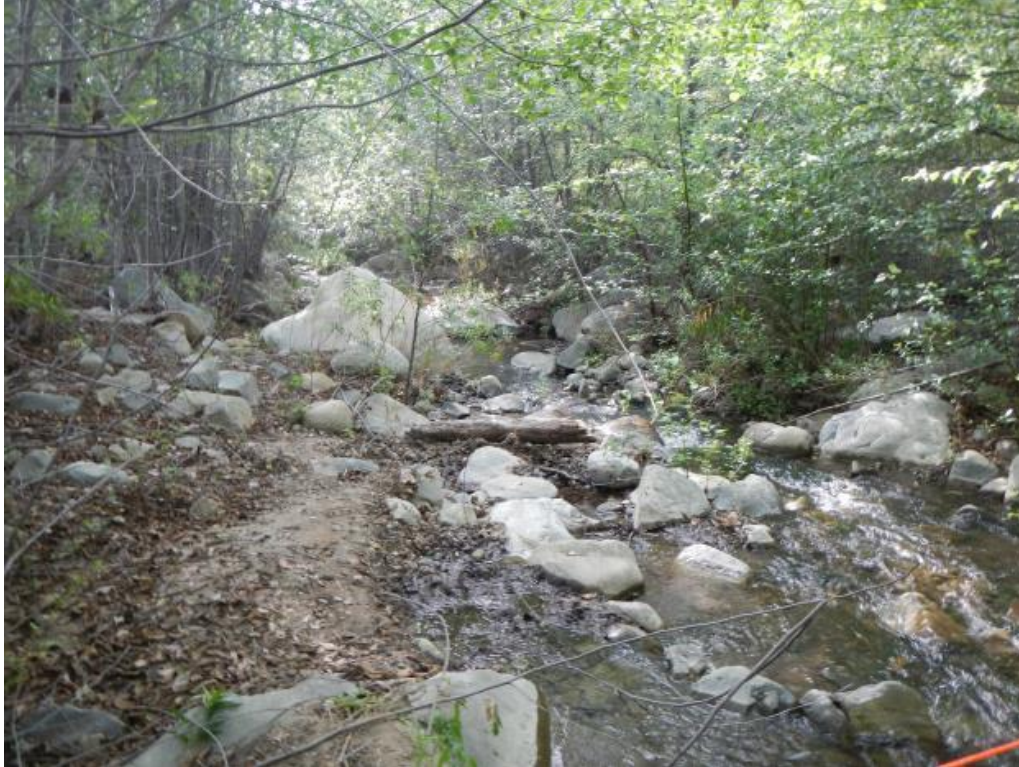
*Picture 16* – Standing at waters-edge-left-bank at cross-section C facing downstream.

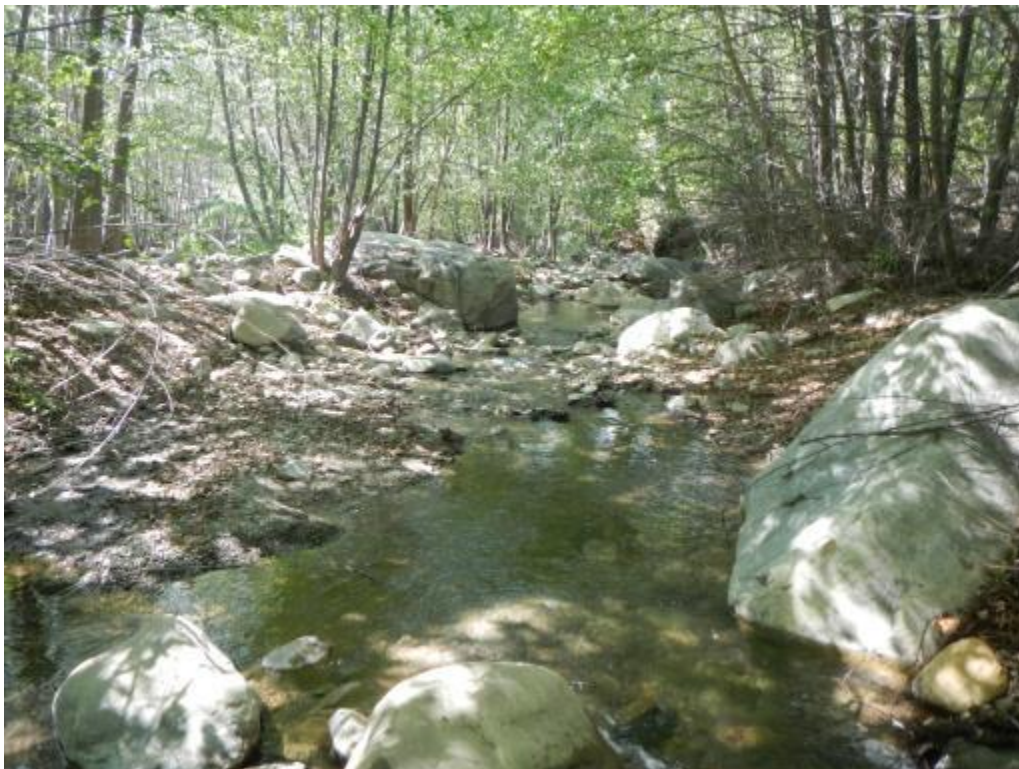
*Picture 17* – Standing in channel at longitudinal profile upstream start, looking downstream.

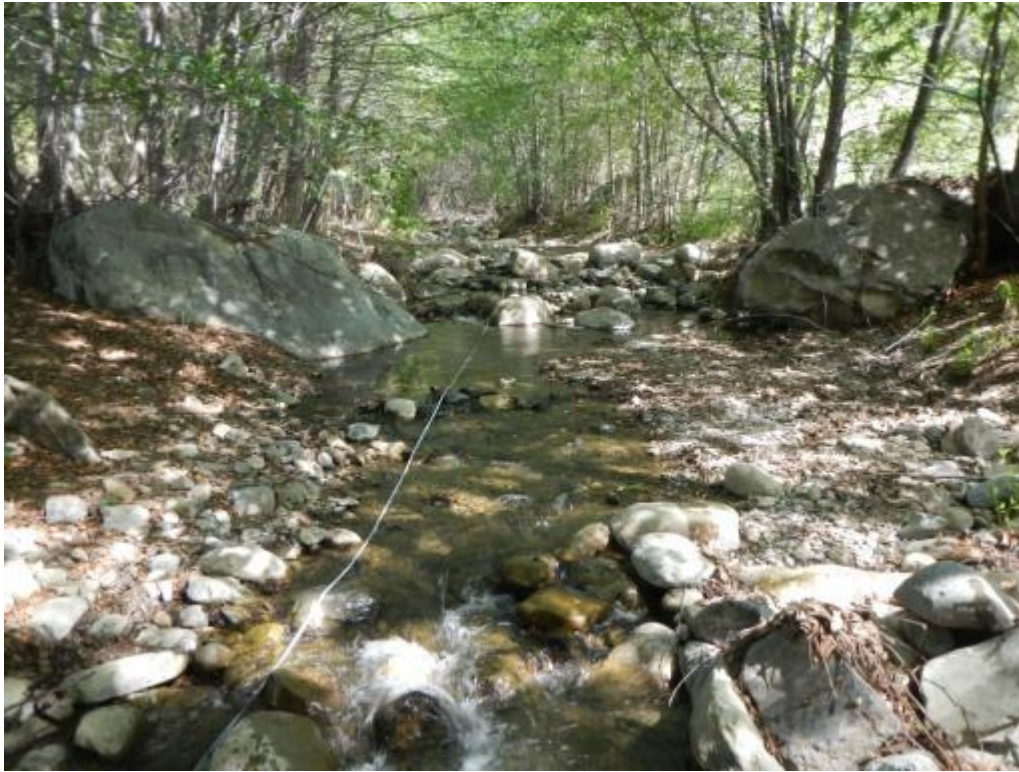
**Picture 18** – Standing in channel 15 meters downstream of longitudinal profile upstream start looking upstream at longitudinal profile upstream start.
