Arborist Report for

Camp Ramah New Machon

385 Fairview Road

February 7, 2019

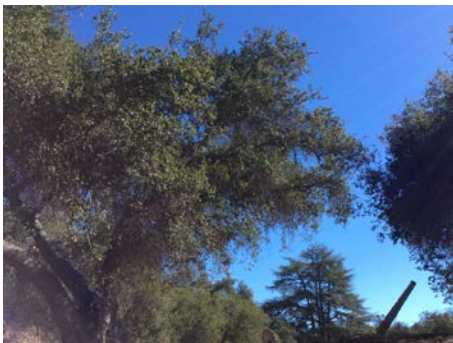
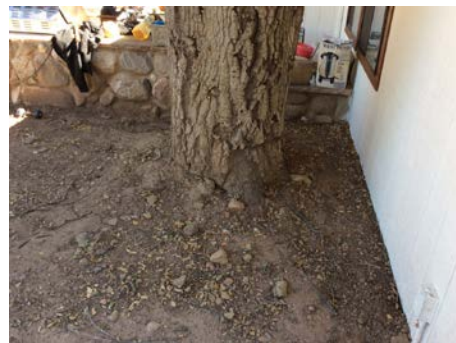
Tree Number: 387
Species: Coast Live Oak (*Quercus agrifolia*)
Number of Trunks: 1
Girth at 54": 97" (DBH 31") - Heritage
Height: 30'
Dripline: 40'
Observations: Scaffold limbs 90 degrees over residence
Overall Health: Good
Project Impact: None
Recommendations: Optional fence around dripline + 5' = 45' during construction, mulch

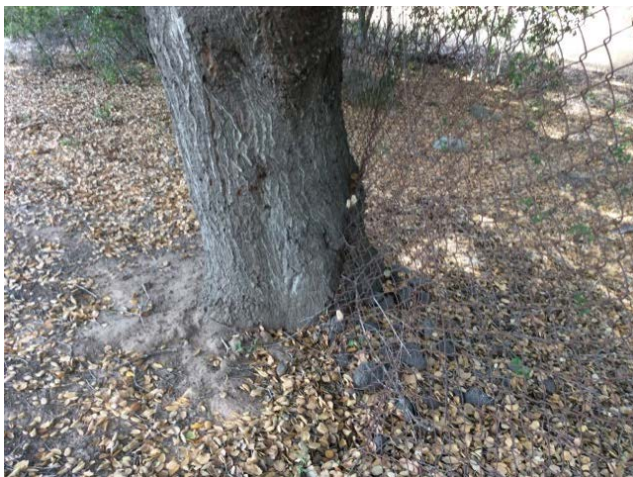
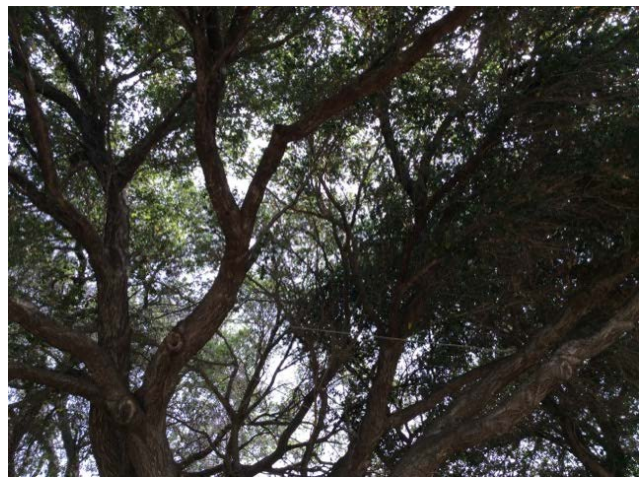
Tree Number: 397
Species: Coast Live Oak (*Quercus agrifolia*)
Number of Trunks: 1
Girth at 54": 80" (DBH 26")
Height: 40'
Dripline: 45'
Observations: Crown raised, overextended branches, next to table
Overall Health: Good
Project Impact: None
Recommendations: Optional fence around dripline + 5' = 50' during construction, mulch

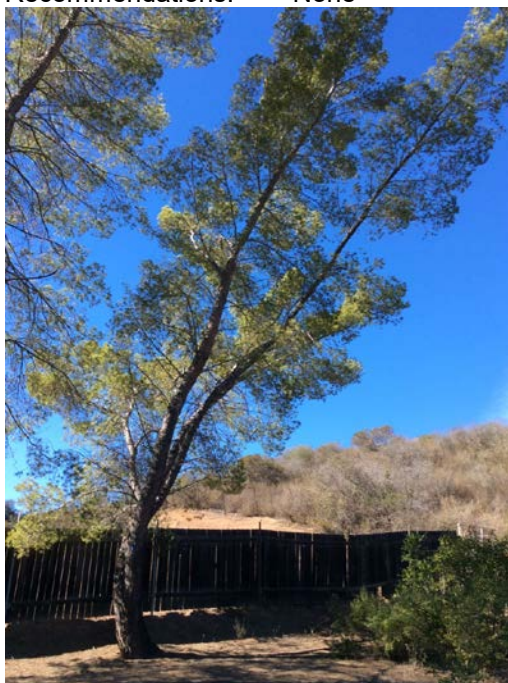
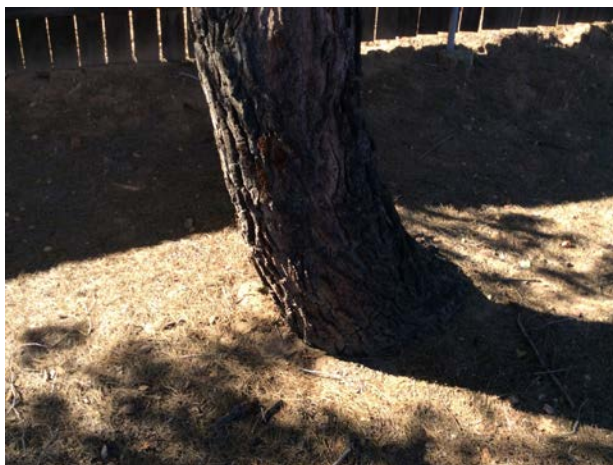
Tree Number: 398
Species: Aleppo Pinus – Pinus halepensis
Number of Trunks: 1
Girth at 54": 62" (DBH 20")
Height 60'
Dripline 35'
Observations: Leaning 30" girth trunk removed to improve safety
Overall Health: Died from insect infestation and removed
Project Impact: None
Recommendations: None

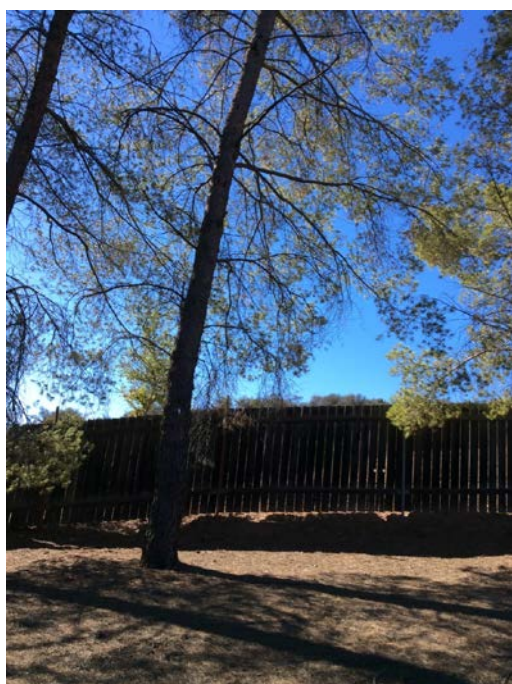
Tree Number: 399
Species: Aleppo Pinus – Pinus halepensis
Number of Trunks: 1
Girth at 54": 50" (DBH 16")
Height 65'
Dripline 30'
Observations: Lower dead branches have been removed
Overall Health: Died from insect infestation and removed
Project Impact: None
Recommendations: None

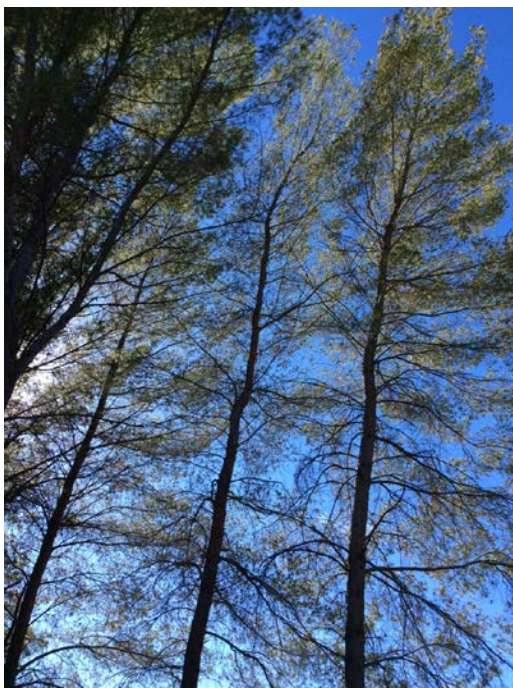
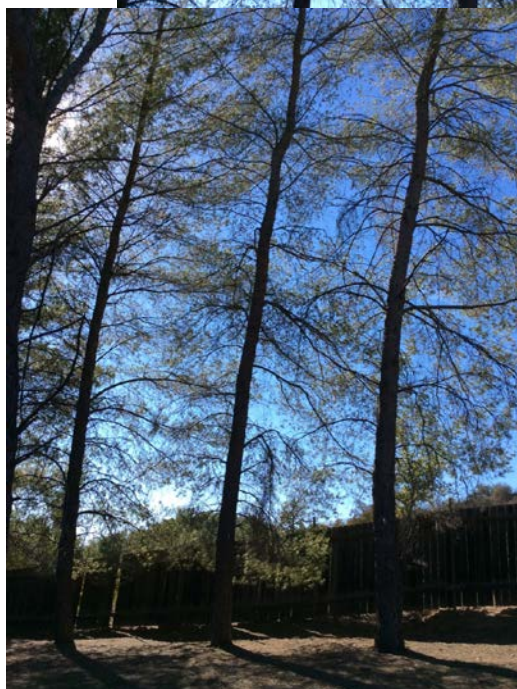
Tree Number: 400
Species: Aleppo Pinus – Pinus halepensis
Number of Trunks: 1
Girth at 54": 43" (DBH 14")
Height 65'
Dripline 30'
Observations: Lower dead branches have been removed
Overall Health: Died from insect infestation and removed
Project Impact: None
Recommendations: None

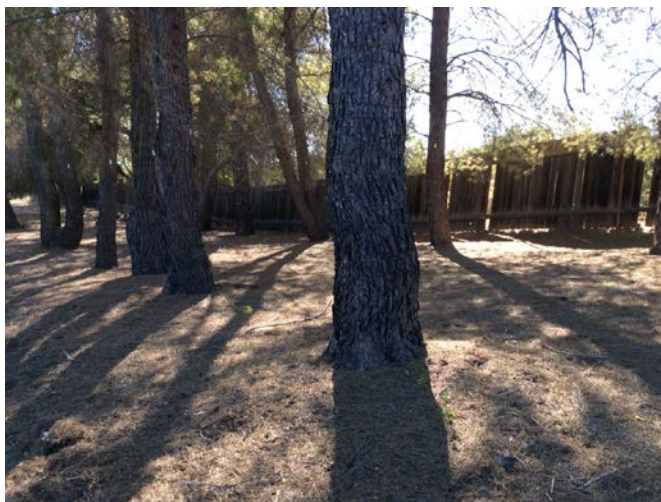
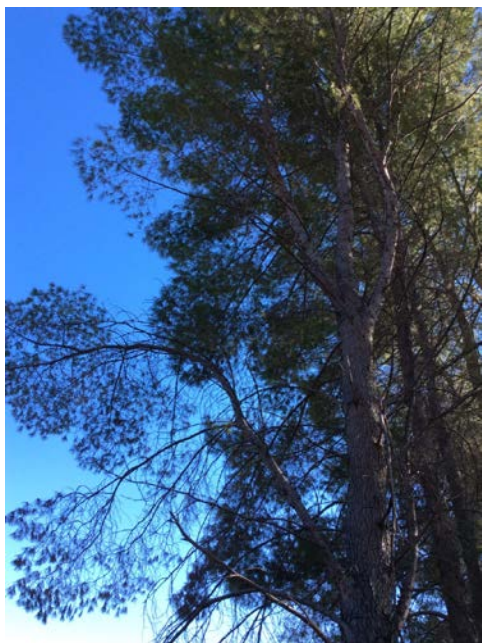
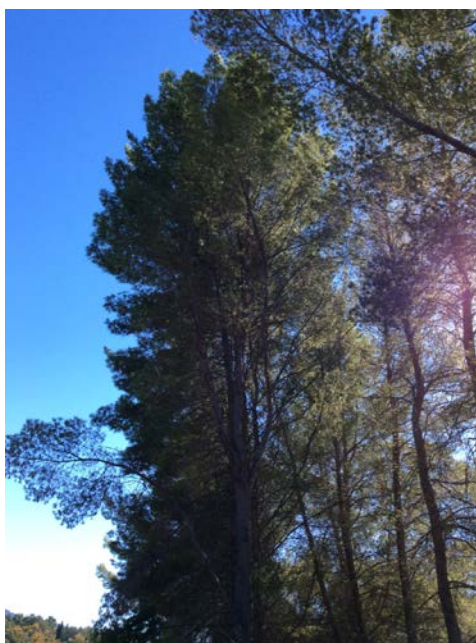
Tree Number: 401
Species: Aleppo Pinus – *Pinus halepensis*
Number of Trunks: 1
Girth at 54": 72" (DBH 23")
Height 80'
Dripline 30'
Observations: Upper codominant trunk has been removed for structural safety
Overall Health: Died from insect infestation and removed
Project Impact: None
Recommendations: None

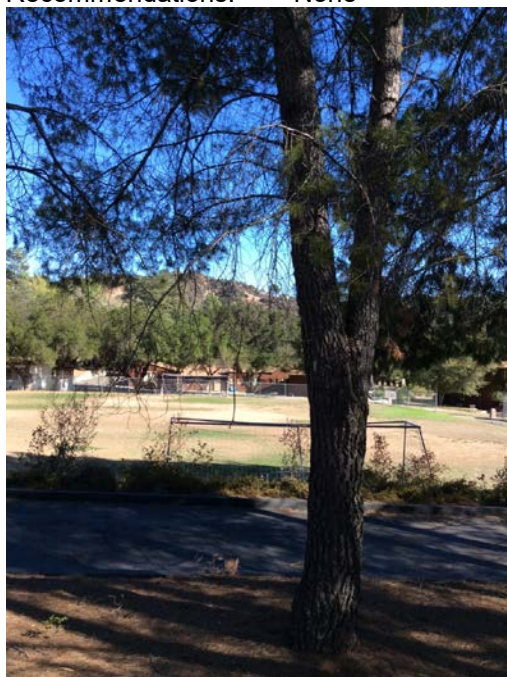
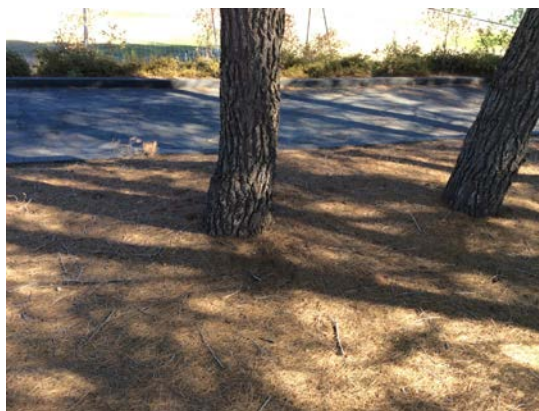
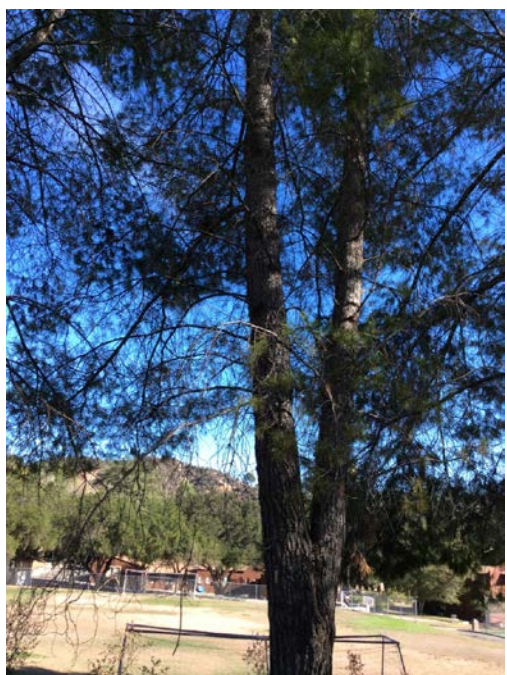
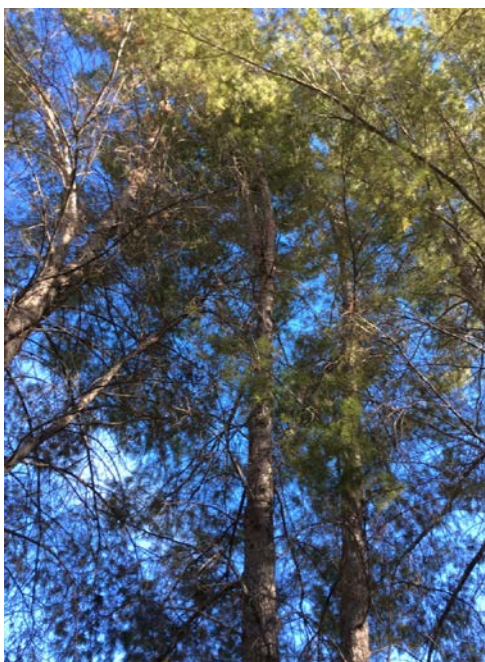
Tree Number: 402
Species: Aleppo Pinus – Pinus halepensis
Number of Trunks: 1
Girth at 54": 55" (DBH 18")
Height 80'
Dripline 30'
Observations: South codominant trunk removed for structural safety
Overall Health: Died from insect infestation and removed
Project Impact: None
Recommendations: None

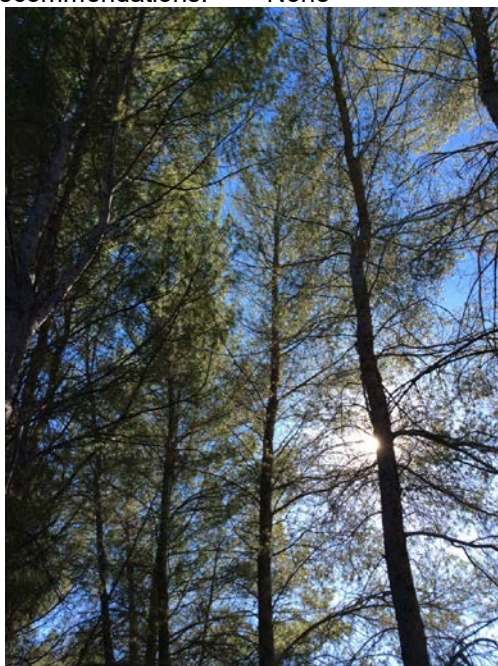
Tree Number: 403
Species: Aleppo Pinus – Pinus halepensis
Number of Trunks: 1
Girth at 54": 45" (DBH 15")
Height 70'
Dripline 30'
Observations: South codominant trunk removed for structural safety
Overall Health: Died from insect infestation and removed
Project Impact: None
Recommendations: None

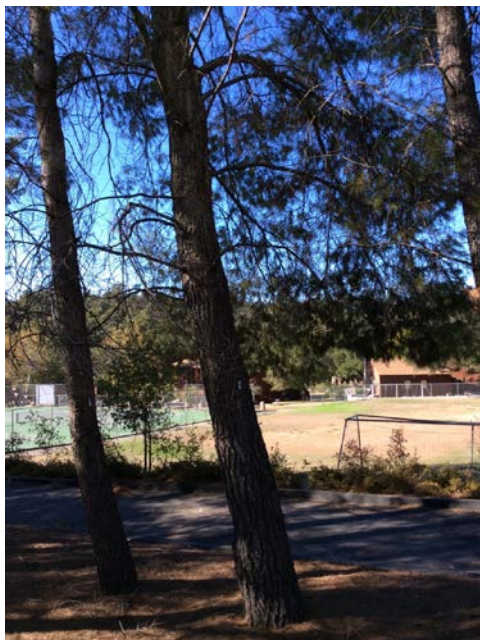
Tree Number: 404
Species: Aleppo Pinus – Pinus halepensis
Number of Trunks: 1
Girth at 54": 55" (DBH 18")
Height 80'
Dripline 30'
Observations: Dead branches removed for safety to people
Overall Health: Died from insect infestation and removed
Project Impact: None
Recommendations: None

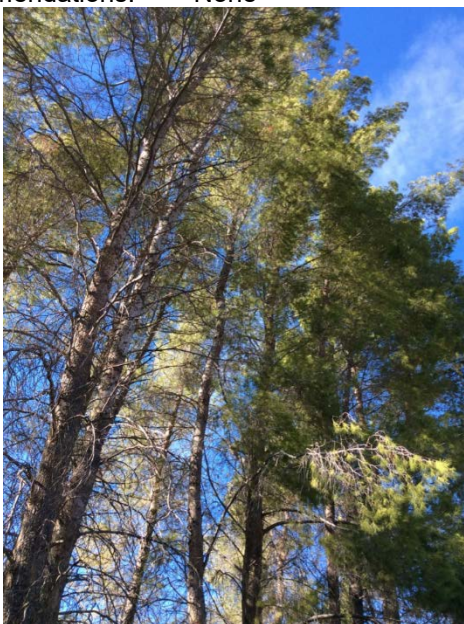
Tree Number: 405
Species: Aleppo Pinus – Pinus halepensis
Number of Trunks: 1
Girth at 54": 40" (DBH 13")
Height 80'
Dripline 30'
Observations: Dead branches removed for safety to people
Overall Health: Died from insect infestation and removed
Project Impact: None
Recommendations: None

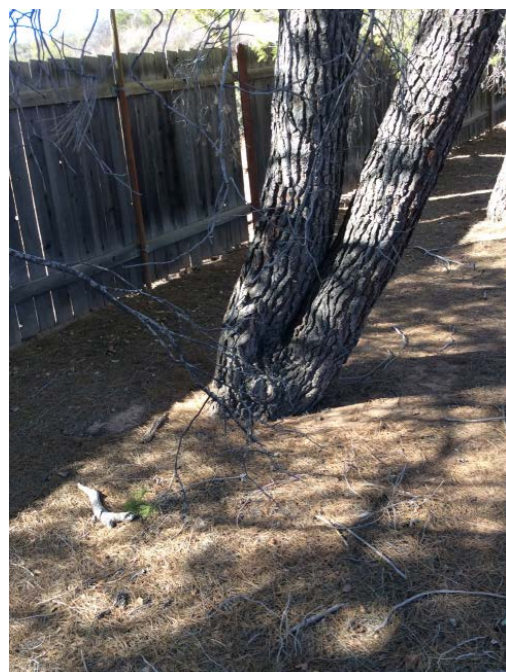
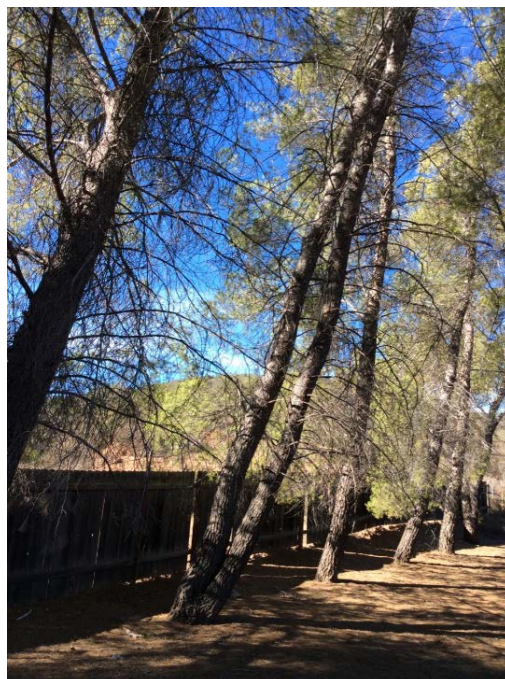
Tree Number: 406
Species: Aleppo Pinus – *Pinus halepensis*
Number of Trunks: 2
Girth at 54": 45" (DBH 12" + 13")
Height 70'
Dripline 30'
Observations: 12" DBH lower trunk removed for structural safety
Overall Health: Died from insect infestation and removed
Project Impact: None
Recommendations: None

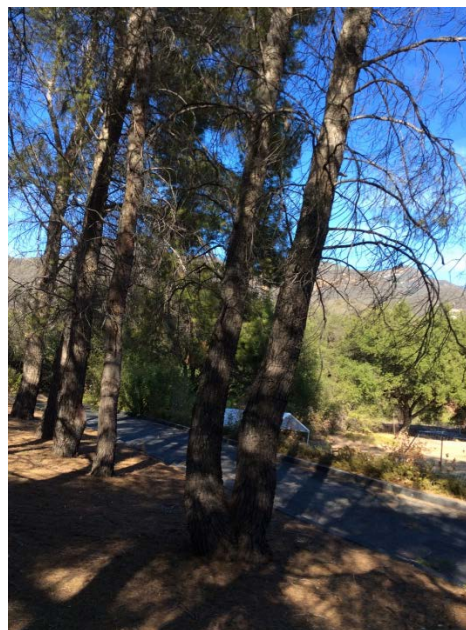
Tree Number: 407
Species: Aleppo Pinus – *Pinus halepensis*
Number of Trunks: 2
Girth at 54": 45" (DBH 16" + 18" = 34") – Not a protected tree
Height 80'
Dripline 30'
Observations: Two trunks cabled for structural safety. Root crown located about two feet from curb.
Overall Health: Good
Project Impact: Minimal if road widened on east side. See TPP
Recommendations: Install fence along west side of road during construction, mulch

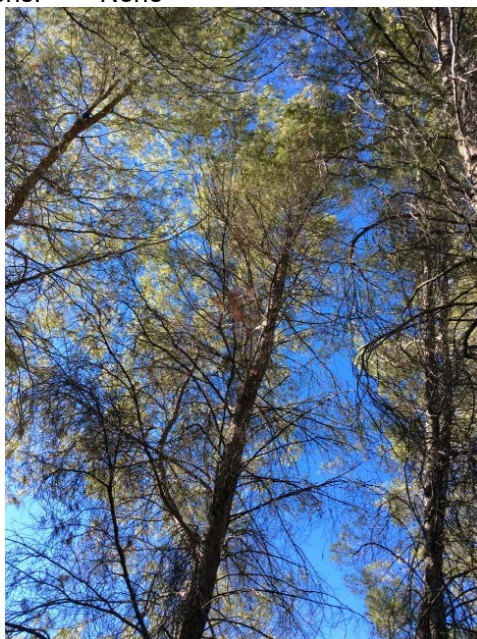
Tree Number: 408
Species: Aleppo Pinus – *Pinus halepensis*
Number of Trunks: 2
Girth at 54": 62" (DBH 20")
Height 70'
Dripline 30'
Observations: 20% trunk lean
Overall Health: Died from insect infestation and removed
Project Impact: None
Recommendations: None

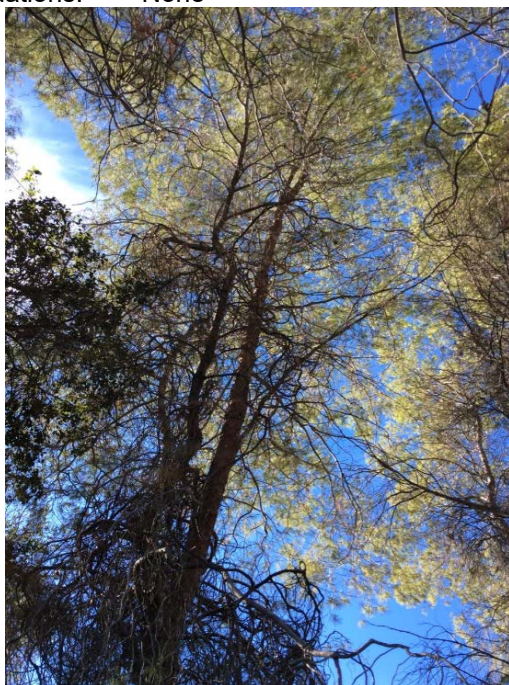
Tree Number: 409
Species: Aleppo Pinus – Pinus halepensis
Number of Trunks: 1
Girth at 54": 90" (DBH 29") - Heritage
Height 60'
Dripline 30'
Observations: two trunks 19", 10", codominant branches
Overall Health: Died from insect infestation and removed
Project Impact: None
Recommendations: None

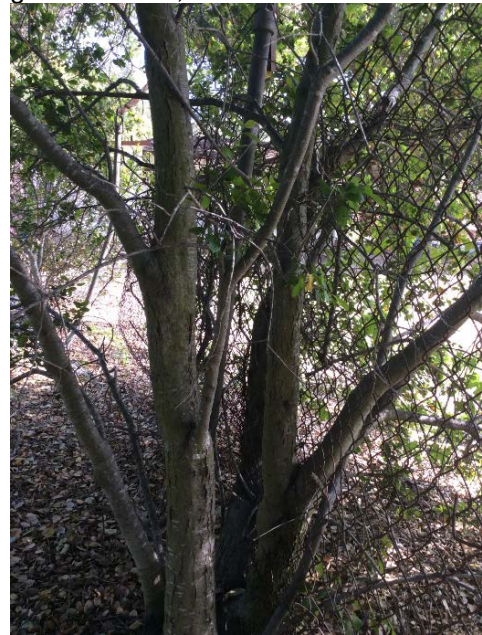
Tree Number	427
Species:	Coast Live Oak – <i>Quercus agrifolia</i>
Number of Trunks:	5
Girth at 54":	43" (6", 9", 11", 10", 7")
Height	25'
Dripline	25'
Observations:	Appears to be regrowth from a stump, located 6' east of tree 395 on the fence line
Overall Health:	Good
Project Impact:	No impact
Recommendations:	Install fence around dripline + 5' = 30' during construction, mulch

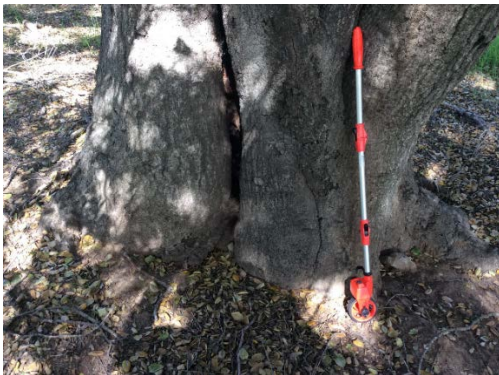
Tree Number 428
Species: Coast Live Oak – *Quercus agrifolia*
Number of Trunks: 1
Girth at 54": 160" - Heritage
Height 40'
Dripline 50'
Observations: Located 29' north of tree 397, northern branches resting on ground
Overall Health: Good
Project Impact: Cabin to be constructed 30' west of tree affecting about 15% of CRZ. See TPP.
Recommendations: Install fence around dripline + 5' = 55' during construction, mulch

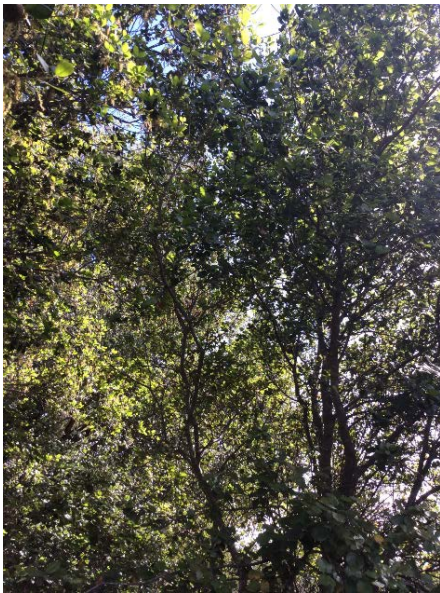
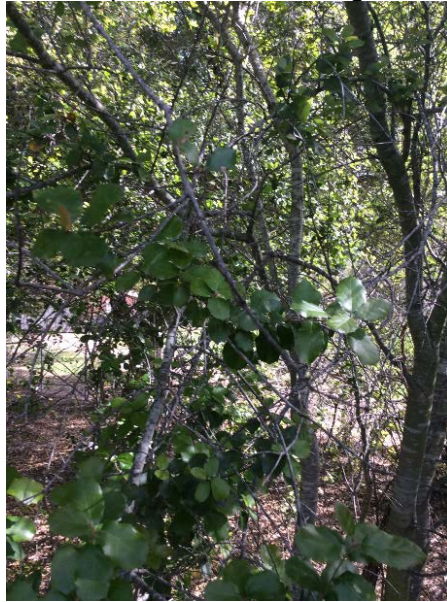
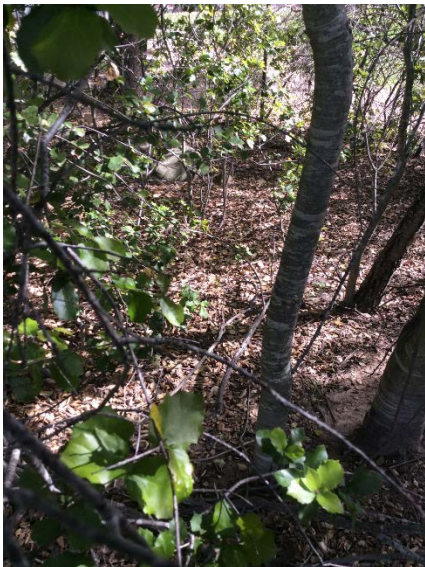
Tree Number	429
Species:	Coast Live Oak – <i>Quercus agrifolia</i>
Number of Trunks:	1
Girth at 54":	9.5"
Height	15'
Dripline	15'
Observations:	Located 29' west of tree 397 and 12' north of the fence
Overall Health:	Good
Project Impact:	None
Recommendations:	Install fence around dripline + 5' = 20' during construction, mulch

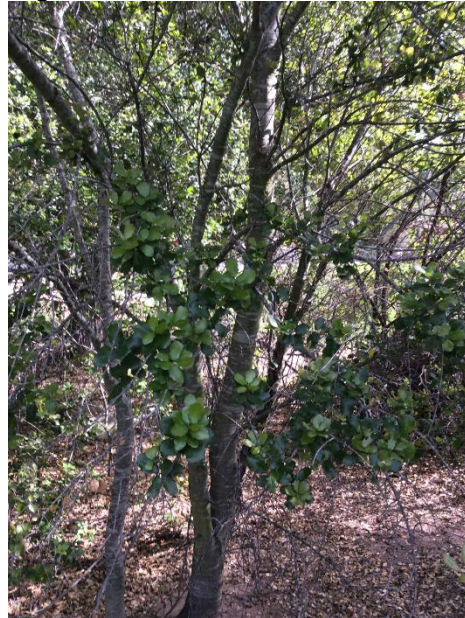
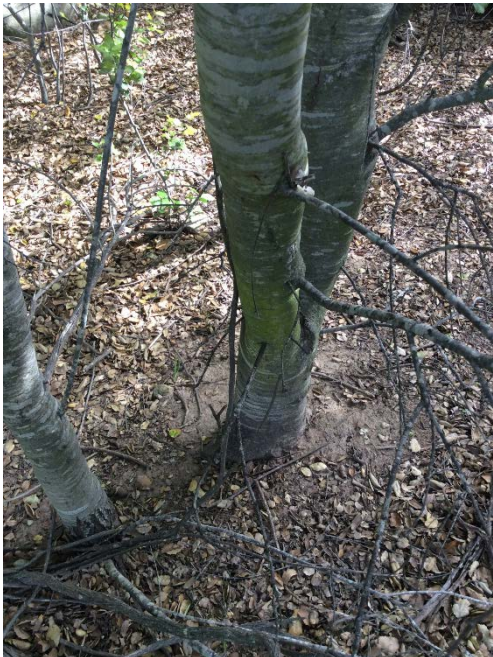
Tree Number	430
Species:	Coast Live Oak – <i>Quercus agrifolia</i>
Number of Trunks:	1
Girth at 54":	15"
Height	20'
Dripline	20'
Observations:	Codominant branches. Located 1' south of tree 429 and 11' north of the fence
Overall Health:	Good
Project Impact:	No impact
Recommendations:	Install fence around dripline + 5' = 25' during construction, mulch

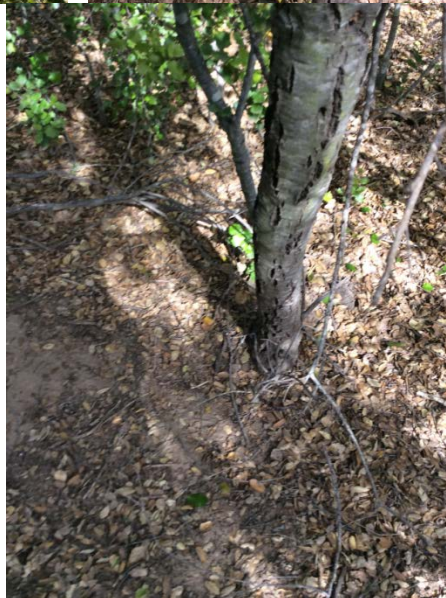
Tree Number 431
Species: Coast Live Oak – *Quercus agrifolia*
Number of Trunks: 1
Girth at 54": 10.5"
Height 20'
Dripline 20'
Observations: Codominant branches. Located 2' southeast of tree 430 and 9' north of the fence
Overall Health: Good
Project Impact: None
Recommendations: Install fence around dripline + 5' = 25' during construction, mulch

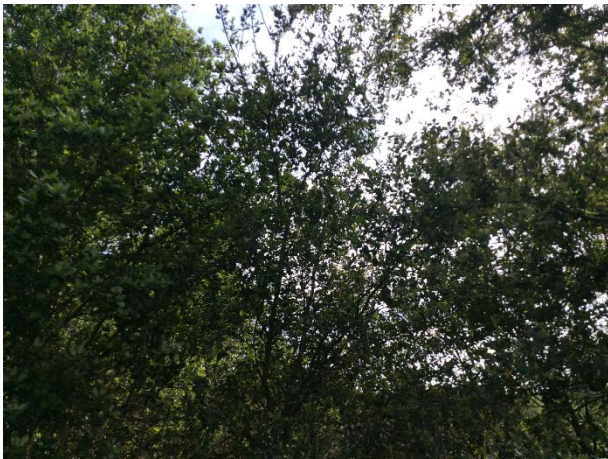
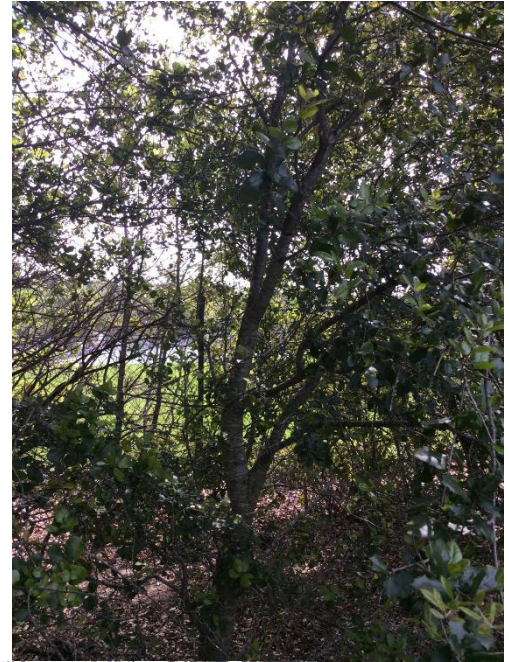
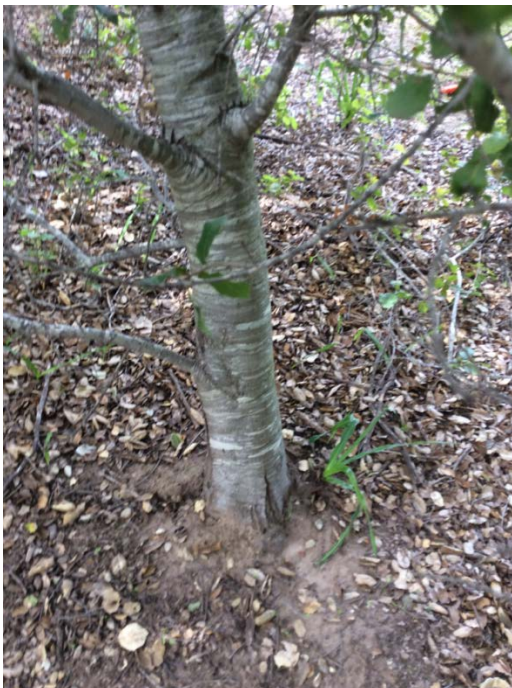
Tree Number 432
Species: Coast Live Oak – *Quercus agrifolia*
Number of Trunks: 1
Girth at 54": 11.5"
Height 20'
Dripline 20'
Observations: Located 5' west of tree 430 and 10' north of the fence
Overall Health: Good
Project Impact: None
Recommendations: Install fence around dripline + 5' = 20' during construction, mulch

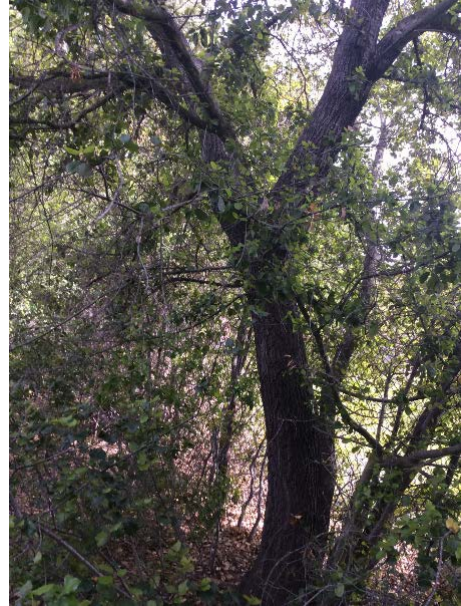
Tree Number	433
Species:	Coast Live Oak – <i>Quercus agrifolia</i>
Number of Trunks:	1
Girth at 54":	38"
Height	30'
Dripline	35'
Observations:	Located 1' north of fence, 16' west of tree 432 west of tree 430 and 10' north of the fence
Overall Health:	Good
Project Impact:	None
Recommendations:	Install fence around dripline + 5' = 40' during construction, mulch

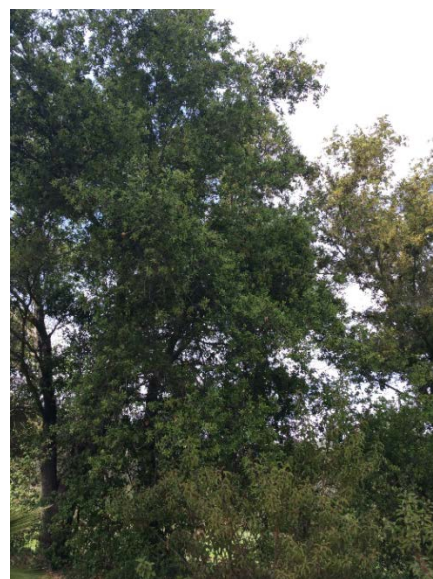
Tree Number	435
Species:	Coast Live Oak – <i>Quercus agrifolia</i>
Number of Trunks:	1
Girth at 54":	86"
Height	35'
Dripline	35'
Observations:	Located just north of fence, 5' west of tree 434
Overall Health:	Good
Project Impact:	None
Recommendations:	Install fence around dripline + 5' = 40' during construction, mulch

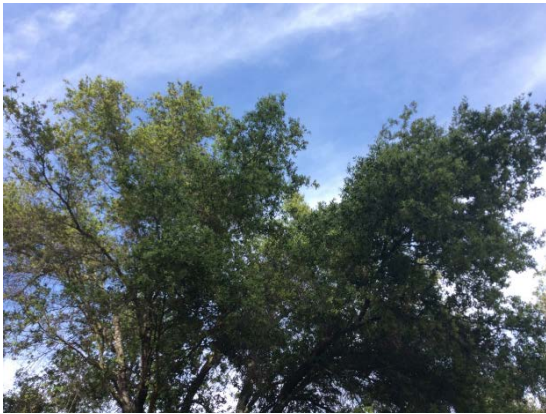
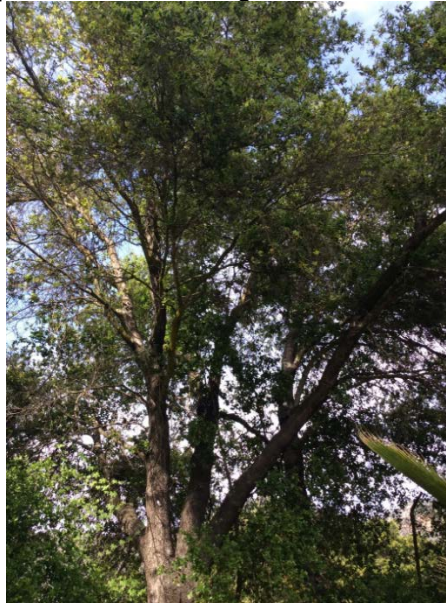
Tree Number	436
Species:	Coast Live Oak – <i>Quercus agrifolia</i>
Number of Trunks:	7
Girth at 54":	56"
Height	25'
Dripline	25'
Observations:	Located on fence line, 15' west of tree 435
Overall Health:	Good
Project Impact:	Approximately 10% CRZ impact from driveway construction north of tree. See TPP.
Recommendations:	Install fence around dripline + 5' = 30' during construction, mulch.

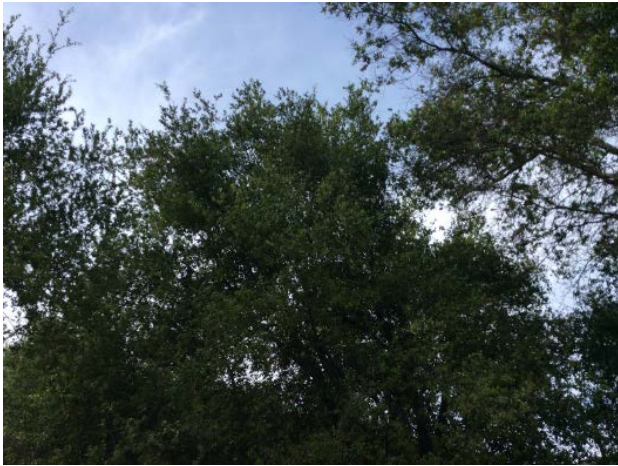
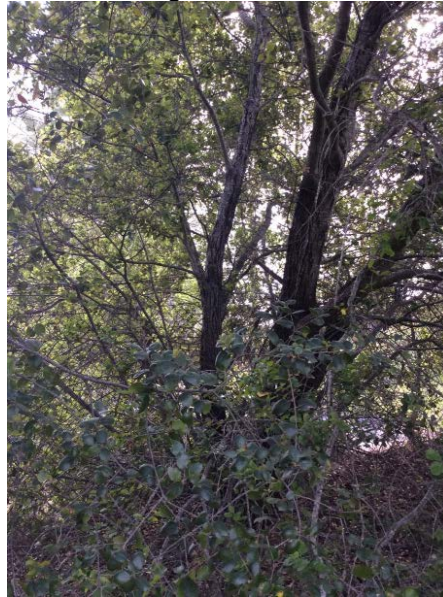
Tree Number	437
Species:	Coast Live Oak – <i>Quercus agrifolia</i>
Number of Trunks:	1
Girth at 54":	15"
Height	20'
Dripline	22'
Observations:	Located 21" south of fence and 5' east of service road
Overall Health:	Good
Project Impact:	Likely to be removed due to road widening
Recommendations:	Remove and mitigate with planting of ten 15-gallon Coast Live Oaks.

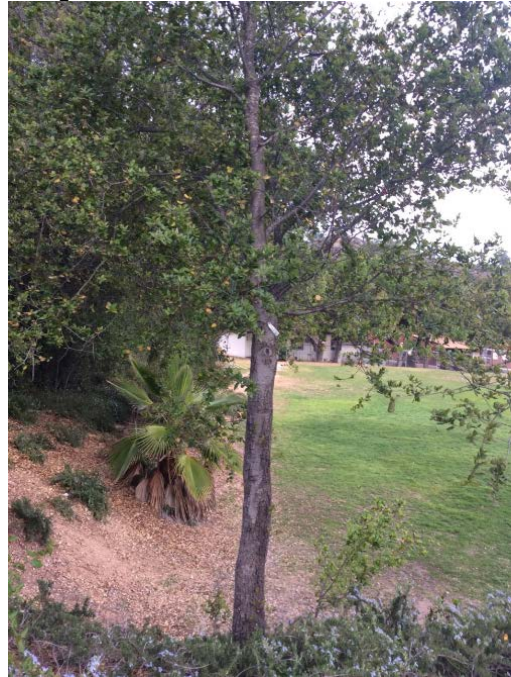
Tree Number	438
Species:	Coast Live Oak – <i>Quercus agrifolia</i>
Number of Trunks:	2
Girth at 54":	7" and 7" = 17"
Height	15'
Dripline	15'
Observations:	Located 9' south of goal and 5' east of service road
Overall Health:	Good
Project Impact:	Likely to be removed if access road widened on the east side
Recommendations:	Remove and replace with ten 15-gallon Coast Live Oaks

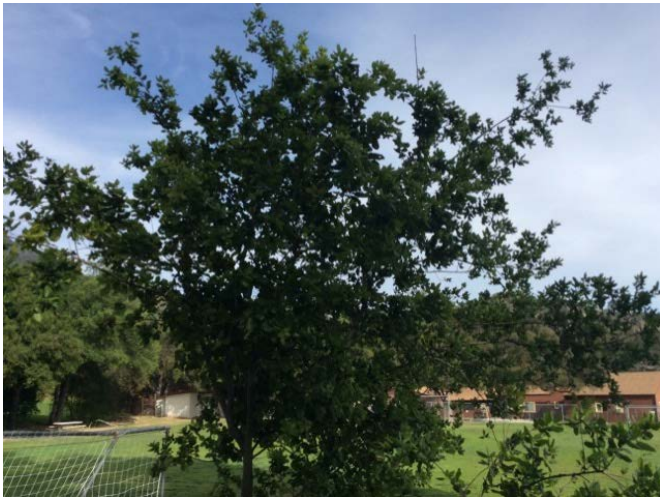
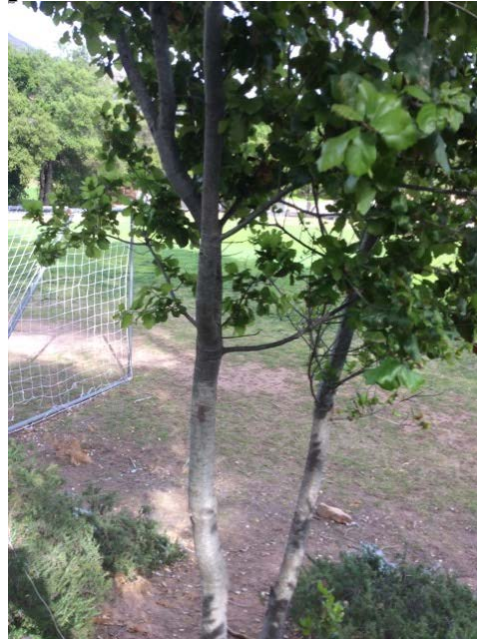
Tree Number 476
Species: Coast Live Oak – *Quercus agrifolia*
Number of Trunks: 1
Girth at 54": 37" (12" DBH)
Height 25'
Dripline 25"
Observations: 55' north of fence, north of tree 432
Overall Health: Destroyed
Project Impact: Tree destroyed during the Thomas Fire by firefighters cutting firebreaks.
Recommendations: None

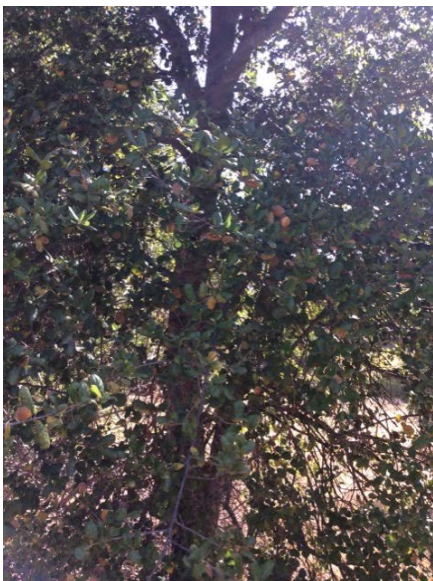
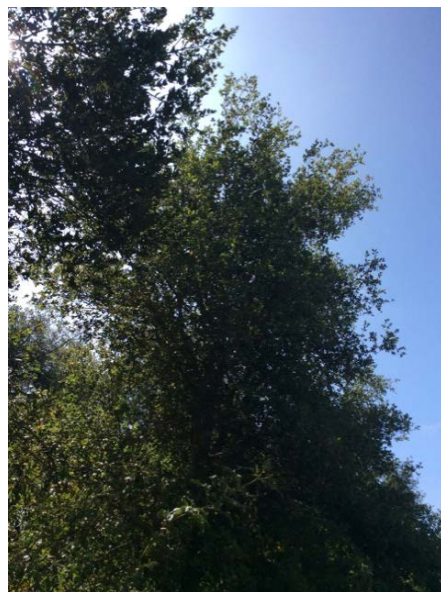
Tree Number 477
Species: Coast Live Oak – *Quercus agrifolia*
Number of Trunks: 1
Girth at 54": 39" (13" DBH)
Height 20'
Dripline 35"
Observations: 73' north of fence, 18' north of tree 476
Overall Health: Destroyed
Project Impact: Tree destroyed by firefighters creating firebreak during Thomas Fire
Recommendations: none

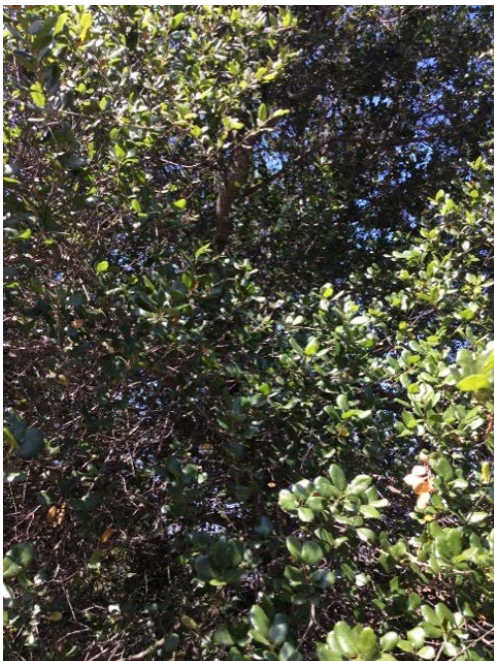
Tree Number	478
Species:	Coast Live Oak – <i>Quercus agrifolia</i>
Number of Trunks:	9
Girth at 54":	10.5" (3" DBH)
Height	15'
Dripline	15"
Observations:	2' south of fence, 5' southwest of tree 436
Overall Health:	Good
Project Impact:	Likely to be removed as part of road widening project
Recommendations:	Remove and replace with ten 15-gallon Coast Live Oaks

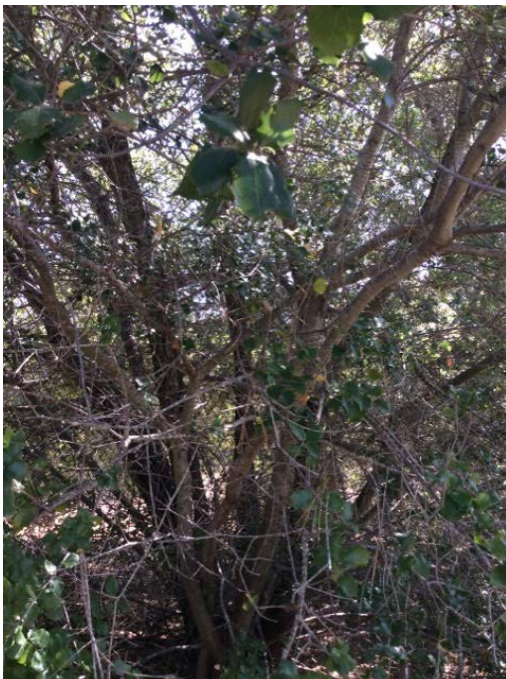
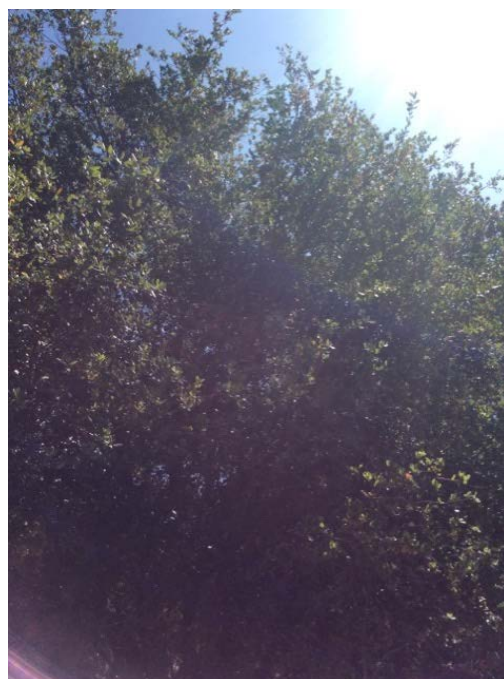
Tree Number 479
Species: Coast Live Oak – *Quercus agrifolia*
Number of Trunks: 1
Girth at 54": 10.5" (3" DBH)
Height 15'
Dripline 15"
Observations: 3' south of fence, 8' west of edge of road at north end
Overall Health: Destroyed by firefighters creating fire break during Thomas Fire
Project Impact: None
Recommendations: None

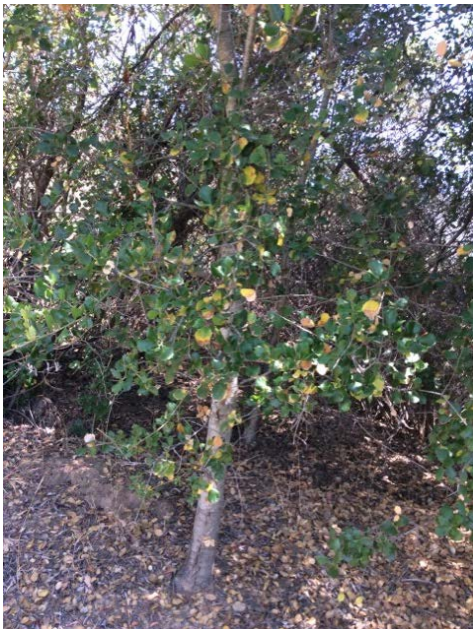
Tree Number	480
Species:	Coast Live Oak – <i>Quercus agrifolia</i>
Number of Trunks:	2
Girth at 54":	10" + 12" = 22" (7.5" DBH)
Height	20'
Dripline	15"
Observations:	3' north of fence,
Overall Health:	Good
Project Impact:	Possible if road widened
Recommendations:	Remove and replace with ten 15-gallon Coast Live Oaks

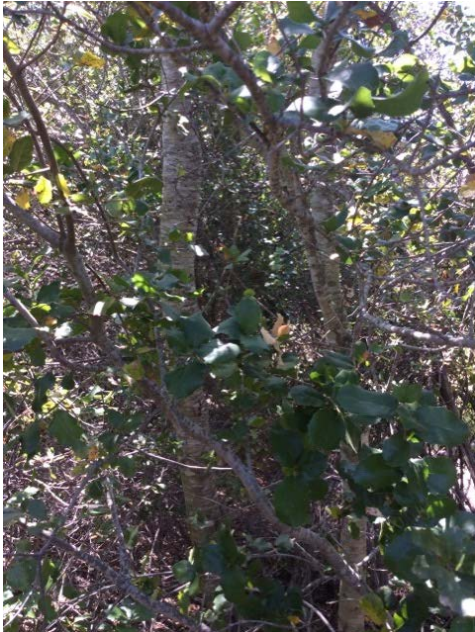
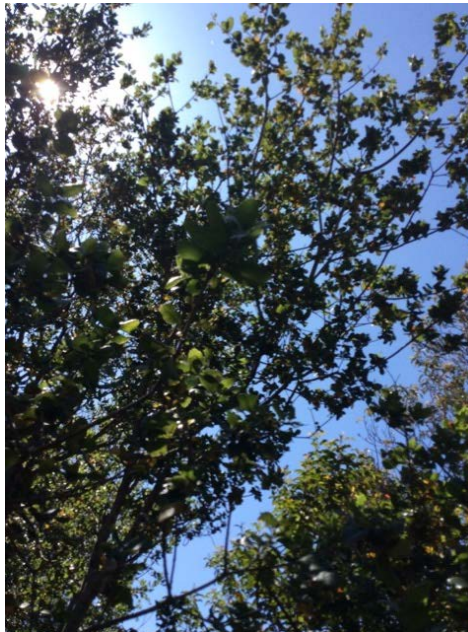
Tree Number 481
Species: Coast Live Oak – *Quercus agrifolia*
Number of Trunks: 2
Girth at 54": $10'' + 7'' = 17''$ (5.5" DBH)
Height 20'
Dripline 15"
Observations: 1' north of fence,
Overall Health: Good
Project Impact: Potential impact to 20% of CRZ. See TPP
Recommendations: Install fence around dripline + 5' = 20' during construction, mulch

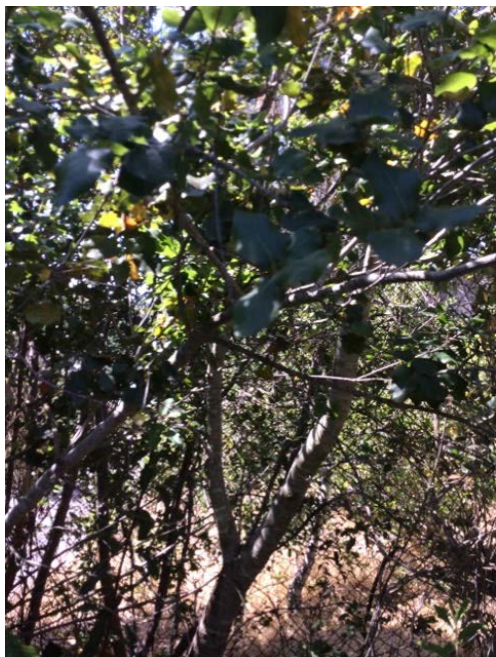
Tree Number 482
Species: Coast Live Oak – *Quercus agrifolia*
Number of Trunks: 2
Girth at 54": 10" + 12" = 22" (7.5" DBH)
Height 15'
Dripline 15"
Observations: 2' north of fence,
Overall Health: Good
Project Impact: None
Recommendations: Install fence around dripline + 5' = 20' during construction, mulch

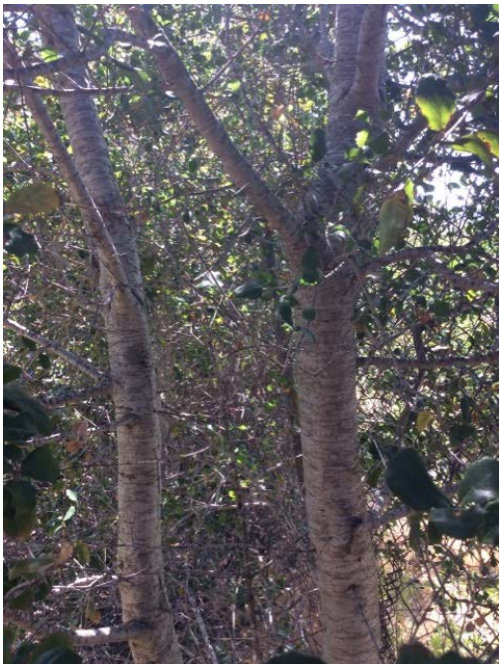
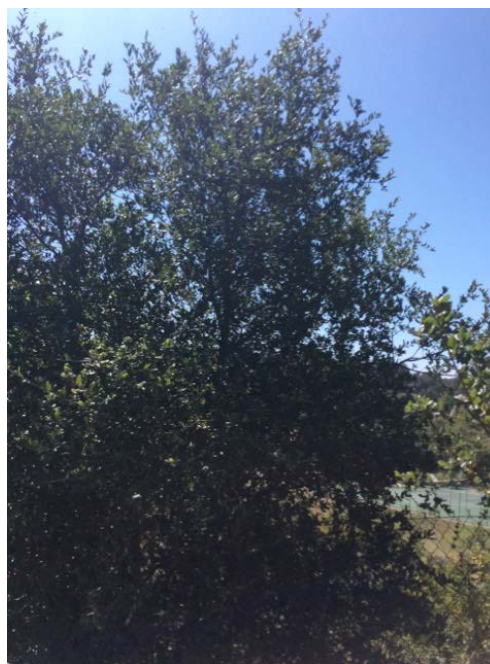
Tree Number 598
Species: Coast Live Oak – *Quercus agrifolia*
Number of Trunks: 1
Girth at 54": 164" (52.5" DBH)
Height 35'
Dripline 45"
Observations: 5th trunk failed, 40% foliage burns from Thomas Fire
Overall Health: Fair - Recovering well from fire
Project Impact: Located 28' from northern most new cabin impacting about 20% of CRZ. See TPP.
Recommendations: Install fence around dripline + 5' = 50' during construction, mulch

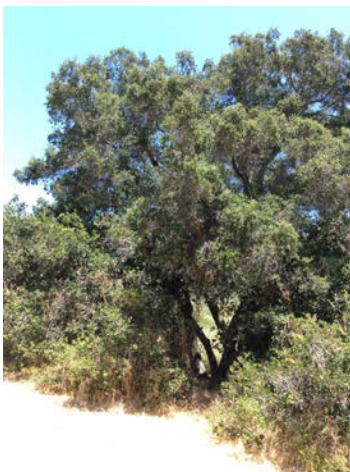
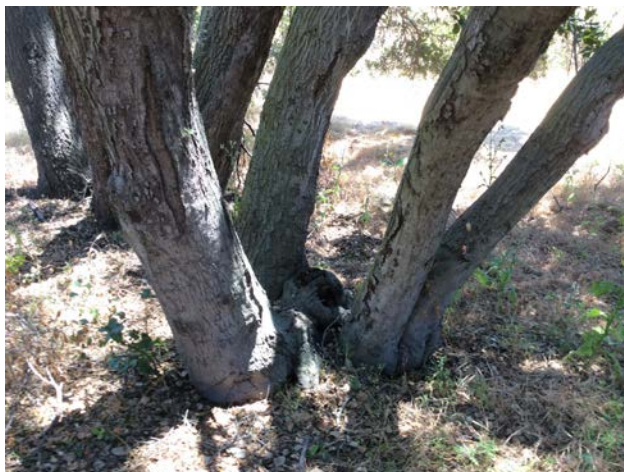
Tree Number	599
Species:	Coast Live Oak – <i>Quercus agrifolia</i>
Number of Trunks:	2
Girth at 54":	$7.5 + 4.5 = 12"$ (4" DBH)
Height	35'
Dripline	45"
Observations:	30% foliage scorched during Thomas Fire
Overall Health:	Fair -Recovering well from fire
Project Impact:	Located 28' from northern most new cabin impacting about 20% of CRZ. See TPP
Recommendations:	Install fence around dripline + 5' = 50' during construction, mulch
