February 28, 2022
SS-434-S

Subject: SOILS ENGINEERING REPORT
Proposed Single-Family Residence, 11820 Topa Vista Road, Upper Ojai, Ventura County, California

Reference: On-Site Wastewater Treatment System Design Report, Existing Studio, 11820 Topa Vista Road, Upper Ojai, Ventura County, California, by *Solid Soils & Geologic*, dated November 29, 2021

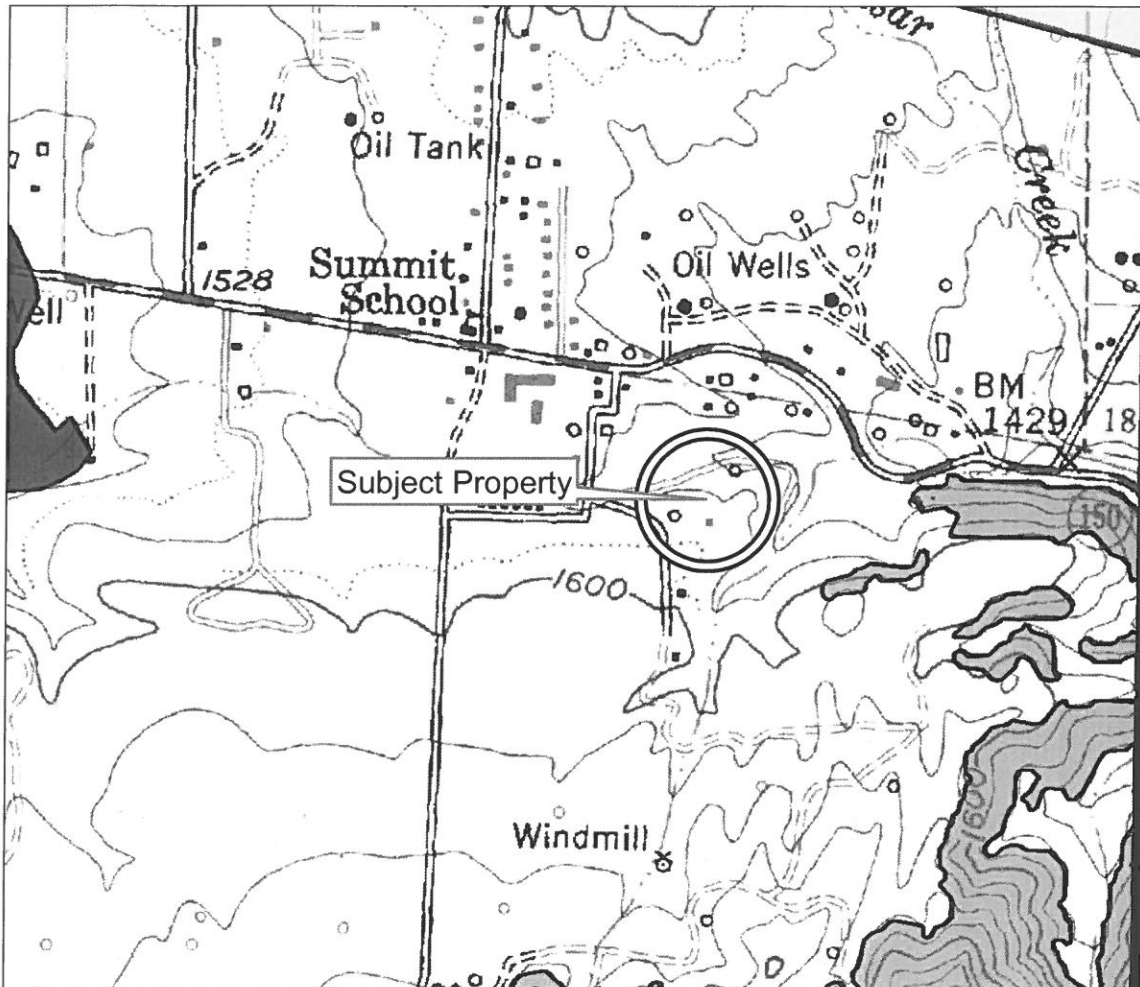
Subject: Seismic Hazard Zones Map
Reference: California Geological Survey
Scale: 1" = 1000'

EARTHQUAKE FAULT ZONES

Zone boundaries are delineated by straight-line segments; the boundaries define the zone encompassing active faults that constitute a potential hazard to structures from surface faulting or fault creep such that avoidance as described in Public Resources Code Section 2621.5(a) would be required.

SEISMIC HAZARD ZONES

Areas where historical occurrence of liquefaction, or local geological, geotechnical and ground water conditions indicate a potential for permanent ground displacements such that mitigation as defined in Public Resources Code Section 2693(c) would be required.

Areas where previous occurrence of landslide movement, or local topographic, geological, geotechnical and subsurface water conditions indicate a potential for permanent ground displacements such that mitigation as defined in Public Resources Code Section 2693(c) would be required.

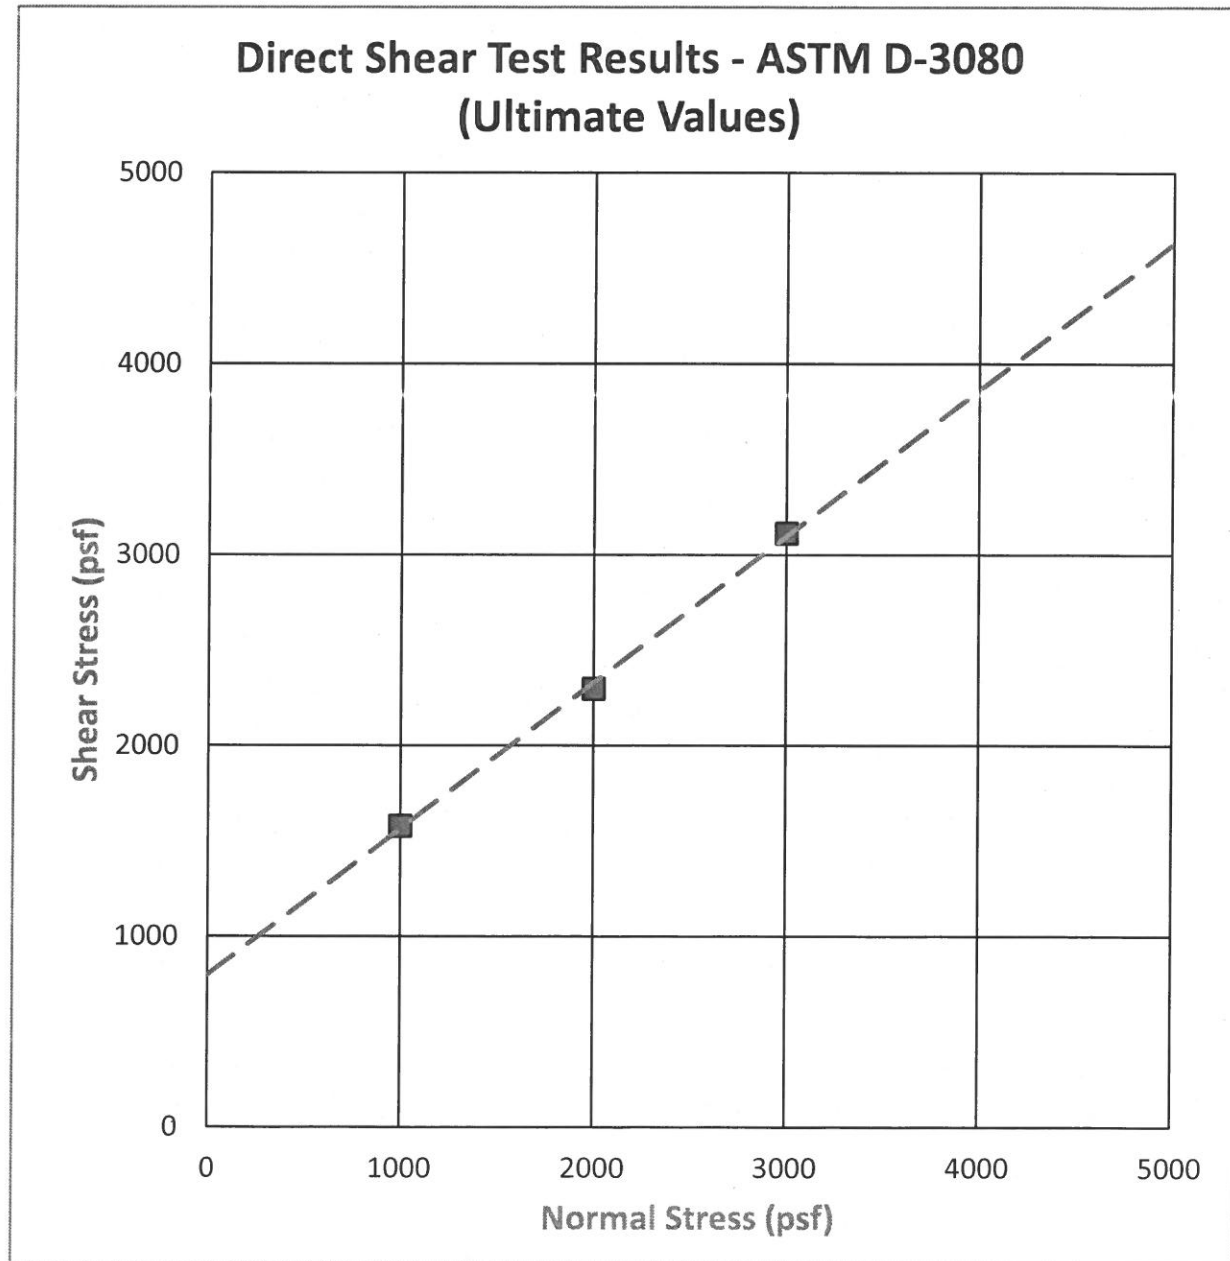
SHEAR DIAGRAM S-1

Initial Moisture Content: 15.1 %

Dry Density: 107.9 (pcf)

Degree of Saturation: 98.3 %

DS SS-434-S Mircetic TP-3 @ 5'.HSDN - DS Test

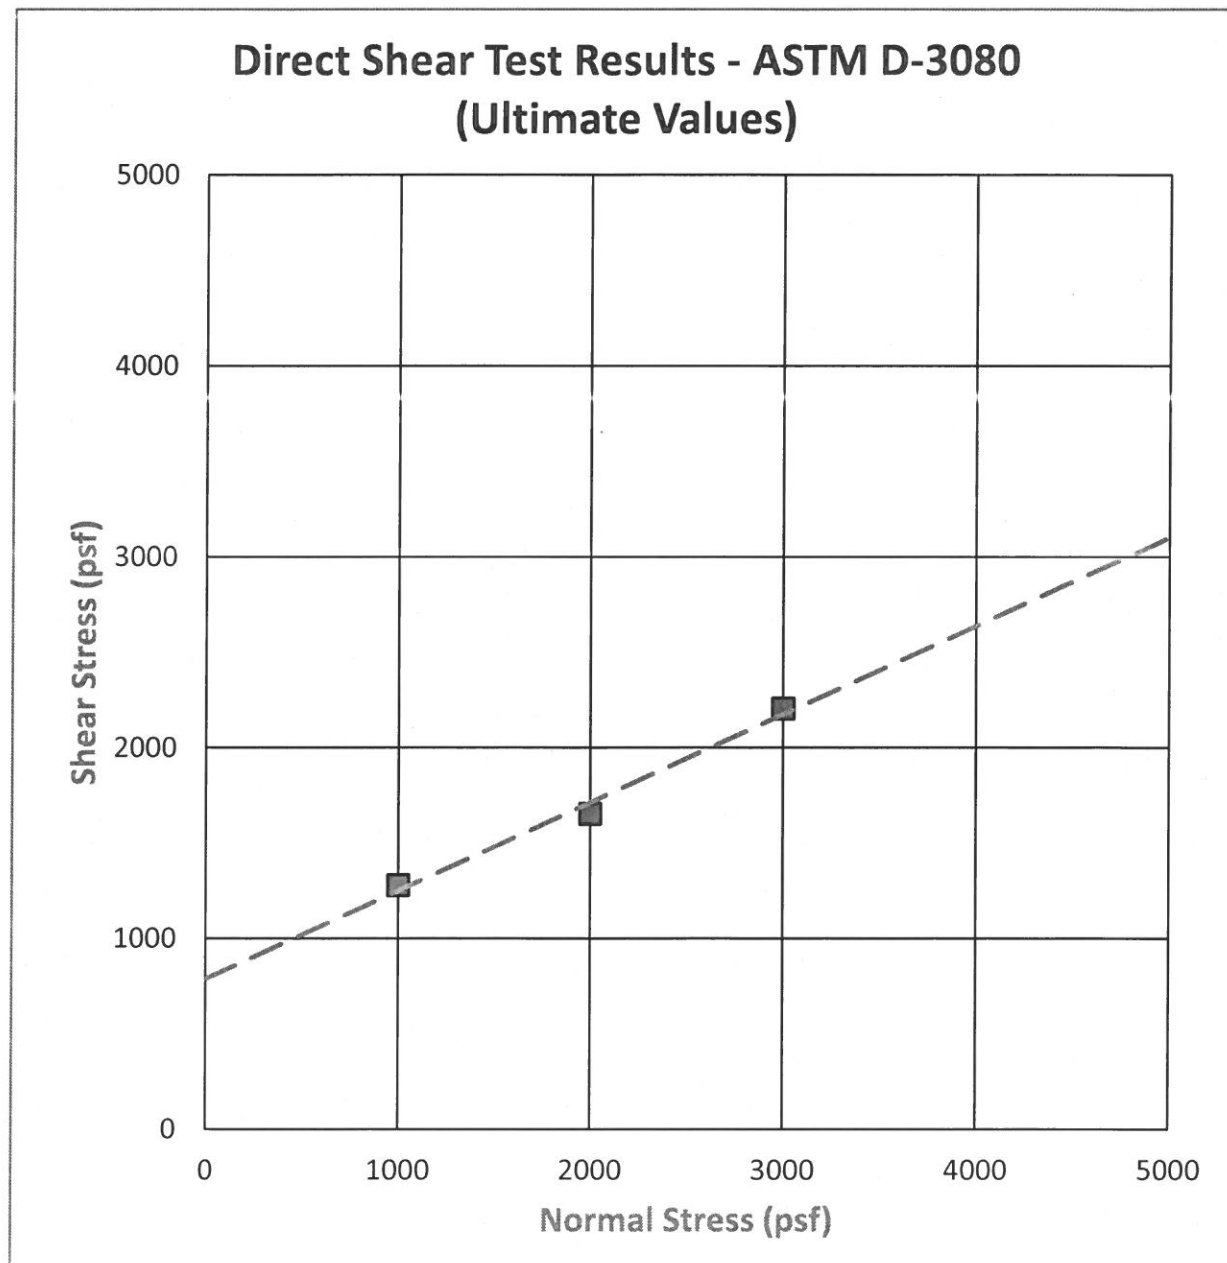
SHEAR DIAGRAM S-2

Phi Angle: 24.8°

Shear Rate: 0.05 in/min

DS SS-434-S Mercetic Composite @ 0-5'.HSDN - DS Test

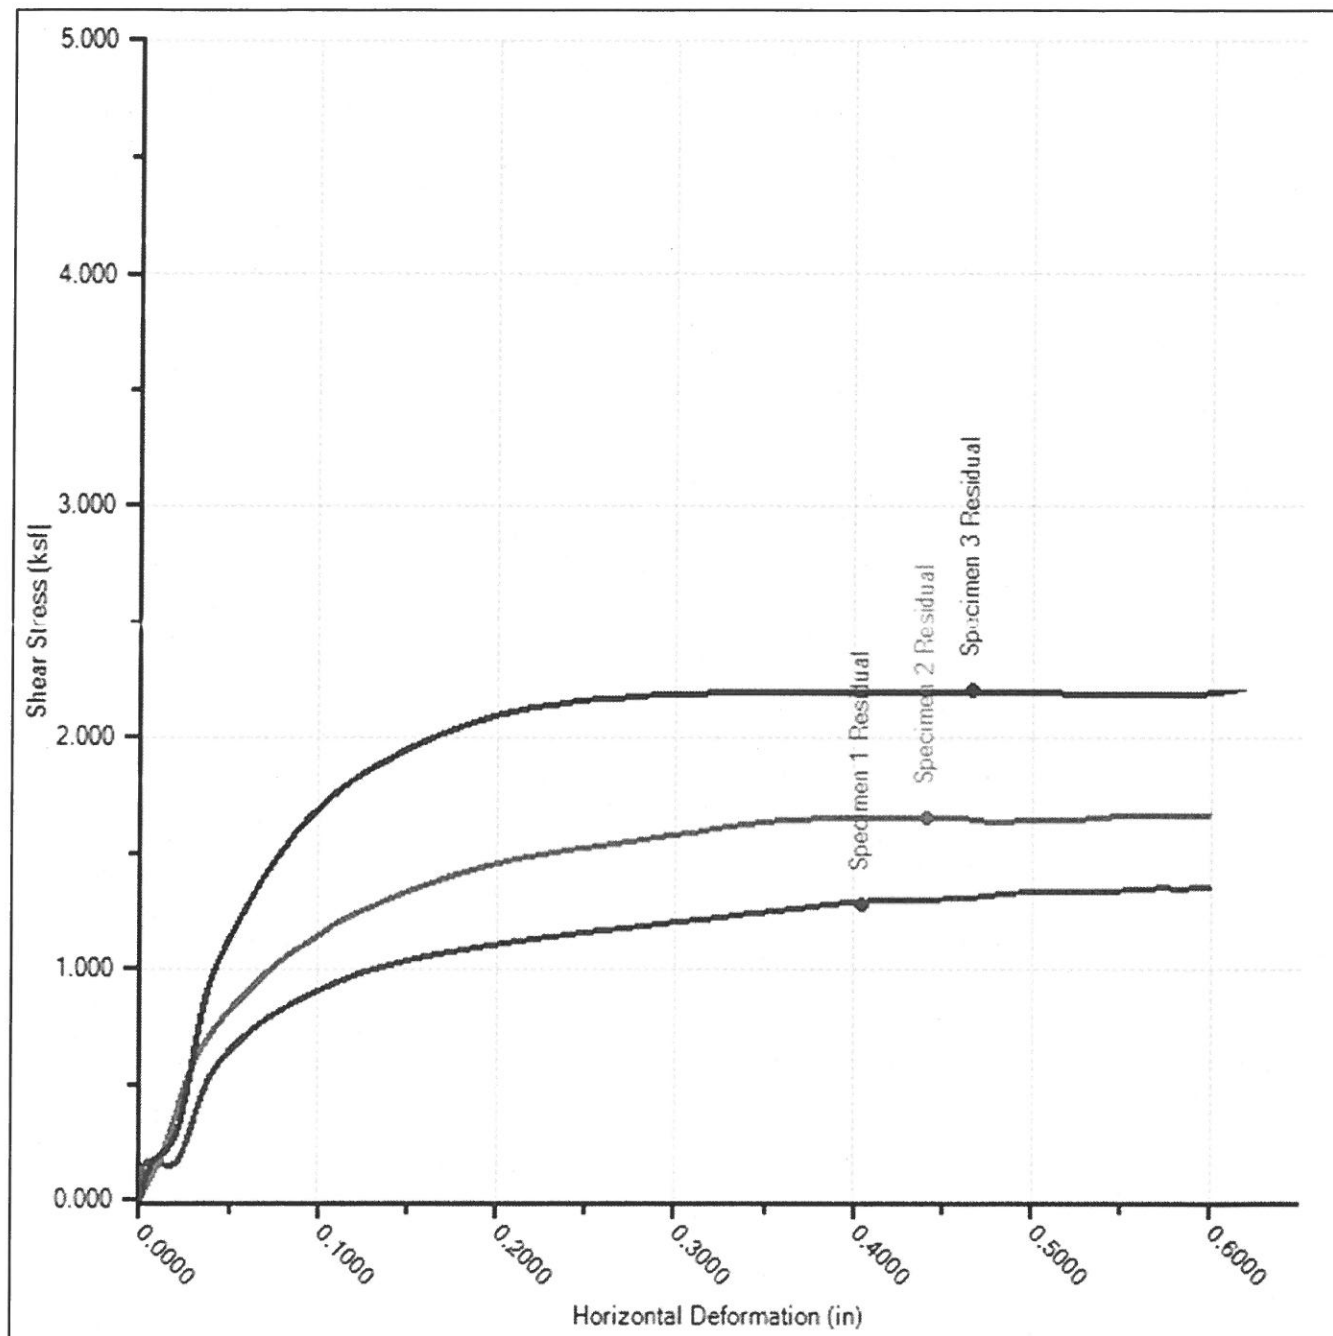
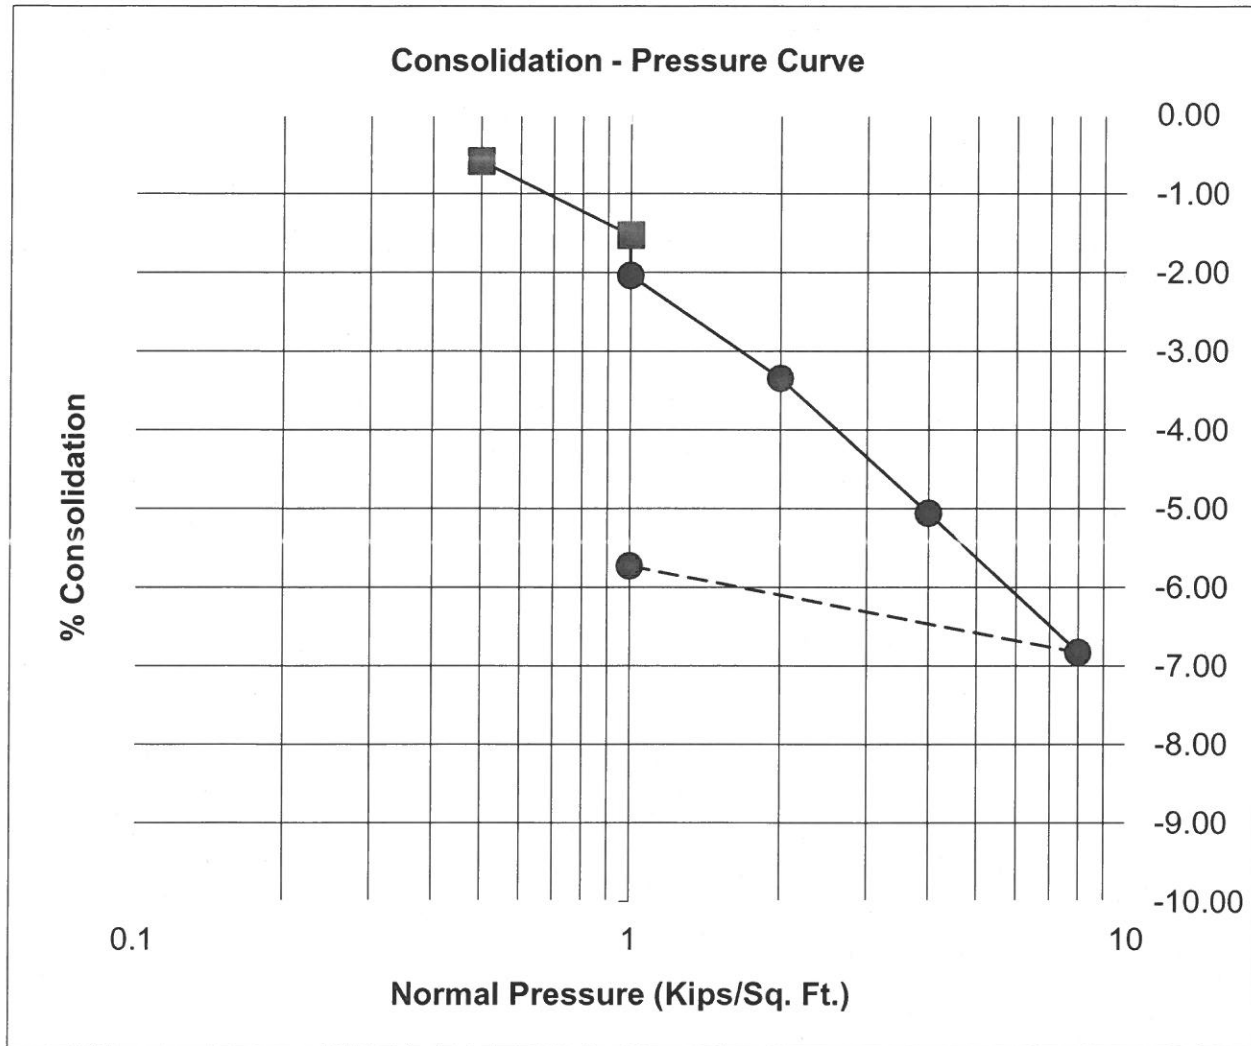
Consolidation Test Results

Job: SS-434-S
Test by: LE
Test Pit or Boring: TP-1

Client: Mircetic
Checked by: JS
Depth: 4.5"

Date: 7/26/21
Subject: Consolidation Diagram
Material: Clayey Silty Sand

■ = Field Moisture

● = Sample Flooded

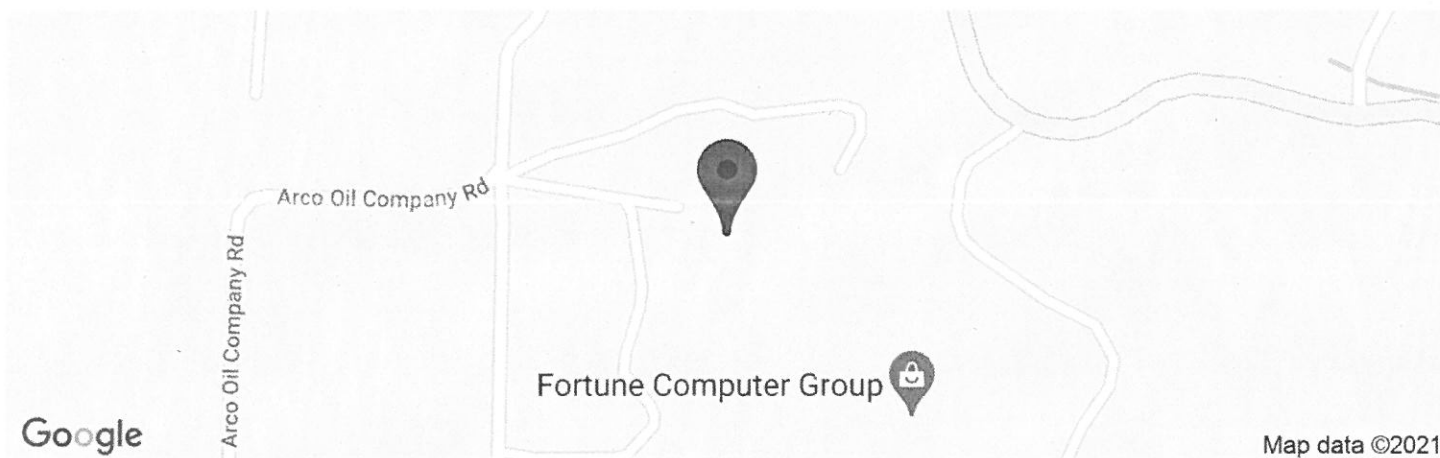
11820 Topa Vista Rd, Santa Paula, CA 93060, USA

Latitude, Longitude: 34.4336708, -119.1332982

Date	7/26/2021, 1:13:13 PM
Design Code Reference Document	ASCE7-16
Risk Category	II
Site Class	D - Default (See Section 11.4.3)

Type	Value	Description
S_S	1.899	MCE_R ground motion. (for 0.2 second period)
S_1	0.727	MCE_R ground motion. (for 1.0s period)
S_{MS}	2.279	Site-modified spectral acceleration value
S_{M1}	null -See Section 11.4.8	Site-modified spectral acceleration value
S_{DS}	1.519	Numeric seismic design value at 0.2 second SA
S_{D1}	null -See Section 11.4.8	Numeric seismic design value at 1.0 second SA

Type	Value	Description
SDC	null -See Section 11.4.8	Seismic design category
F_a	1.2	Site amplification factor at 0.2 second
F_v	null -See Section 11.4.8	Site amplification factor at 1.0 second
PGA	0.833	MCE_G peak ground acceleration
F_{PGA}	1.2	Site amplification factor at PGA
PGA_M	0.999	Site modified peak ground acceleration
T_L	8	Long-period transition period in seconds
S_{sRT}	1.899	Probabilistic risk-targeted ground motion. (0.2 second)
S_{sUH}	2.128	Factored uniform-hazard (2% probability of exceedance in 50 years) spectral acceleration
S_{sD}	2.148	Factored deterministic acceleration value. (0.2 second)
S_{1RT}	0.727	Probabilistic risk-targeted ground motion. (1.0 second)
S_{1UH}	0.815	Factored uniform-hazard (2% probability of exceedance in 50 years) spectral acceleration.
S_{1D}	0.77	Factored deterministic acceleration value. (1.0 second)
PGA_d	0.885	Factored deterministic acceleration value. (Peak Ground Acceleration)

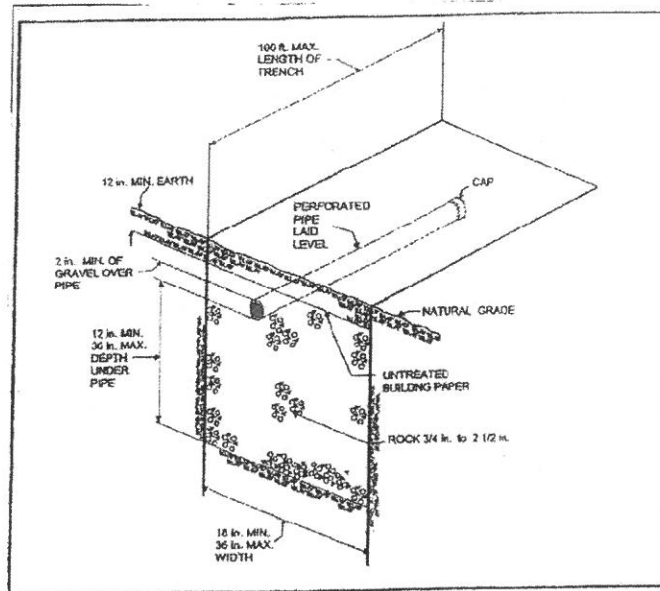
Typical Leach Lines

Square Feet Per Lineal Foot Trench Widths and Depths

Width of Trench Bottom			
		18 inches	24 inches	30 inches	36 inches
Depth of Gravel Below Pipe	12 inches	1 1/2 Feet ²	2 Feet ²	2 1/2 Feet ²	3 Feet ²
	18 inches	2 1/2 Feet ²	3 Feet ²	3 1/2 Feet ²	4 Feet ²
	24 inches	3 Feet ²	4 Feet ²	4 1/2 Feet ²	5 Feet ²
	30 inches	3 Feet ²	4 Feet ²	5 Feet ²	6 Feet ²
	36 inches	3 Feet ²	4 Feet ²	5 Feet ²	6 Feet ²

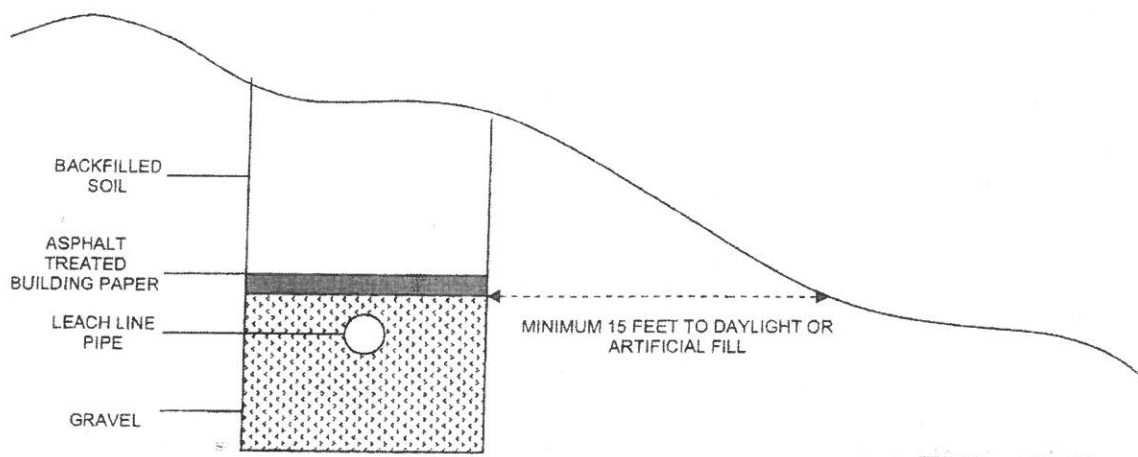
Leach Line Horizontal Setback from Daylight

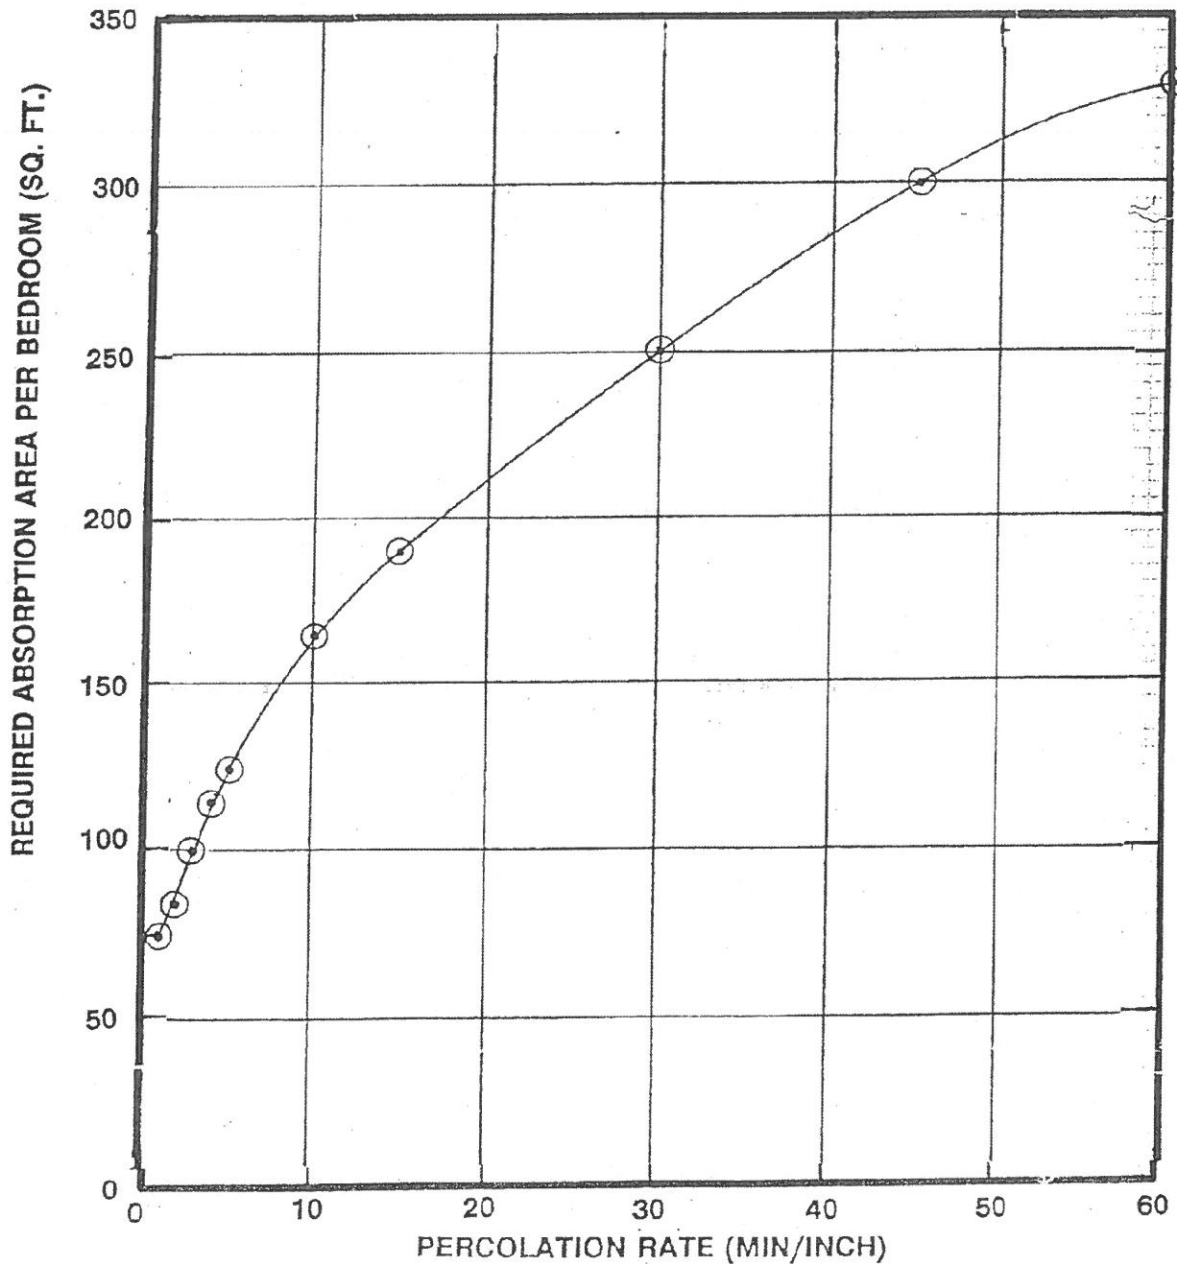
PLOT OF UPC TABLE I-6

REFERENCE: UPC Table I-6, as modified by the County of Ventura Environmental Health, 8/23/90

Plot of UPC Table I-6

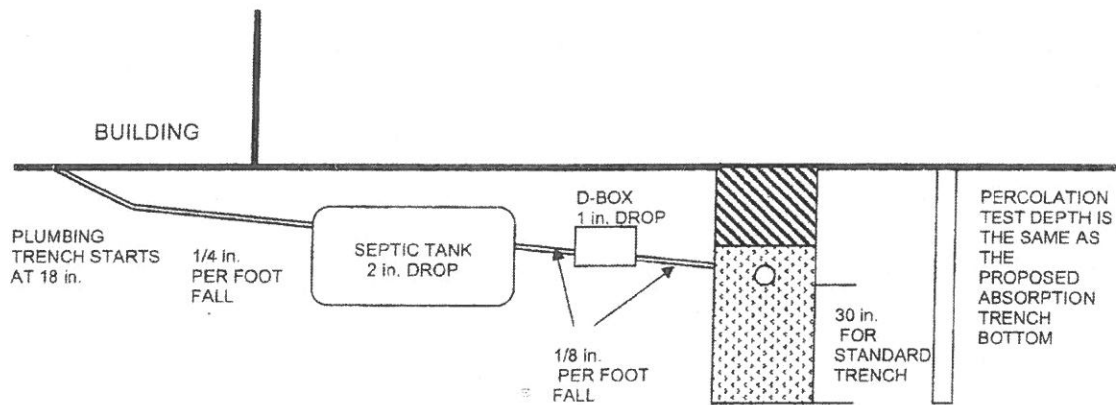
Cross Section of a Septic System with Rock Filled Leach Line

Cross Section of a Septic with Rock Filled Leach Line
