**February 28, 2022**  
**SS-434-S**

**Subject: SOILS ENGINEERING REPORT**  
Proposed Single-Family Residence, 11820 Topa Vista Road, Upper Ojai, Ventura County, California

**Reference:** On-Site Wastewater Treatment System Design Report, Existing Studio, 11820 Topa Vista Road, Upper Ojai, Ventura County, California, by *Solid Soils & Geologic*, dated November 29, 2021

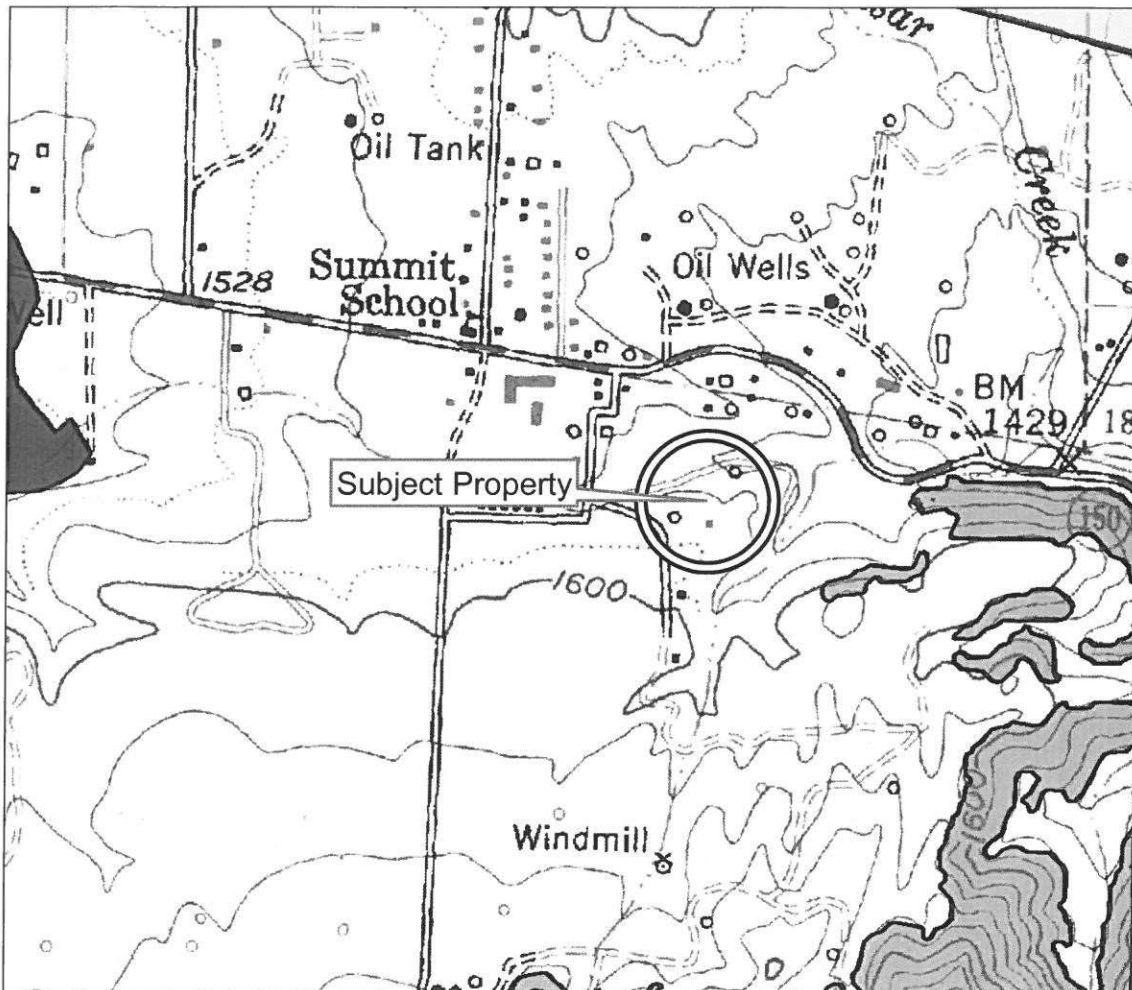
## Seismic Hazard Zones Map

Subject: Seismic Hazard Zones Map  
Reference: California Geological Survey  
Scale: 1" = 1000'

Zone boundaries are delineated by straight-line segments; the boundaries define the zone encompassing active faults that constitute a potential hazard to structures from surface faulting or fault creep such that avoidance as described in Public Resources Code Section 2621.5(a) would be required.

Areas where historical occurrence of liquefaction, or local geological, geotechnical and ground water conditions indicate a potential for permanent ground displacements such that mitigation as defined in Public Resources Code Section 2693(c) would be required.

Areas where previous occurrence of landslide movement, or local topographic, geological, geotechnical and subsurface water conditions indicate a potential for permanent ground displacements such that mitigation as defined in Public Resources Code Section 2693(c) would be required.

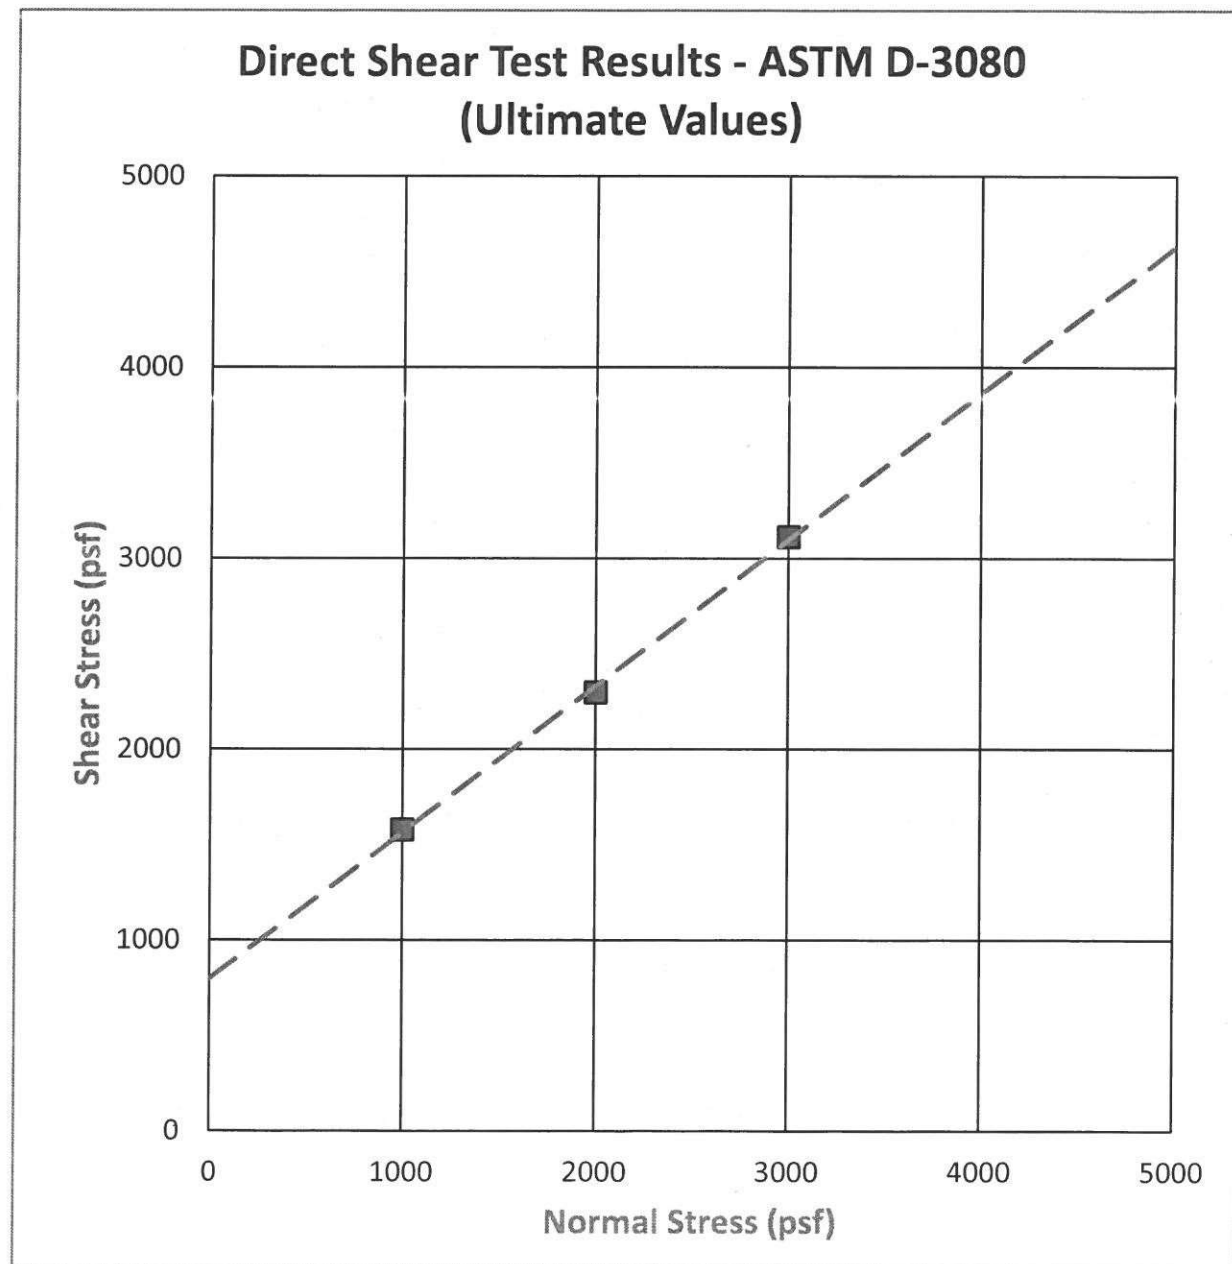
**SHEAR DIAGRAM S-1**

Initial Moisture Content: 15.1 %

Dry Density: 107.9 (pcf)

Degree of Saturation: 98.3 %

Vicinity Maps	
Plot Plan	
Test Pit Logs .....	Plates TP-1 through TP-7
Shear Test Results .....	Plates S-1 and S-2
Consolidation Test Results .....	Plate C-1
Seismic Information	
Percolation Test Data & Information

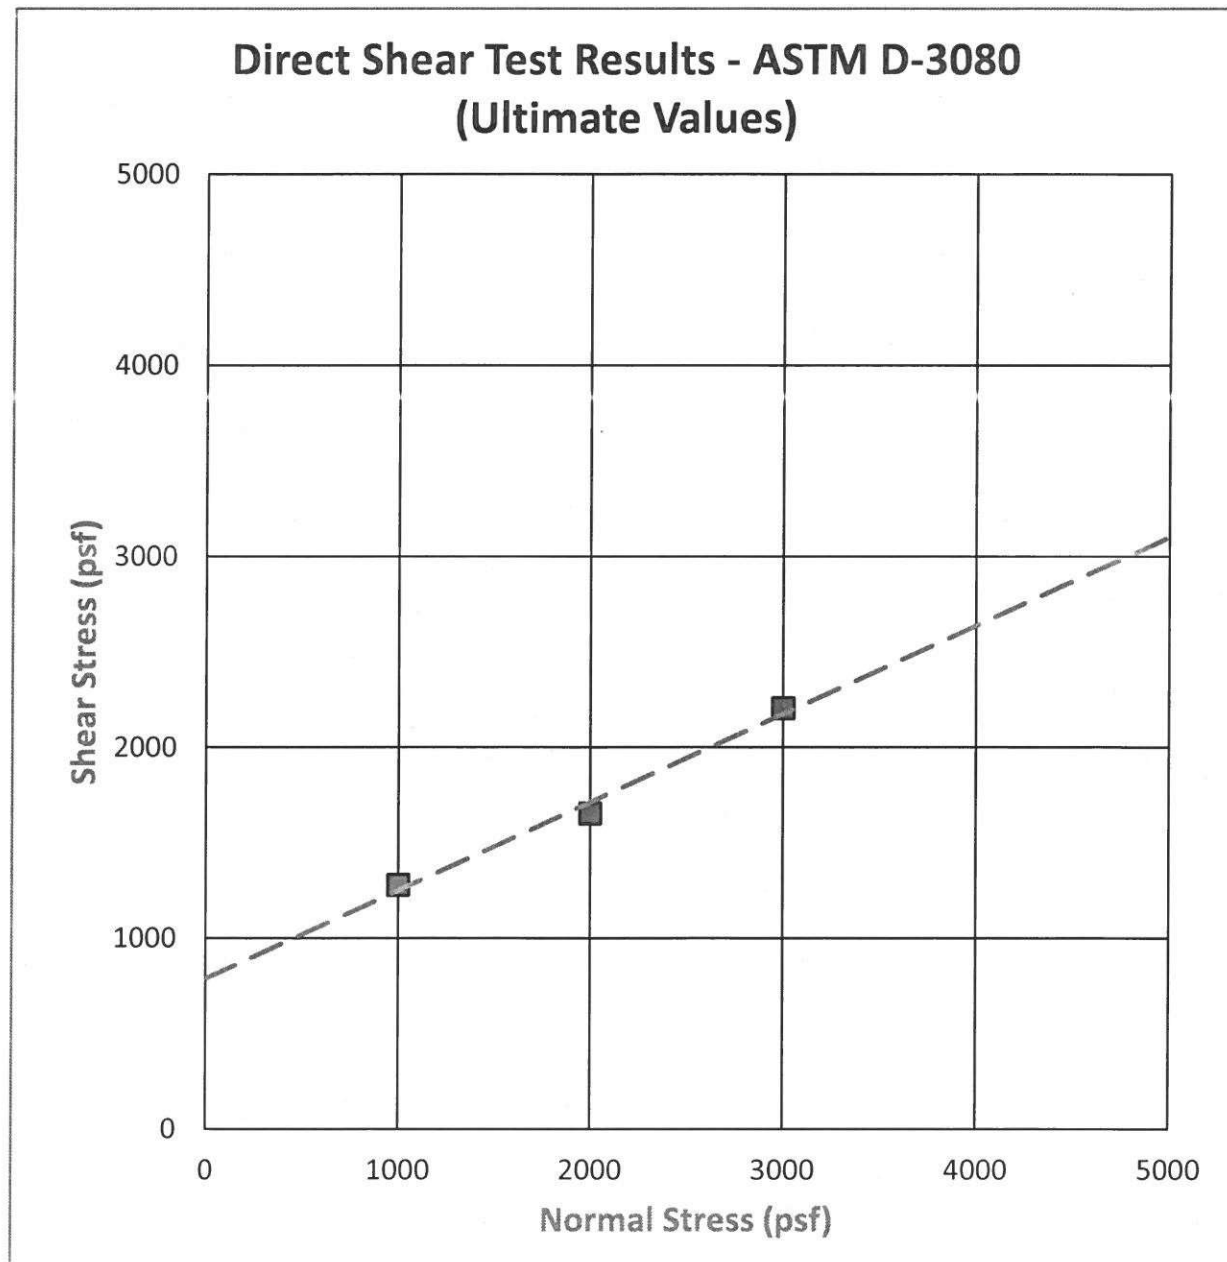
**SHEAR DIAGRAM S-2**

Phi Angle: 24.8°

Shear Rate: 0.05 in/min

DS SS-434-S Mercetic Composite @ 0-5'.HSDN - DS Test

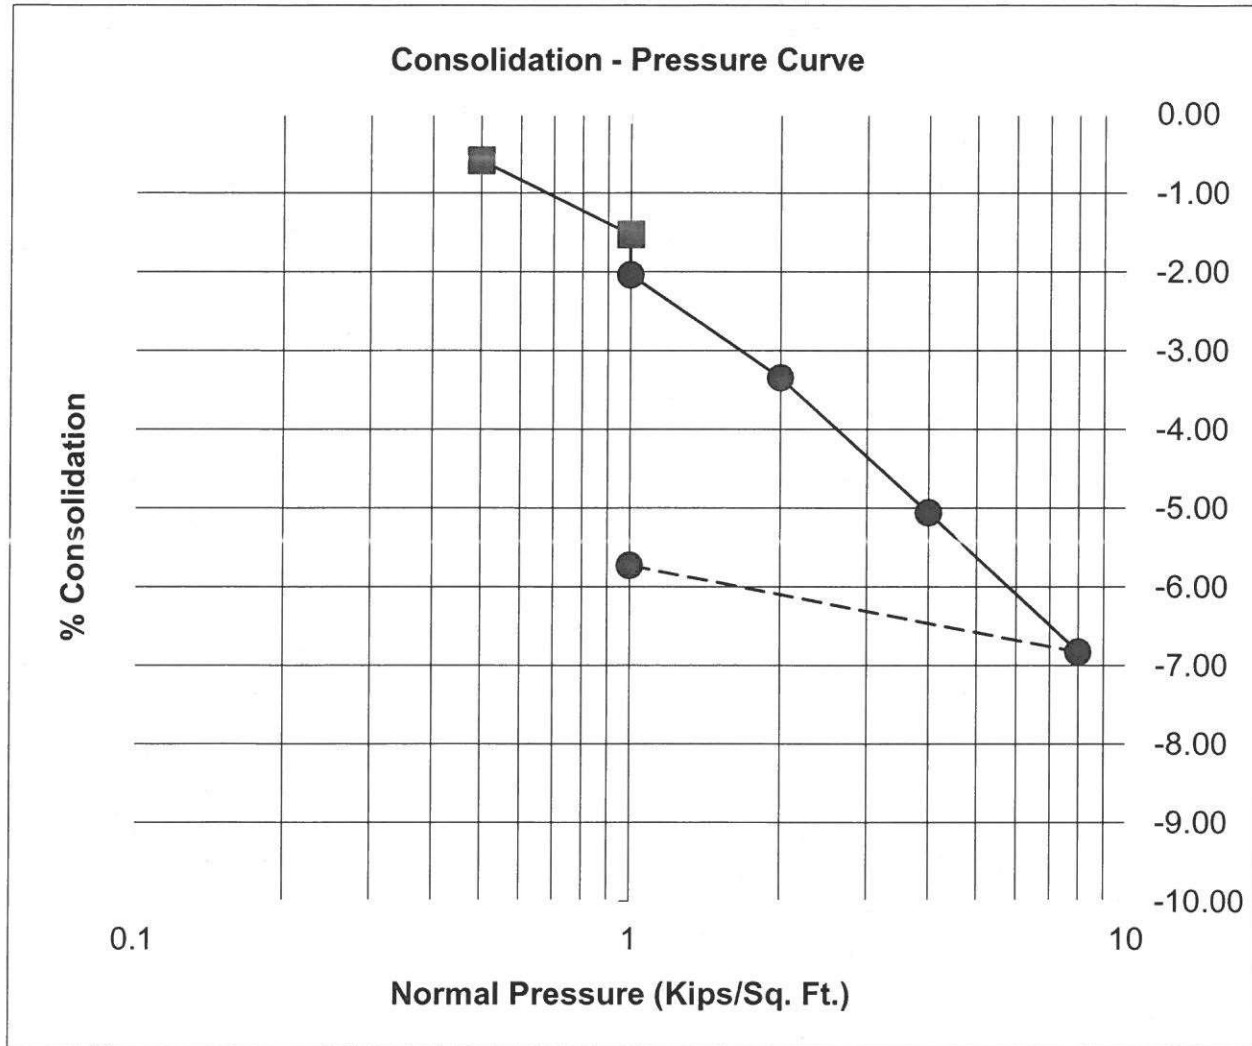
# Consolidation Test Results

Job: SS-434-S  
Test by: LE  
Test Pit or Boring: TP-1

Client: Mircetic  
Checked by: JS  
Depth: 4.5"

Date: 7/26/21  
Subject: Consolidation Diagram  
Material: Clayey Silty Sand

■ = Field Moisture

● = Sample Flooded

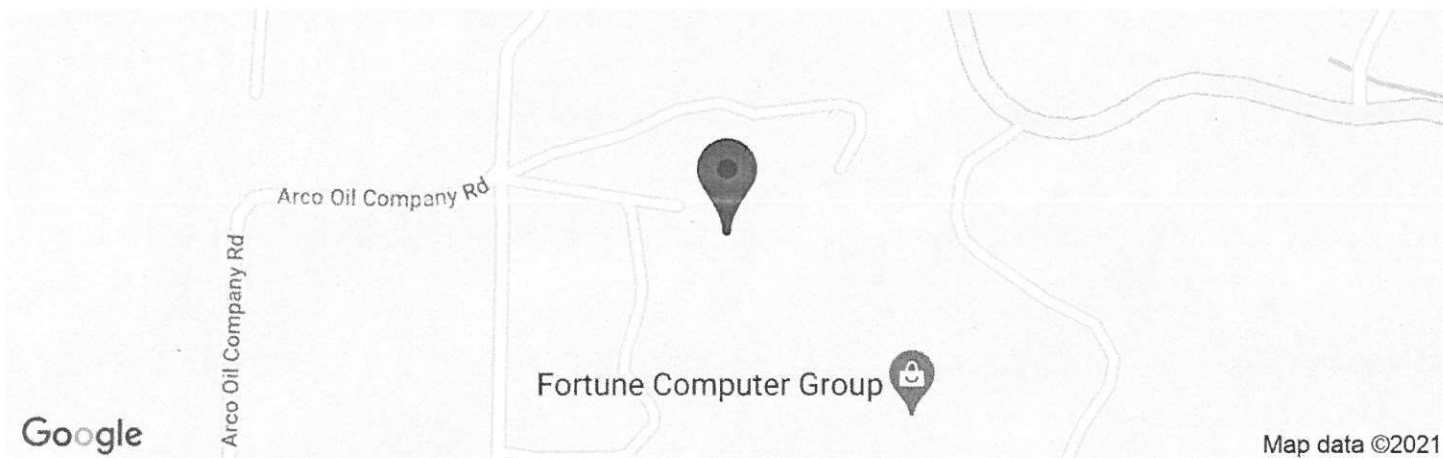
Date	7/26/2021, 1:13:13 PM
Design Code Reference Document	ASCE7-16
Risk Category	II
Site Class	D - Default (See Section 11.4.3)

Type	Value	Description
$S_S$	1.899	$MCE_R$ ground motion. (for 0.2 second period)
$S_1$	0.727	$MCE_R$ ground motion. (for 1.0s period)
$S_{MS}$	2.279	Site-modified spectral acceleration value
$S_{M1}$	null -See Section 11.4.8	Site-modified spectral acceleration value
$S_{DS}$	1.519	Numeric seismic design value at 0.2 second SA
$S_{D1}$	null -See Section 11.4.8	Numeric seismic design value at 1.0 second SA

Type	Value	Description
SDC	null -See Section 11.4.8	Seismic design category
$F_a$	1.2	Site amplification factor at 0.2 second
$F_v$	null -See Section 11.4.8	Site amplification factor at 1.0 second
PGA	0.833	$MCE_G$ peak ground acceleration
$F_{PGA}$	1.2	Site amplification factor at PGA
$PGA_M$	0.999	Site modified peak ground acceleration
$T_L$	8	Long-period transition period in seconds
$S_{sRT}$	1.899	Probabilistic risk-targeted ground motion. (0.2 second)
$S_{sUH}$	2.128	Factored uniform-hazard (2% probability of exceedance in 50 years) spectral acceleration
$S_{sD}$	2.148	Factored deterministic acceleration value. (0.2 second)
$S_{1RT}$	0.727	Probabilistic risk-targeted ground motion. (1.0 second)
$S_{1UH}$	0.815	Factored uniform-hazard (2% probability of exceedance in 50 years) spectral acceleration.
$S_{1D}$	0.77	Factored deterministic acceleration value. (1.0 second)
$PGA_d$	0.885	Factored deterministic acceleration value. (Peak Ground Acceleration)

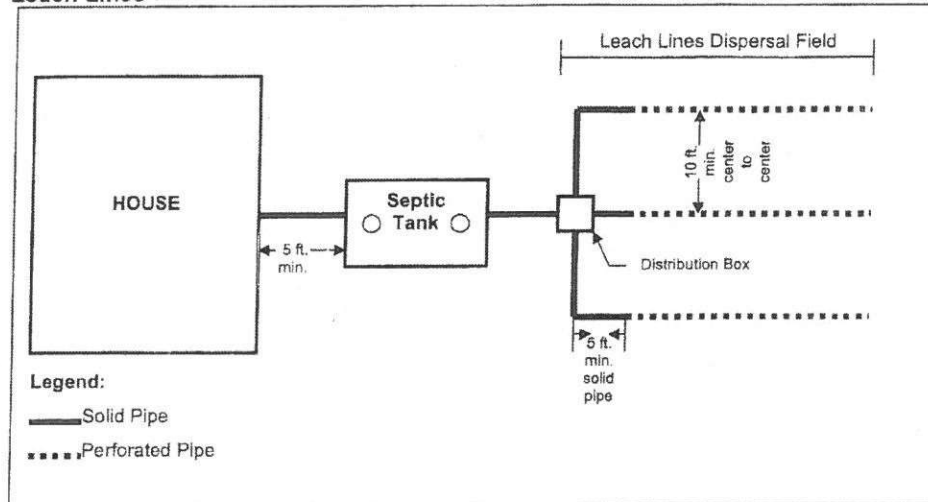
#### Leach Lines

### Typical Septic Tank System with Conventional Dispersal Field

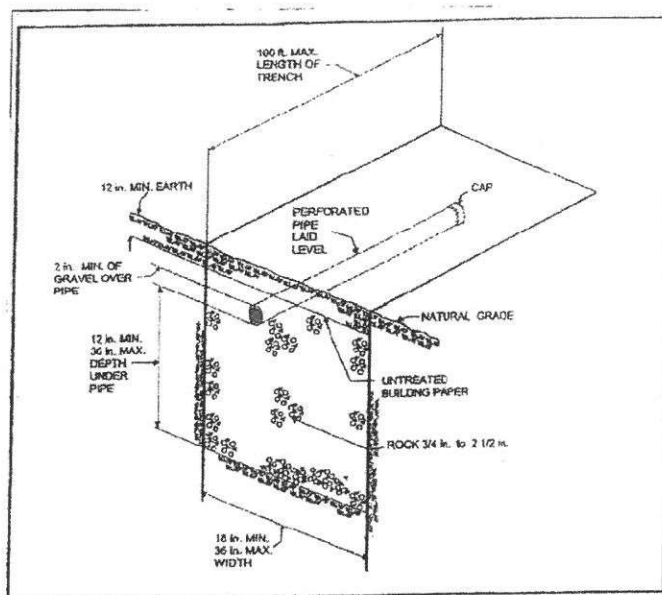
### Typical Leach Lines

### Square Feet Per Lineal Foot Trench Widths and Depths

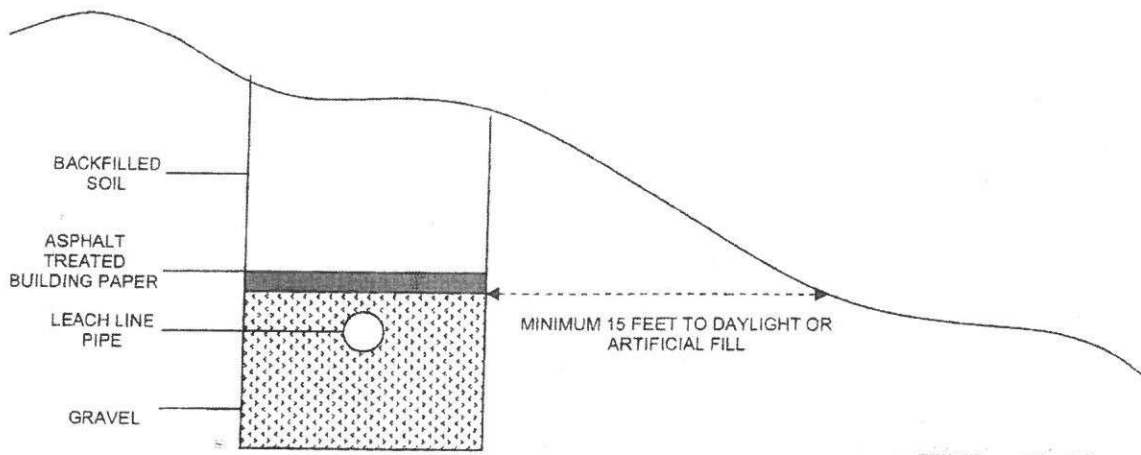
### Leach Line Horizontal Setback from Daylight

Leach Line Horizontal  
Setback from Daylight

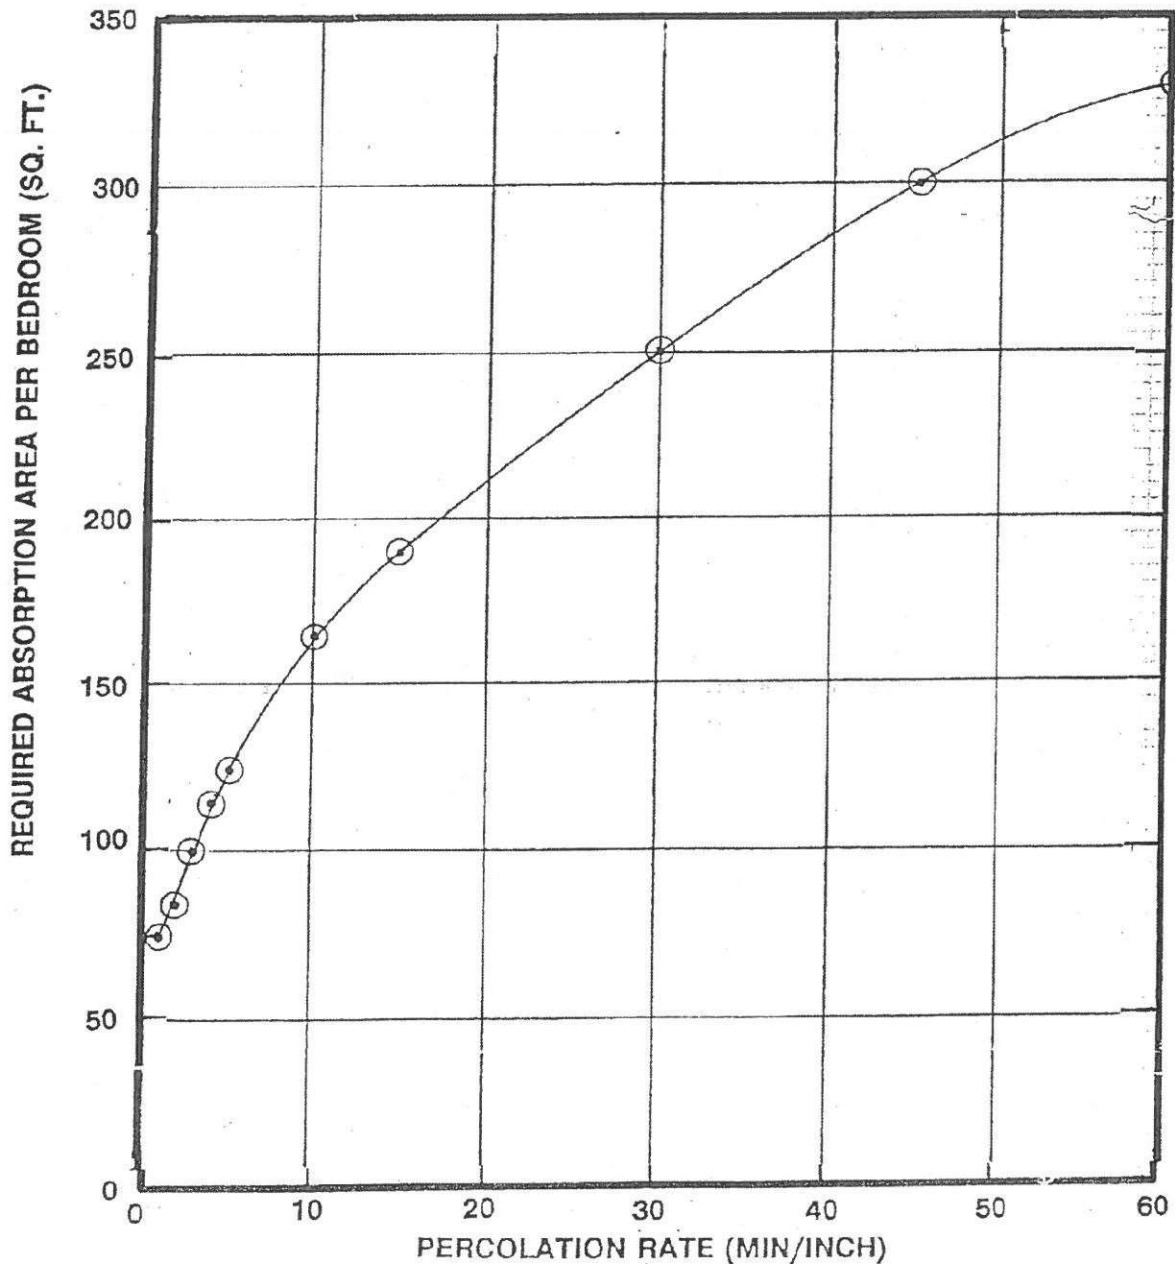
## PLOT OF UPC TABLE I-6

REFERENCE: UPC Table I-6, as modified by the County of Ventura Environmental Health, 8/23/90

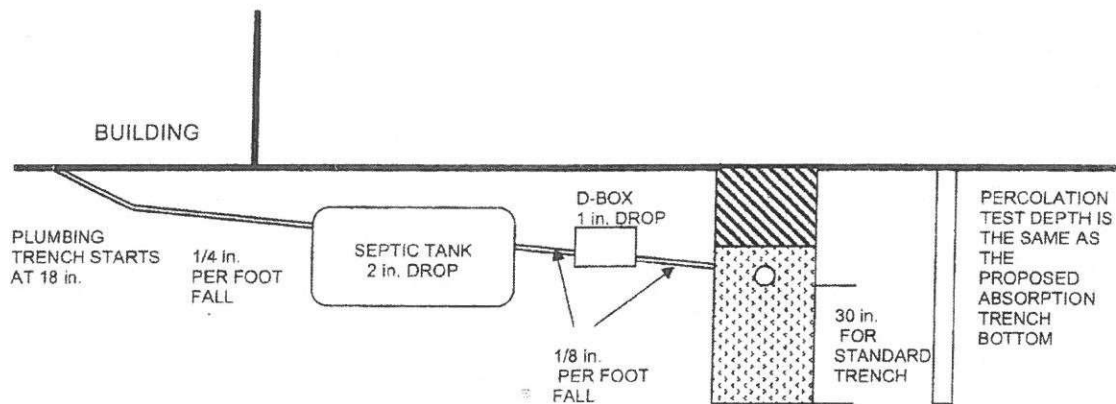
### Cross Section of a Septic System with Rock Filled Leach Line

## Cross Section of a Septic with Rock Filled Leach Line
