February 28, 2022
SS-434-S

Subject: SOILS ENGINEERING REPORT
Proposed Single-Family Residence, 11820 Topa Vista Road, Upper Ojai, Ventura County, California

Introduction

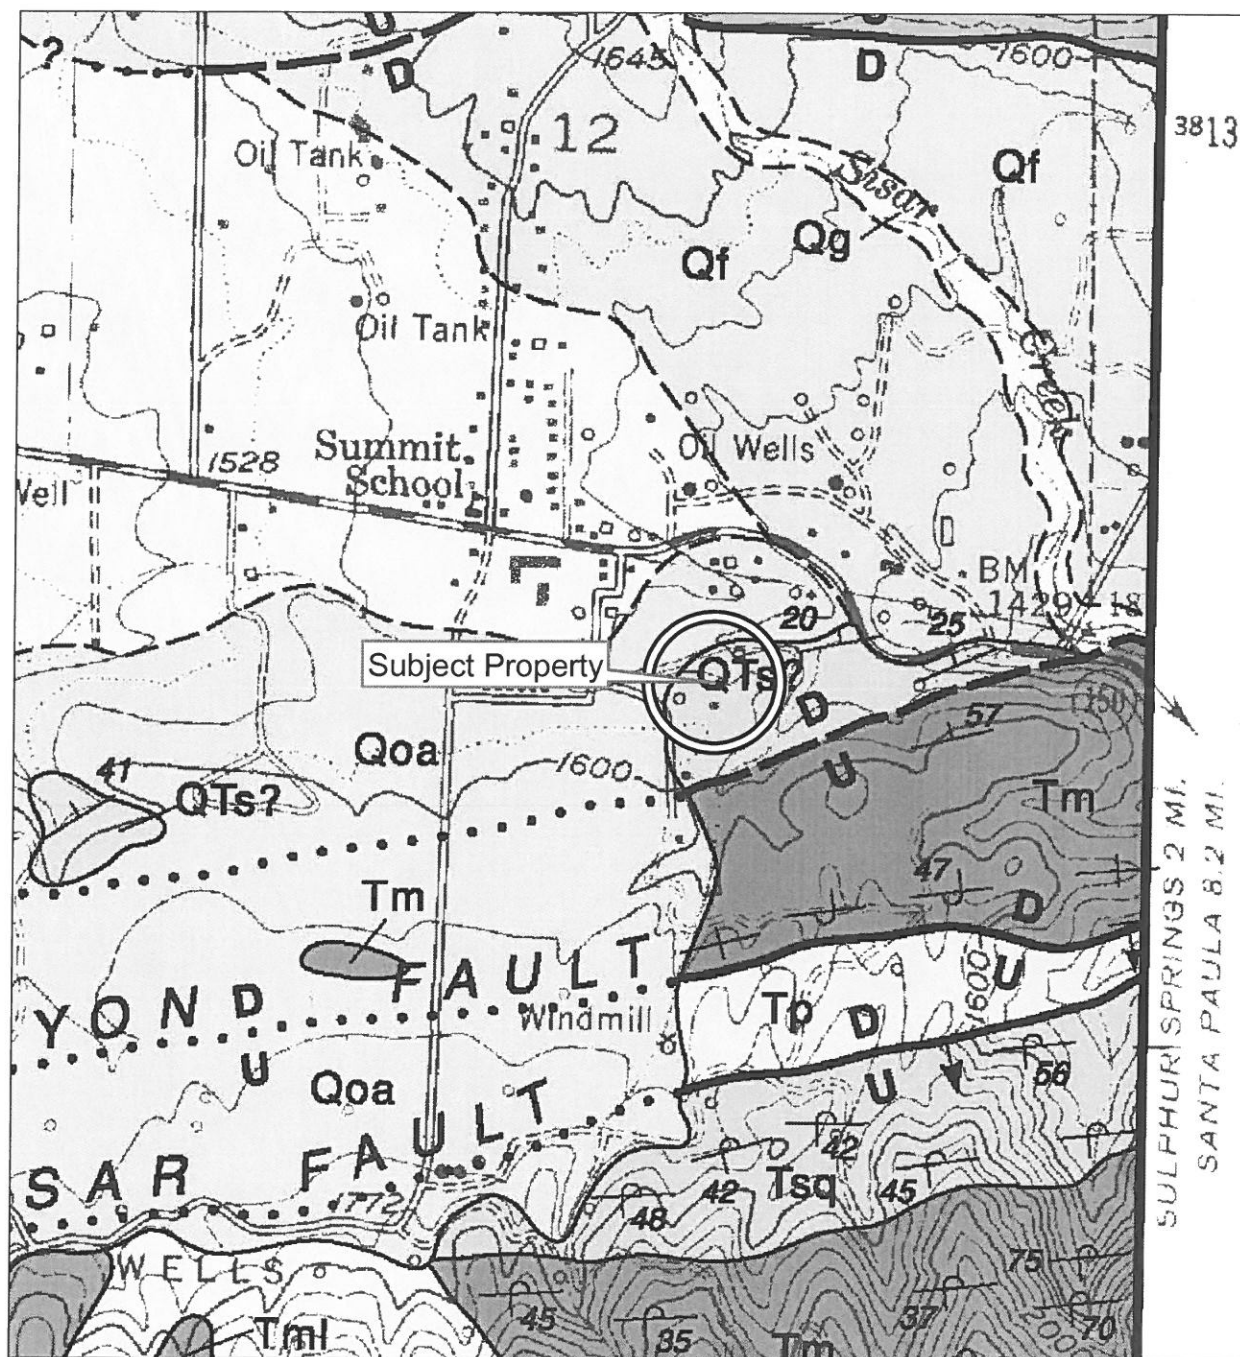
Subject: Vicinity Geologic Map 1
Reference: Dibblee, Ojai Quad
Scale: 1" = 1000'

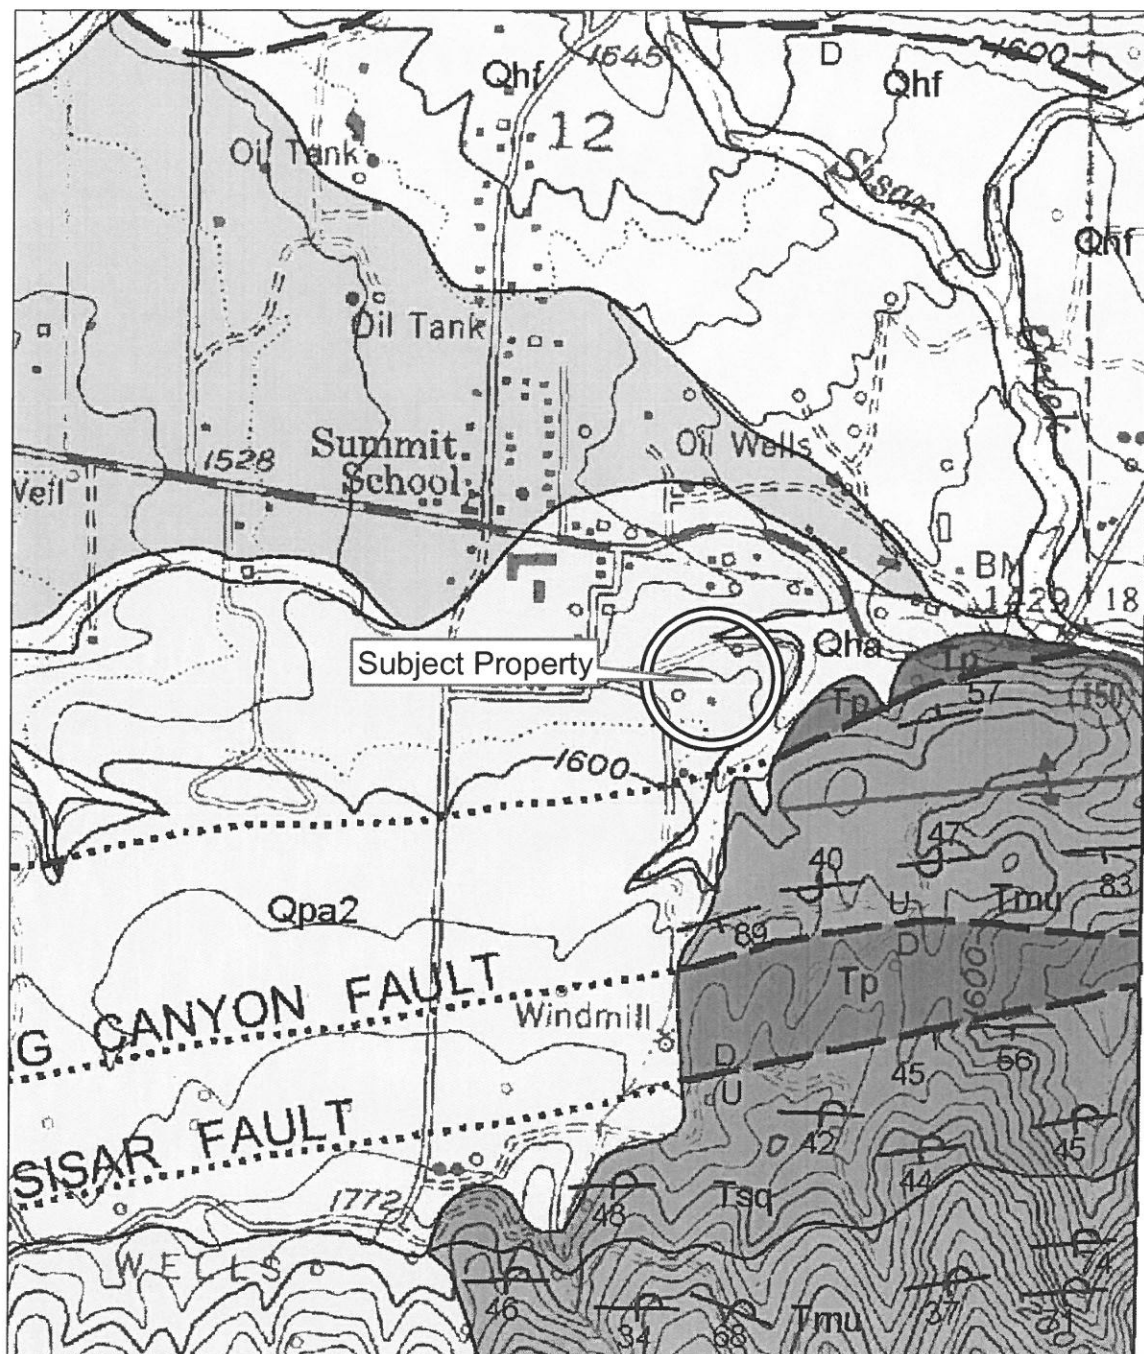
Subject: Vicinity Geologic Map 2
Reference: USGS Ojai Quad
Scale: 1" = 1000'

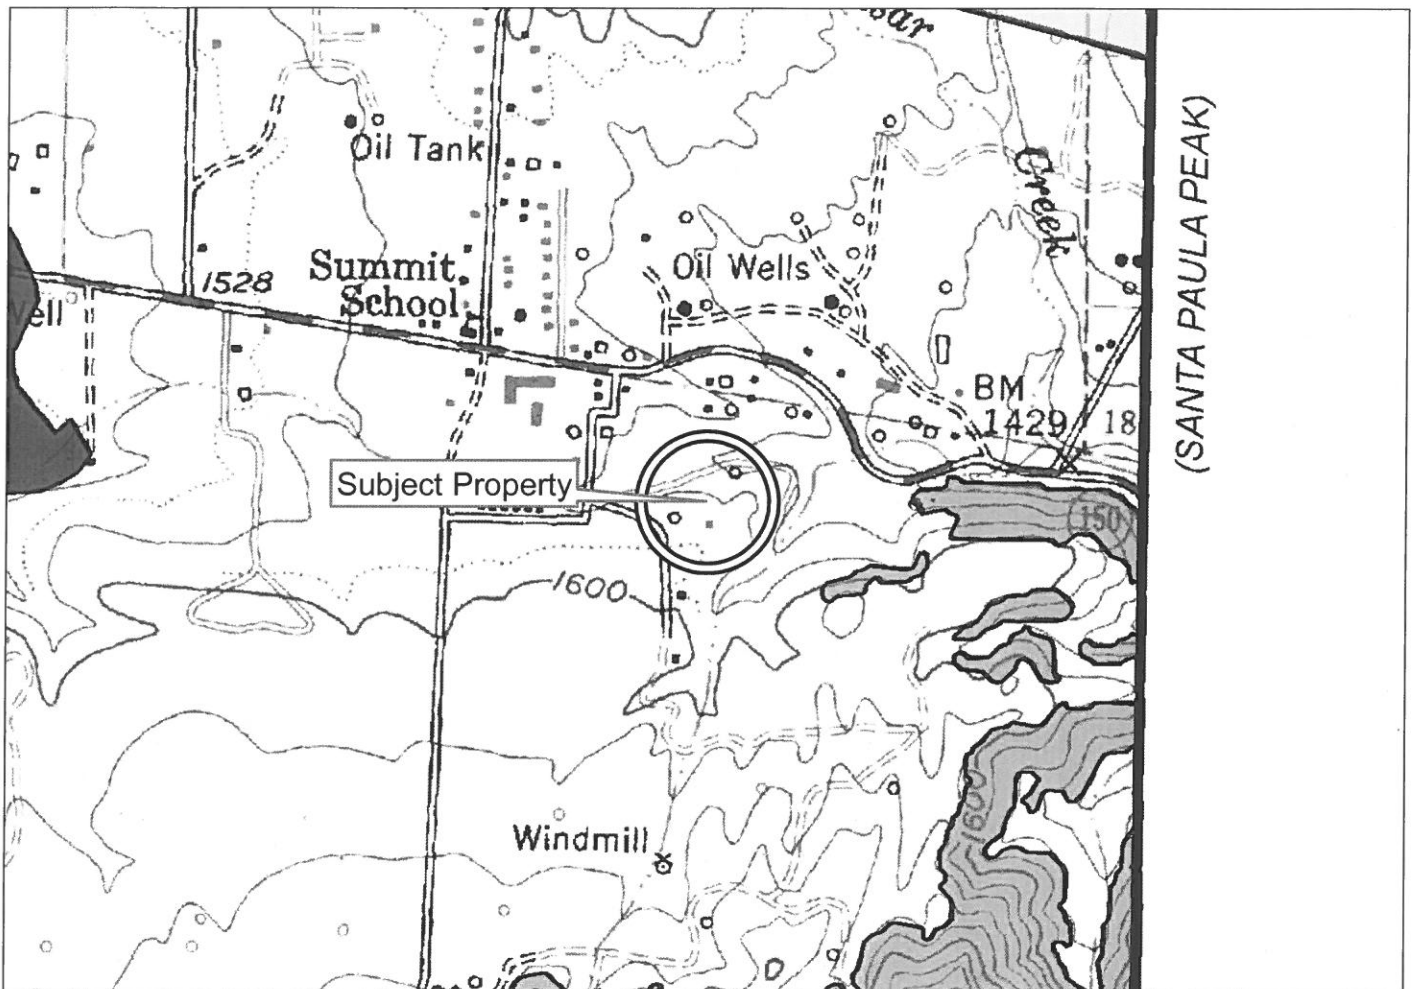
Subject: Seismic Hazard Zones Map
Reference: California Geological Survey
Scale: 1" = 1000'

Zone boundaries are delineated by straight-line segments; the boundaries define the zone encompassing active faults that constitute a potential hazard to structures from surface faulting or fault creep such that avoidance as described in Public Resources Code Section 2621.5(a) would be required.

Areas where historical occurrence of liquefaction, or local geological, geotechnical and ground water conditions indicate a potential for permanent ground displacements such that mitigation as defined in Public Resources Code Section 2693(c) would be required.

Areas where previous occurrence of landslide movement, or local topographic, geological, geotechnical and subsurface water conditions indicate a potential for permanent ground displacements such that mitigation as defined in Public Resources Code Section 2693(c) would be required.

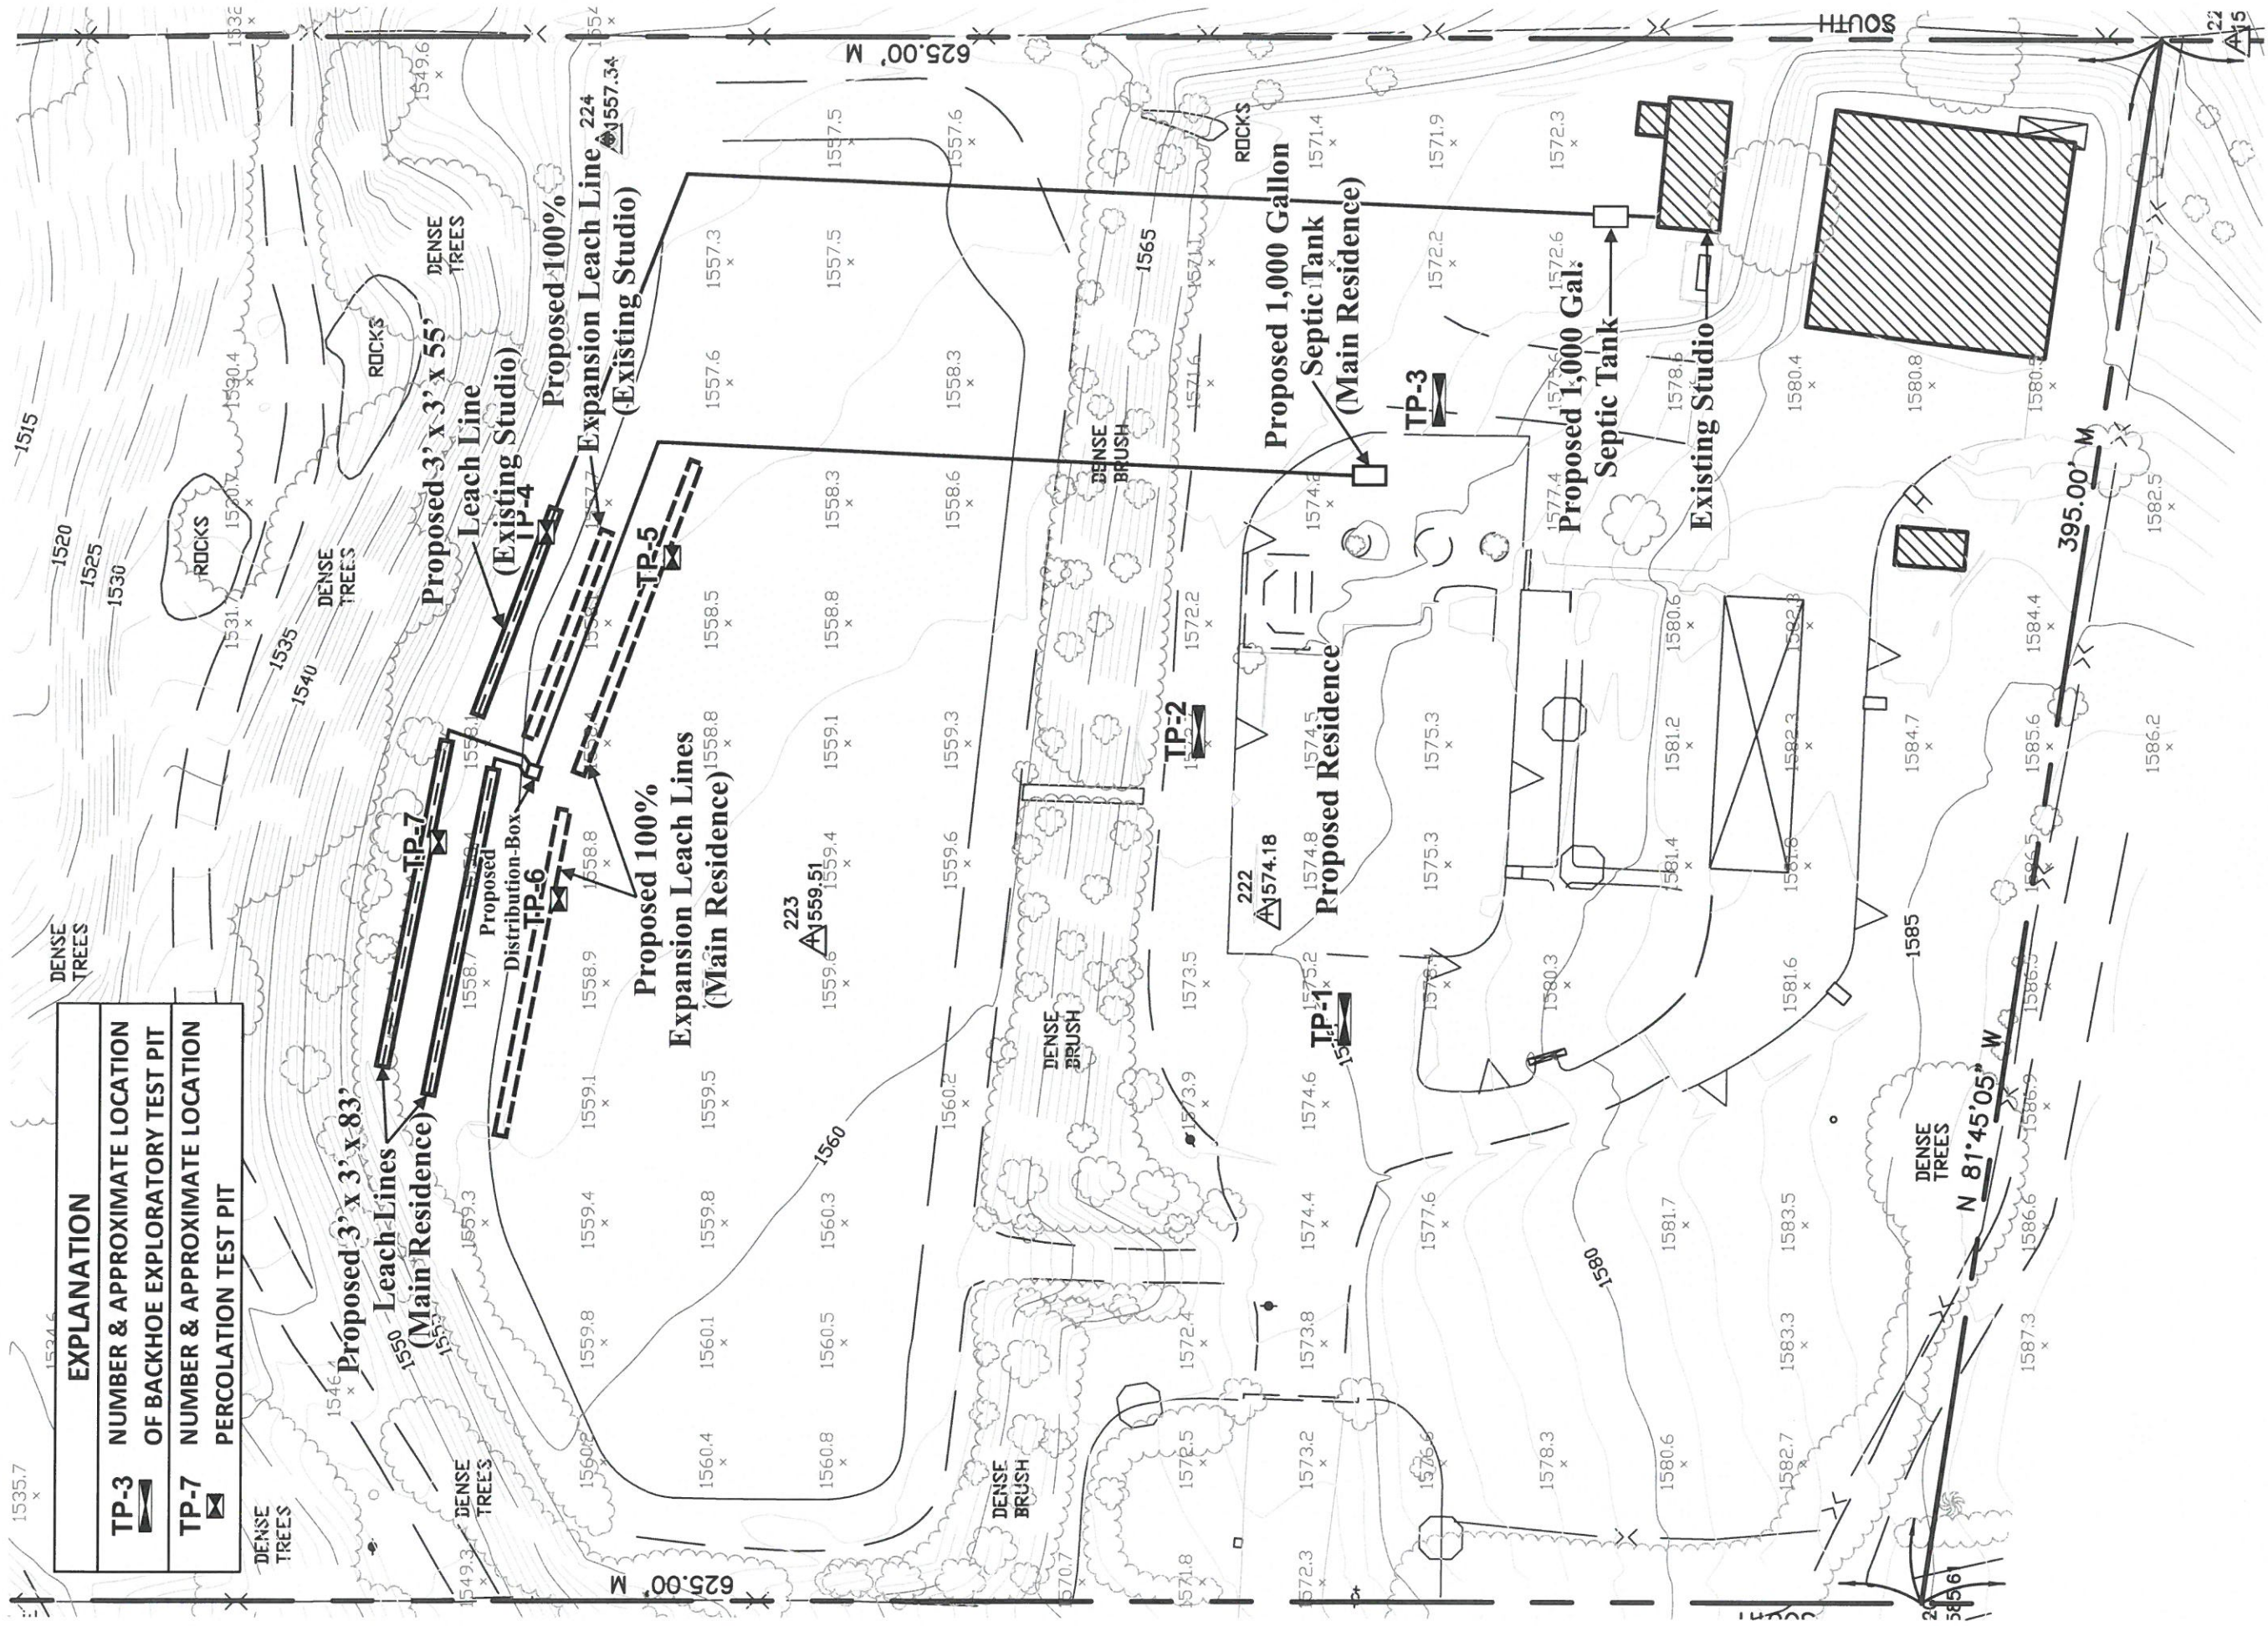
EXPLANATION	
TP-3	NUMBER & APPROXIMATE LOCATION OF BACKHOE EXPLORATORY TEST PIT
TP-7	NUMBER & APPROXIMATE LOCATION PERCOLATION TEST PIT

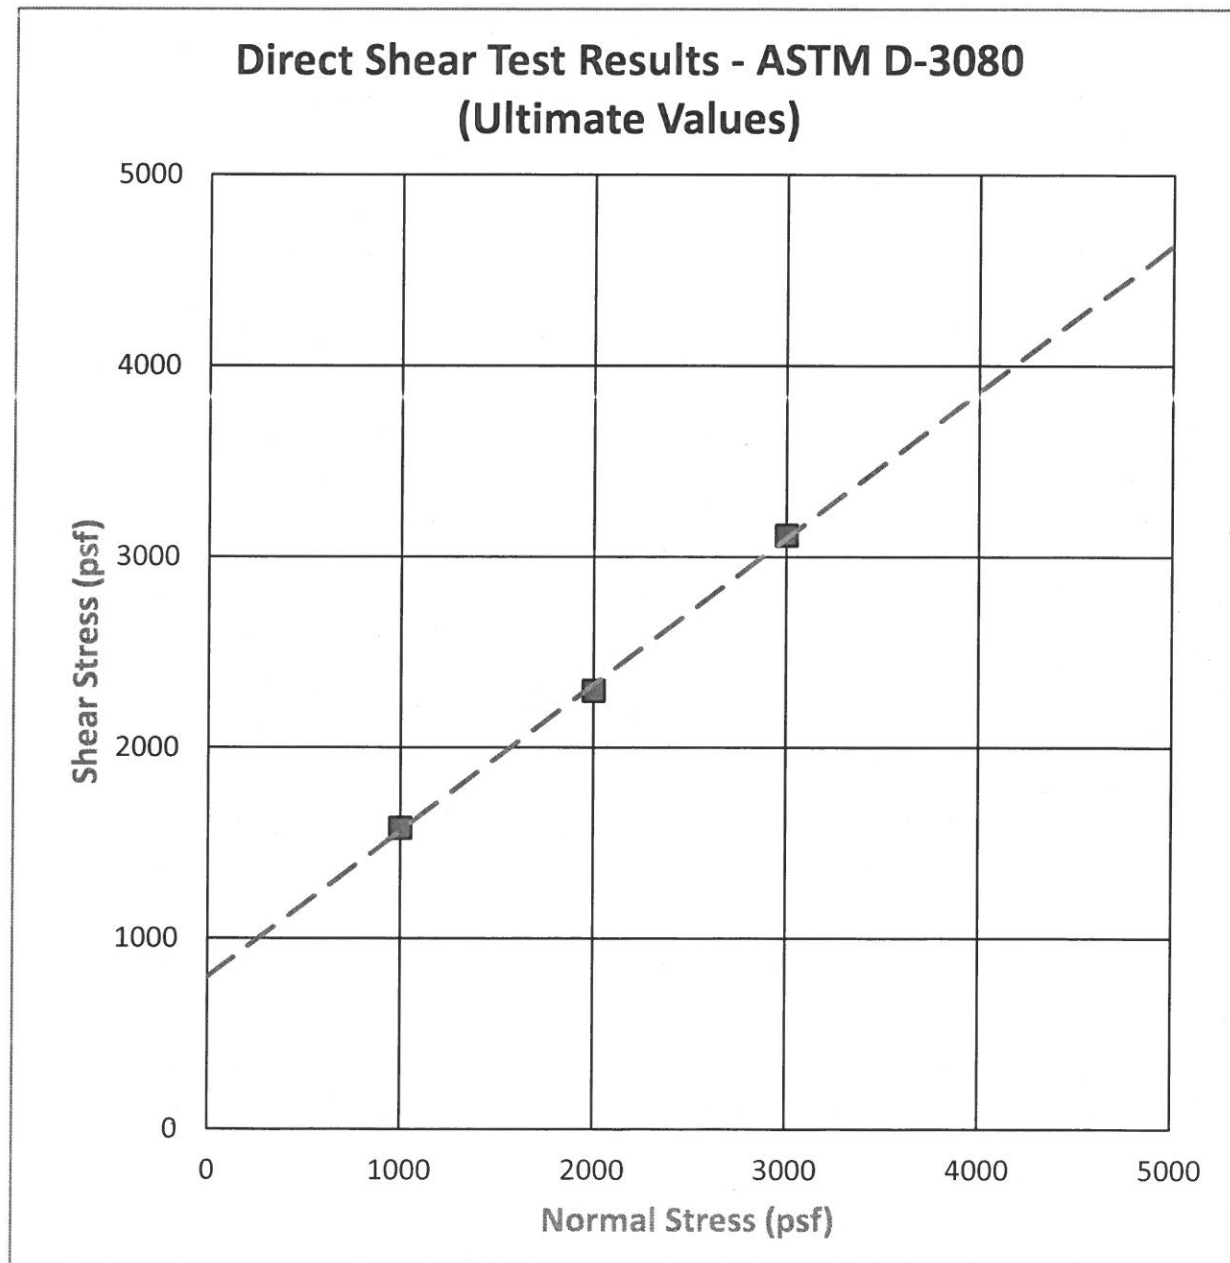
SHEAR DIAGRAM S-1

Cohesion: 797.0 (psf)
Phi Angle: 37.5°
Shear Rate: 0.05 in/min

Initial Moisture Content: 15.1 %
Dry Density: 107.9 (pcf)
Degree of Saturation: 98.3 %

DS SS-434-S Mircetic TP-3 @ 5'.HSDN - DS Test

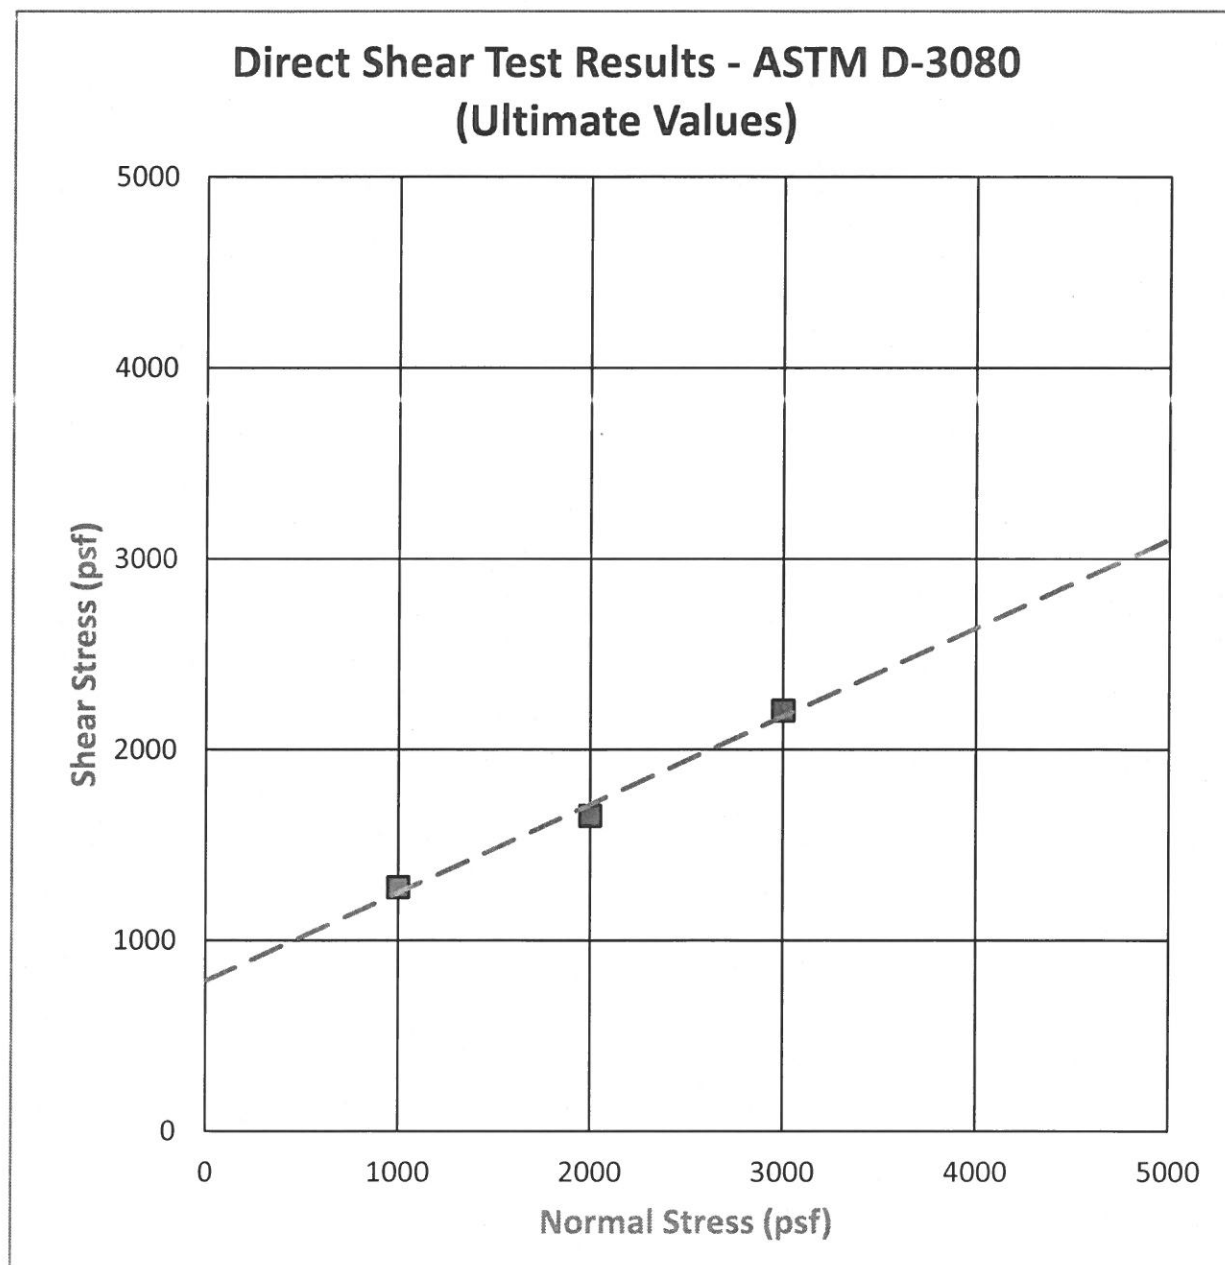
SHEAR DIAGRAM S-2

Phi Angle: 24.8°

Shear Rate: 0.05 in/min

DS SS-434-S Mercetic Composite @ 0-5'.HSDN - DS Test

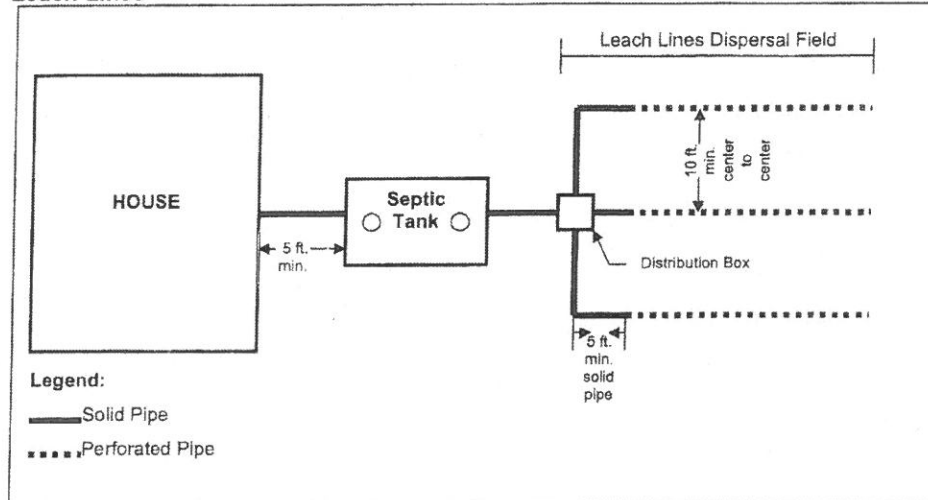
Leach Lines

Typical Septic Tank System with Conventional Dispersal Field

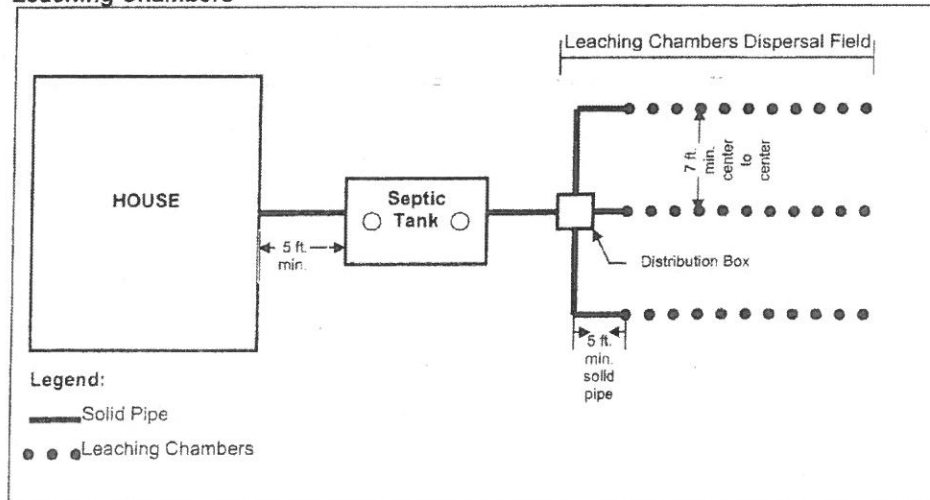
Leaching Chambers

Typical Septic Tank System with Conventional Dispersal Field

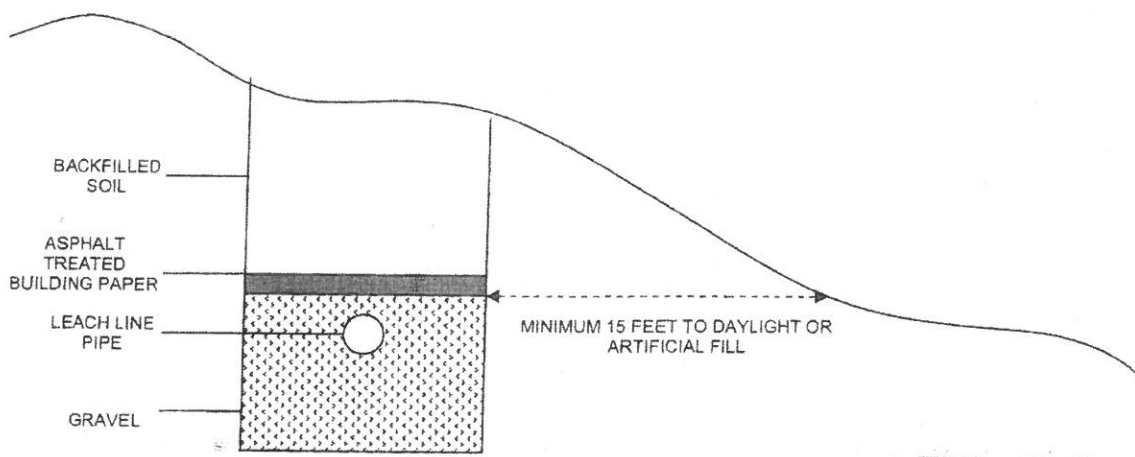
Leach Line Horizontal Setback from Daylight
