Hydrologic Considerations of CUP PL 13-050

Drill Site No. 7 – Ferndale Lease, Ojai Oil Field

County of Ventura Board of Supervisors Hearing - October 20, 2015

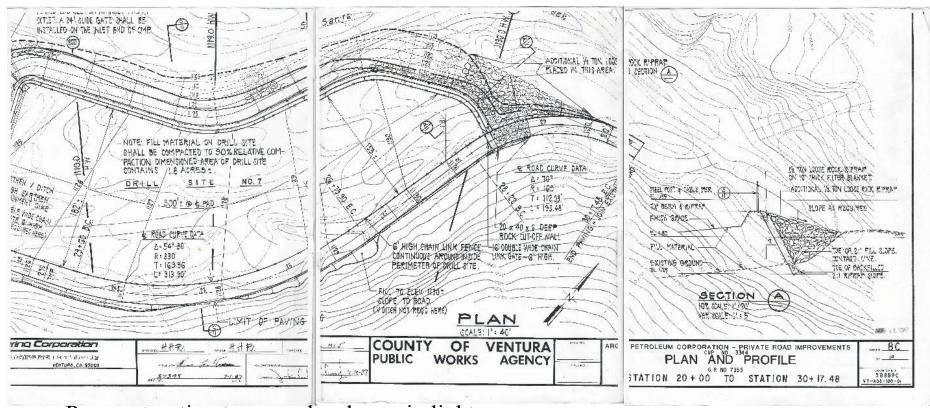
Plan & Profile CUP No. 3344

- Preconstruction topography shown in light gray
- Shows Drill Site 7 (DS7) was built within the Santa Paula Creek channel
- 20 ft (west end) to 5 ft (east end) of fill material
- Percolation downward into channel
- Lateral flow off DS7 into channel
- Contaminants are carried with water and sediment

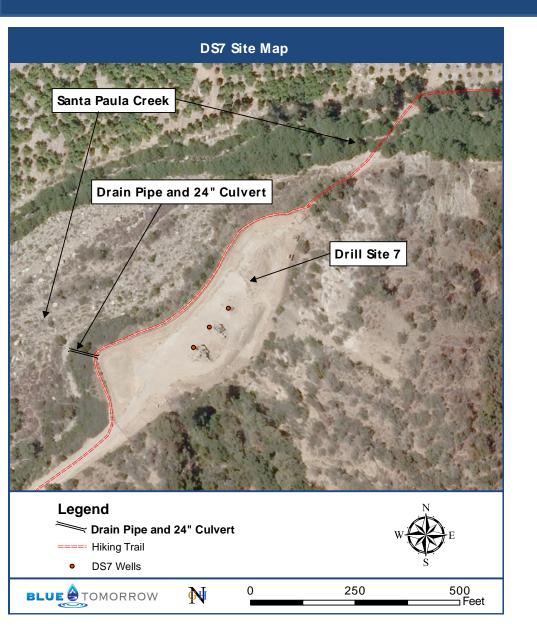
Current Site Facilities

- 24" culvert discharges directly into Santa Paula Creek
- 3 existing wells:2 currently with pumps; 1 idle
- Cement cellar at each well
- Pipes to convey oil from site to off-site facilities
- Berm and fence, access road

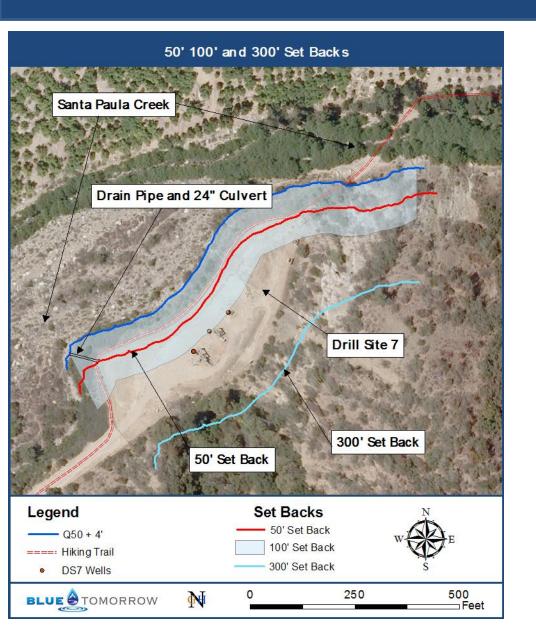
New Wells & Facilities Within Setback

- VCWPD designated Santa Paula
 Creek a "red line" creek, 300' set back
- USGS 2000' scale shows Santa Paula Creek as a "blue line" creek, 100' set back
- In no case shall facilities be within 50' of channel
- Existing facilities are within 50 ft of Q50 + 4' boundary

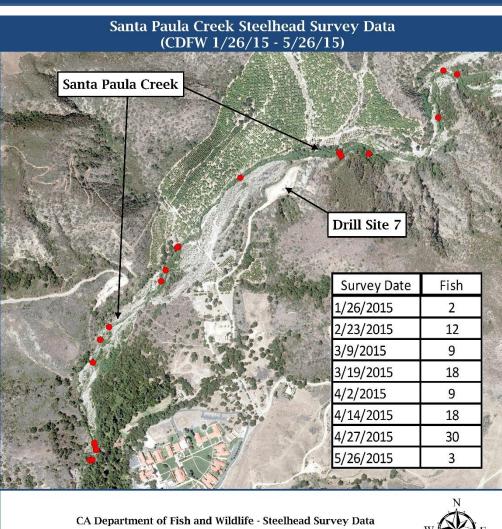
Endangered Steelhead by Drill Site 7

- CDFW rescued 112 steelhead near DS7 on September 4 & 11, 2014
