Technical Memorandum Re: Crestview Mutual Water Company Alternatives Siting Study for New Well

This alternatives siting study was prepared to review, consider, and evaluate each of the alternative sites for possible construction of Well #7. This report presents each alternative site and evaluates each possible location. **Based on the siting criteria, the operational characteristics of Crestview's system, and the existing regulatory parameters, 191 Alviso Drive is the most reasonable, responsible and viable location for the new Well #7 production facility.**

WELL 7 SITE
ALTERNATIVES EXHIBIT

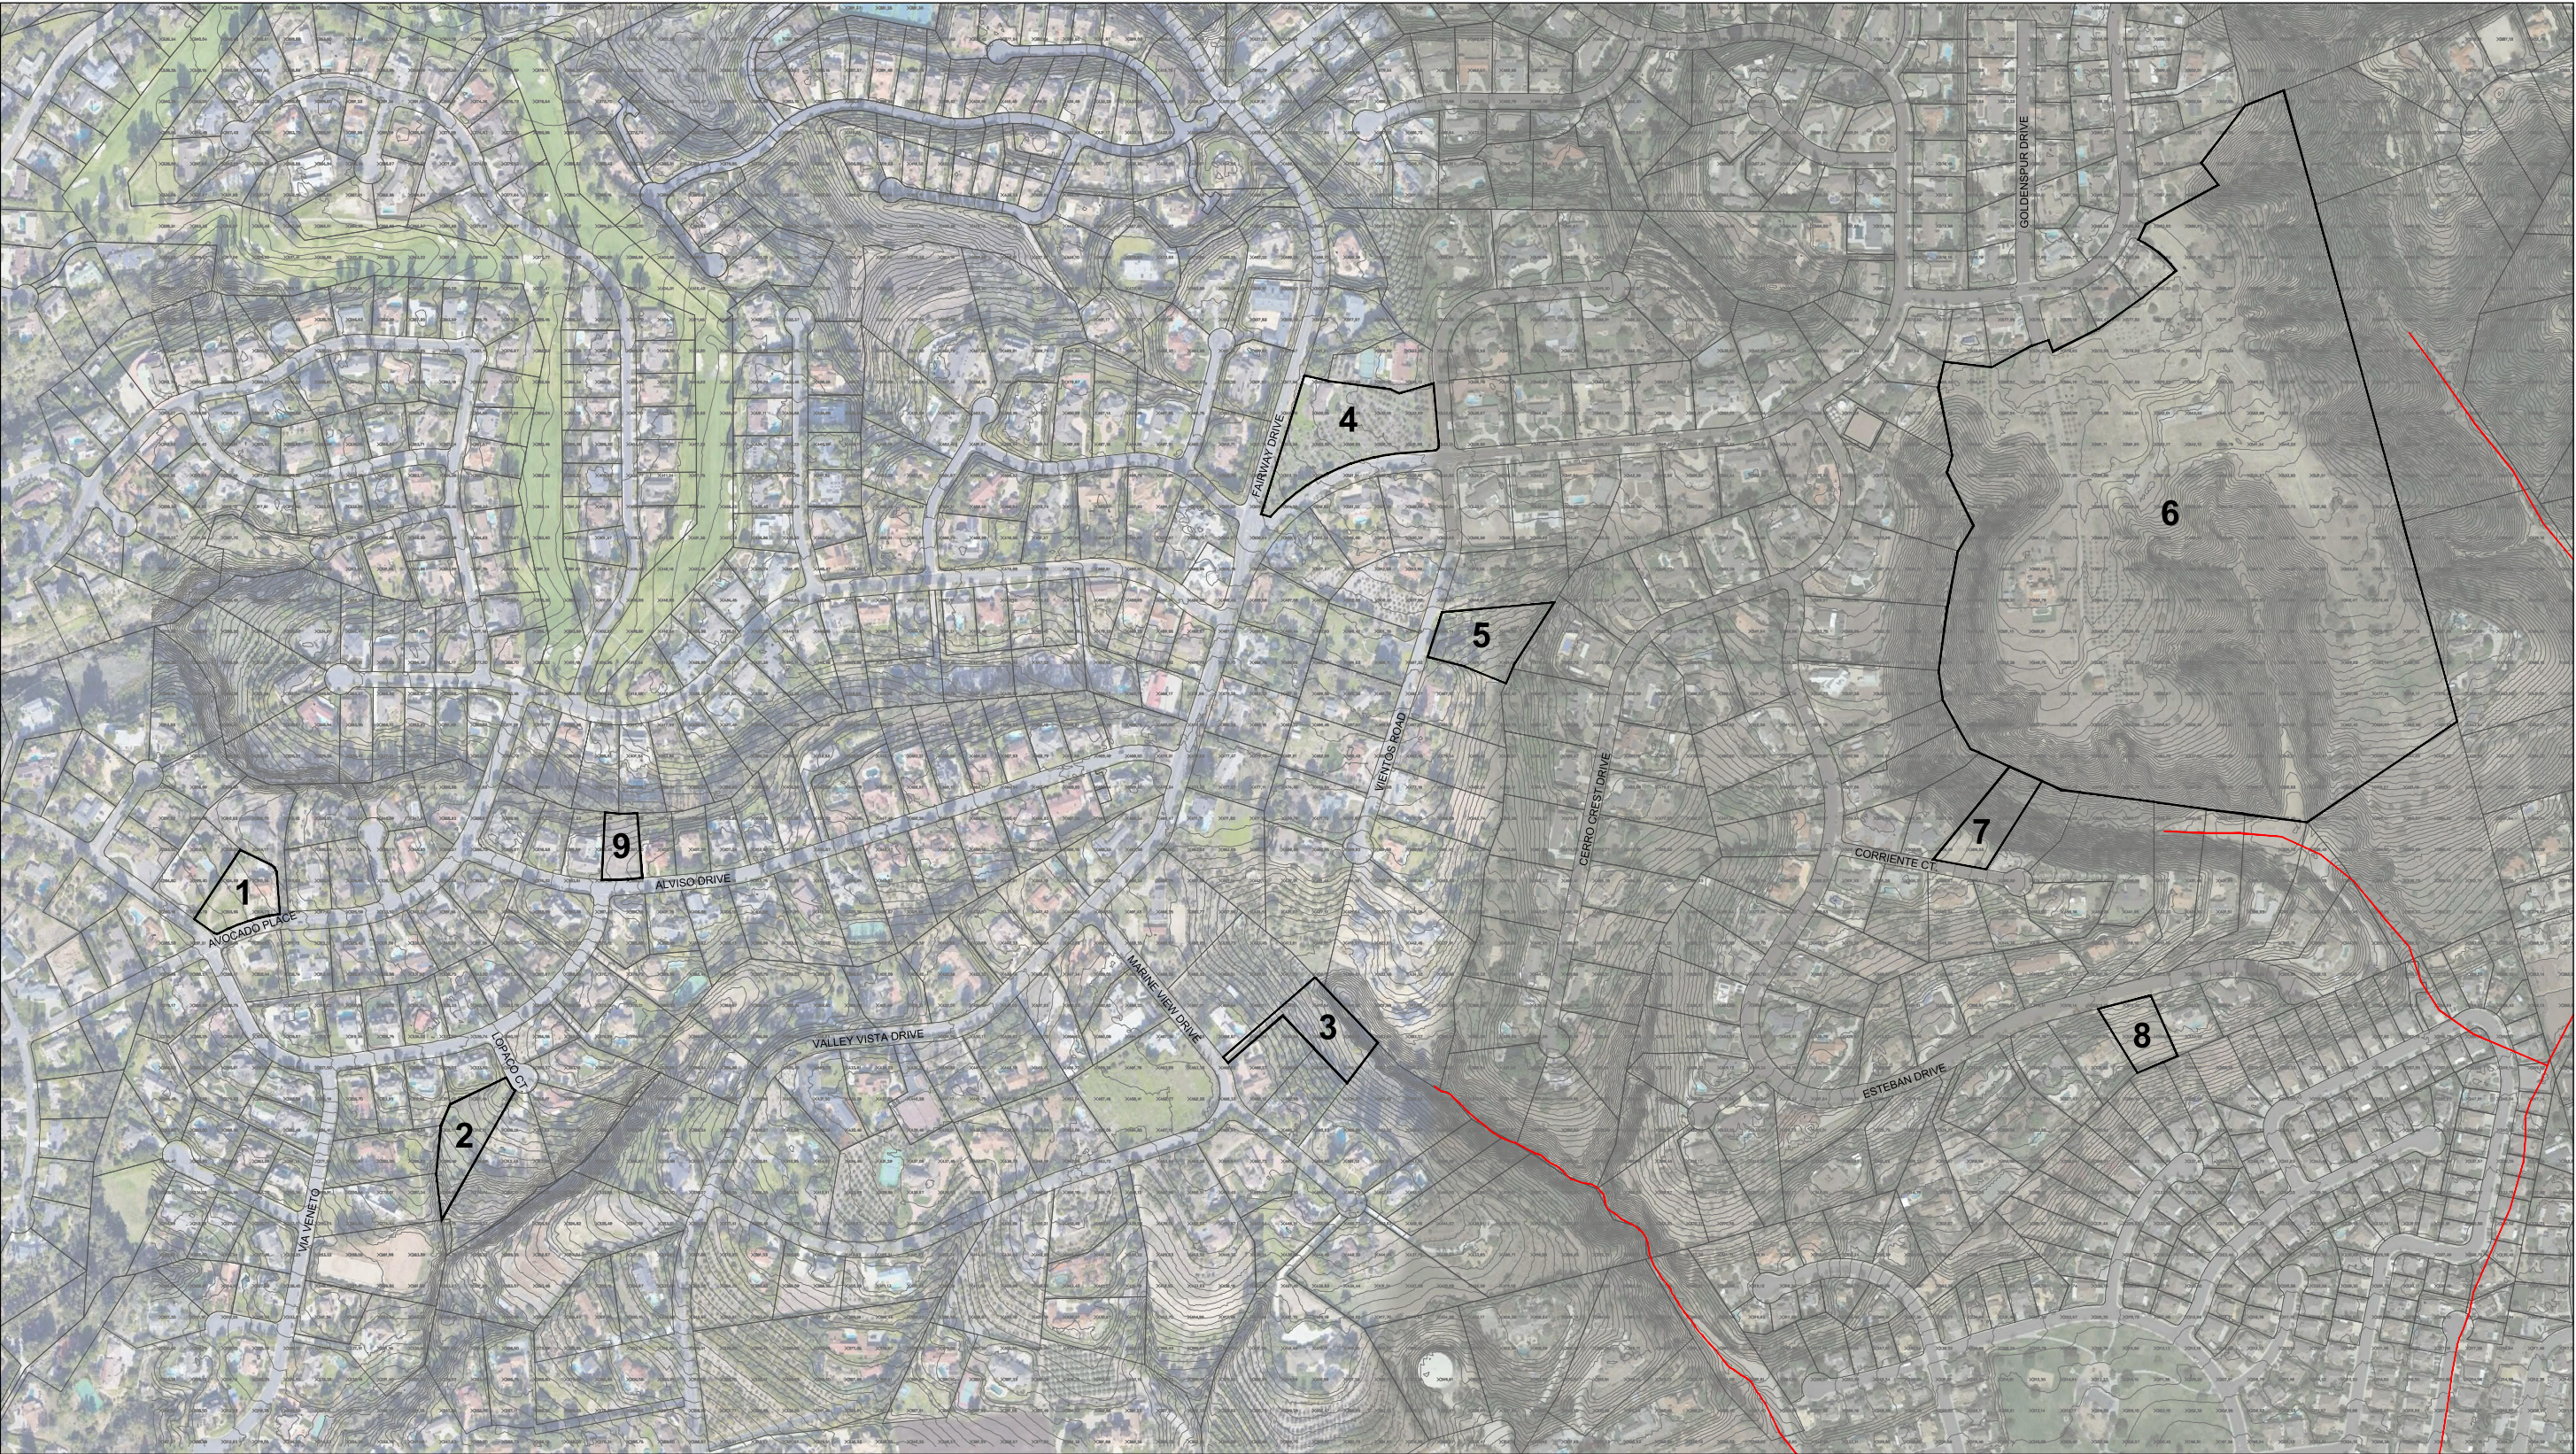
#	ADDRESS	APN	ACERAGE
1	489 AVOCADO PL.	152-0-050-165	1.00
2	82 LOPACO CT.	152-0-352-055	1.14
3	191 MARINE VIEW DR.	152-0-110-015	1.27
4	640 FAIRWAY DR.	152-0-062-185	3.00
5	64 VIENTOS RD.	152-0-061-295	1.38
6	2711 GOLDENSPUR DR.	158-0-020-065	57.15
7	651 CORRIENTE CT.	158-0-091-055	1.12
8	167 ESTABAN DR.	158-0-110-065	0.81
9	191 ALVISO DR.	152-0-341-065	0.56

1. Attachment 1 – Well 7 Site Alternatives Exhibit
2. Attachment 2 – Site Suitability Matrix
3. Attachment 3 – Countyview Printouts Alternative Sites 1 through 9
4. Attachment 4 – Department of Water Resources Water Well Drillers Report
June 21, 1984 by Floyd V. Wells, Inc.
