GOLD COAST GEOSERVICES, INC.

SUBJECT: Updated Stability Analysis for Ojai Quarry, Mine ID #91-56-0025,
Ojai, County of Ventura.

County of Ventura Planning Commission Hearing Case No. PL18-0136 Exhibit 3d - Slope Stability Analysis

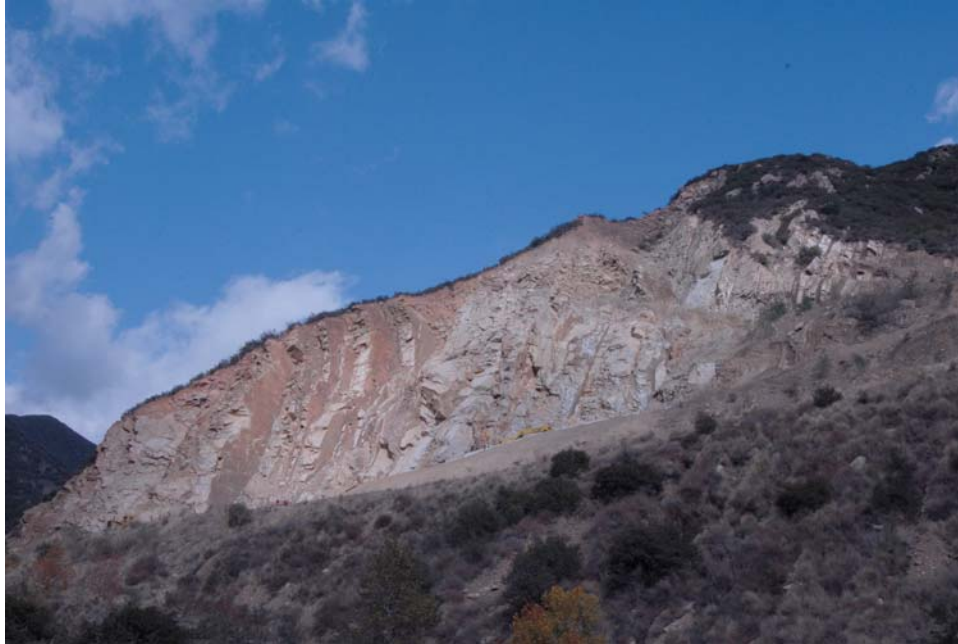
Photo 1: The northern part of the quarry, Domain A (looking north).

Domain A is located at the northern side of the quarry (Photo 1). It consists of thick (3 to 30 feet) sandstone beds and thin siltstone beds (most under 1 foot thick; Photo 3). It appears to contain two fining upward sequences (from north to south), each about 150 feet thick. The upper part of each sequence contains thicker and more numerous siltstone beds while the basal part contains thick sandstone beds with scattered, thin siltstone beds. Domain B is a narrow zone (~100 ft wide) near the middle of the quarry (Photos 2 and 4). It consists mainly of siltstone beds less than 1 inch wide with occasional sandstone beds up to a few feet wide. It is more erodable than the other domains and forms a broad gully that extends up and down the slope. The siltstones are easily broken apart with a rock hammer (and sometimes by hand) and can be excavated with machinery. Domain C is located at the southern side of the quarry (Photos 2 and 5). It consists of massive sandstone units with few, thin siltstone beds. It is about 200 feet thick. In this area, bedding can be difficult to identify even in fresh exposures. At the ground surface, these sandstones erode into large boulders.

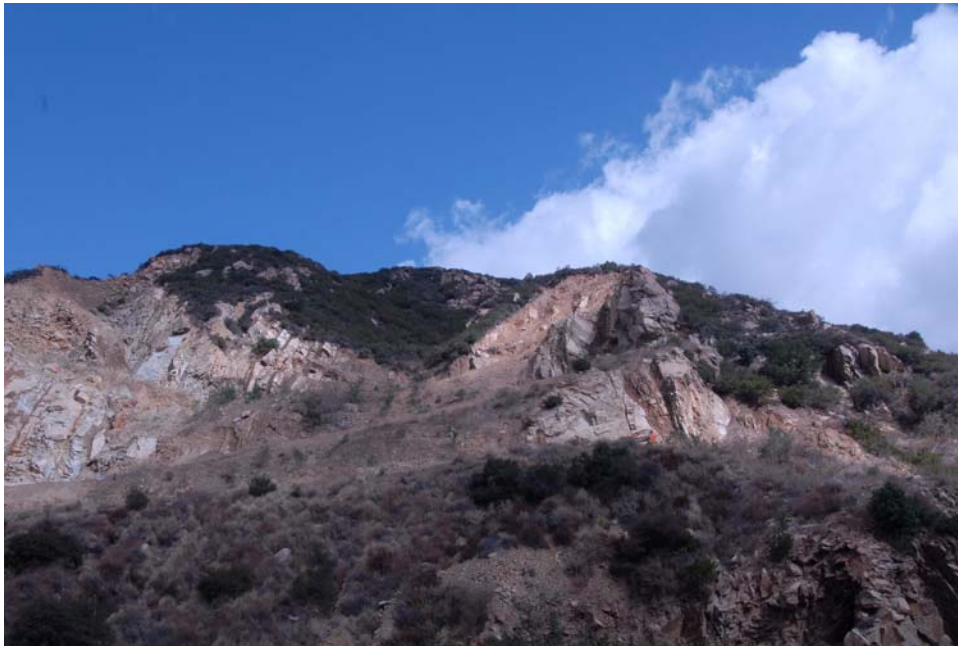
Photo 2: The southern part of the quarry (looking east). Siltstone beds of Domain B form the valley in the upper part of the photograph. Domain C sandstones are being mined in the area to the right.

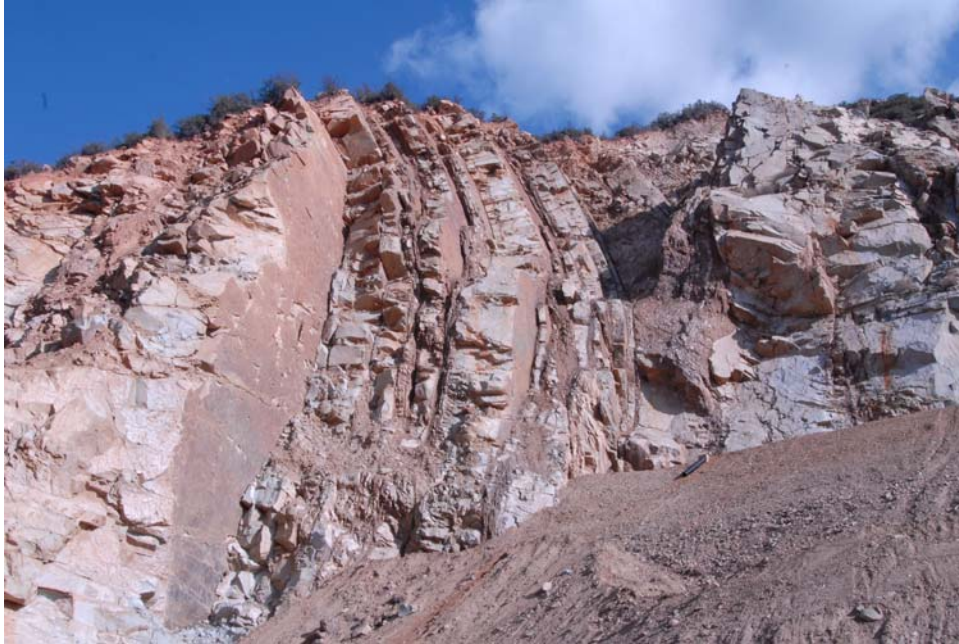
Photo 3: Sandstone beds at the northern end of the quarry (Domain A). There are thin siltstone beds between most of the sandstone beds. Even though jointing is pervasive, few joints extend across multiple beds.

In the quarry, the Matilija formation consists of interbedded sandstones and siltstones (Photo 3). Sandstone beds vary from a foot or so thick to massive beds more than 30 feet thick. The sandstones are fine- to coarse-grained and contain few obvious depositional features. The siltstones are thin bedded (an inch or less) and form zones a few inches thick to more than 20 feet thick. The sandstones are light brown in color while the siltstones are dark brown (blackish looking). The sandstones are hard enough that they have to be blasted.

We observed bedding plane slip (a fault) in the middle of Domain A (Photos 3 and 8). The upper part of this fault appeared to widen out into a triangular shape at the base of the triangle zone. The structural relationship between this fault and the triangle zone is unknown.

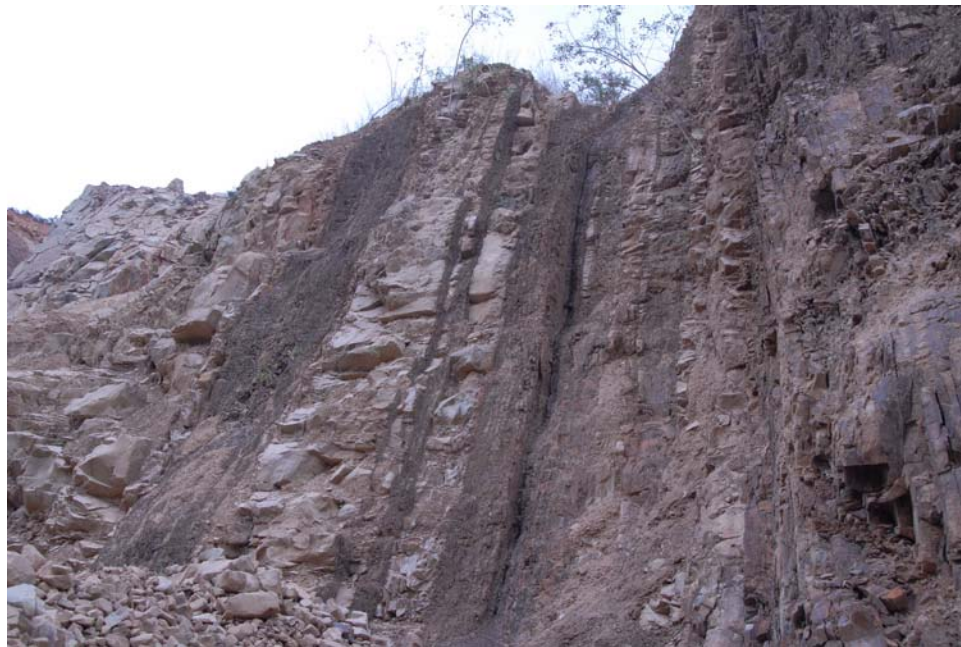
Photo 4: The siltstone beds in Domain B. Note the interbedding of siltstone and sandstone.

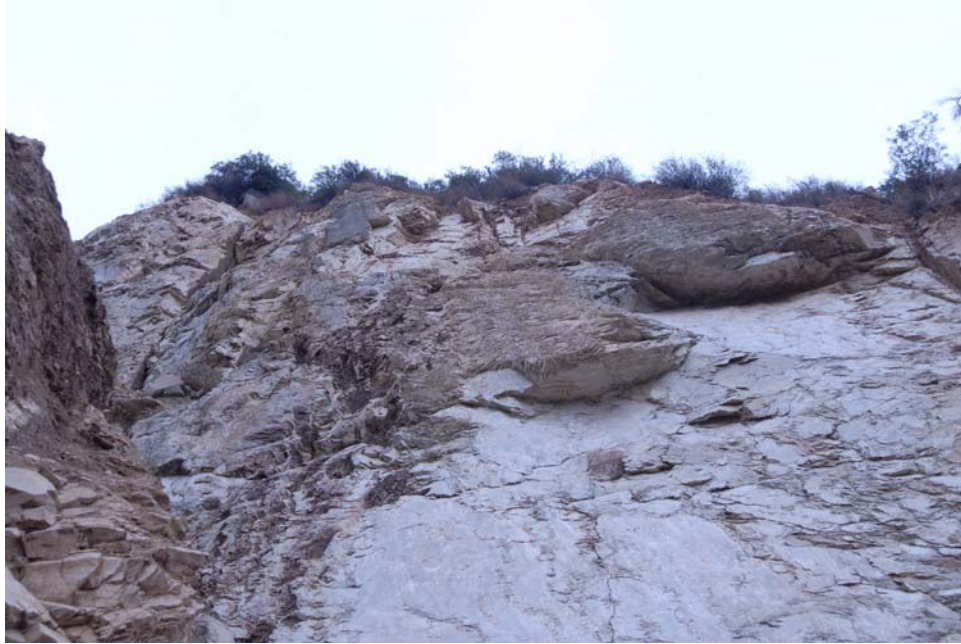
Photo 7: The fault plane at the top of the quarry. This is a naturally occurring gully. It has not been mined. The triangle zone (Photo 6) is located just to the left of this photograph.

We observed a fault at the upper part of Domain A (above bench 3, Photo 7). The fault is exposed in a naturally occurring gully that existed prior to any quarrying. The strike and dip of the fault is N25W 55SW. About 200 feet of the fault plane exposed in a gully. The gully is 20 to 30 feet deep and the fault plane forms the south side of the gully. We do not know the uphill extension of the fault. The fault could be traced down into the upper road (part of bench 3) that

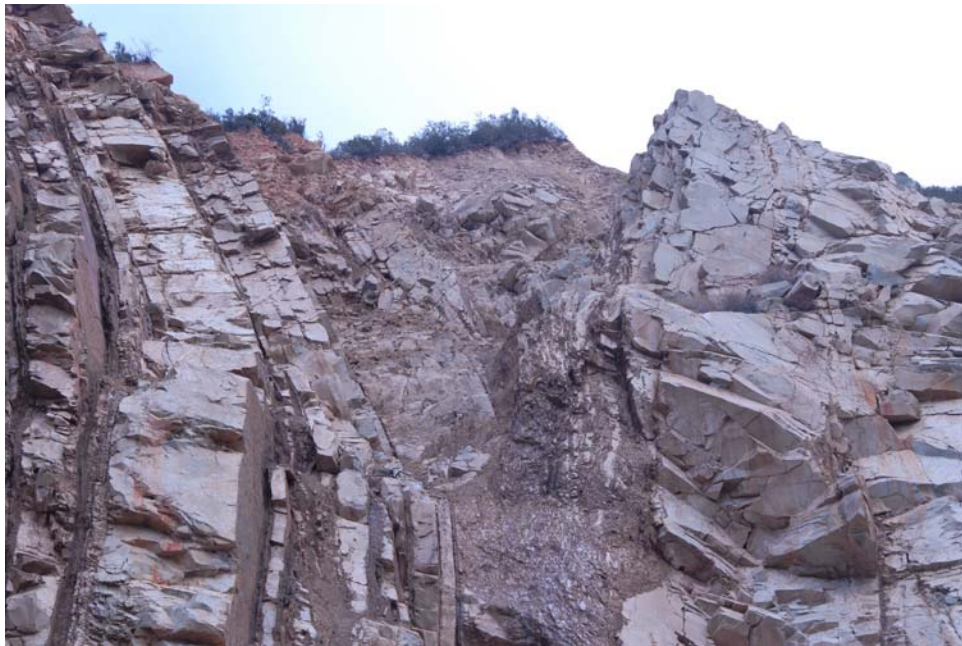
Photo 8: A fault zone in the upper part of Domain A (triangle shape). The Triangle Zone (Photo 6) is located up-slope of this area.

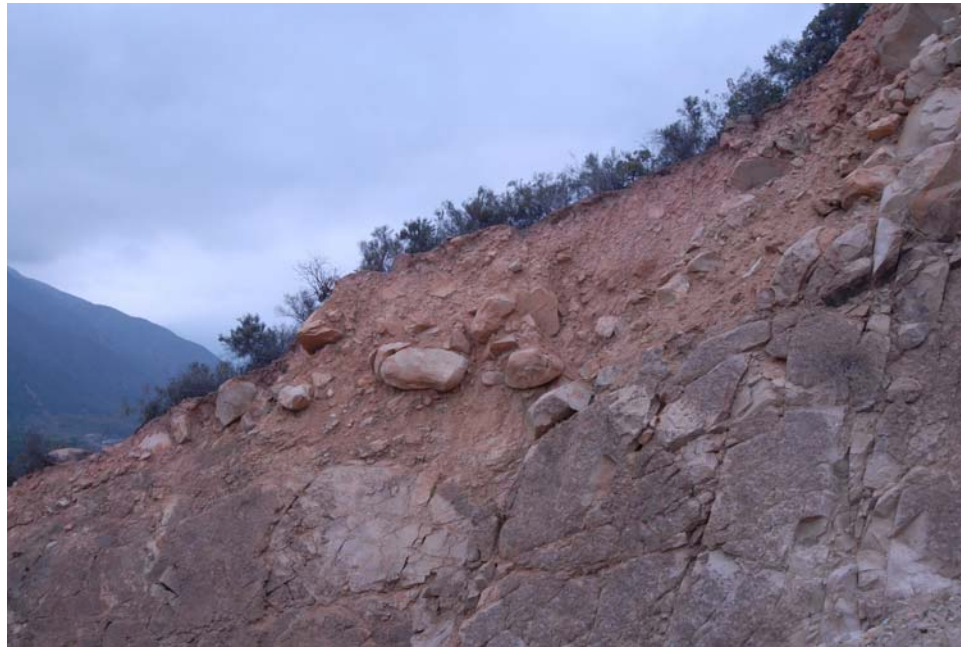
Photo 9: A typical weathering profile above the sandstones in Domain A.

Residual soils a few feet thick overlie bedded sandstones and siltstones in Domains A and B. In the fractured rock (sub-domain A) and massive sandstones (Domain C), bedrock is overlain by sands and sandstone corestones forming a zone that is 10 to 50 feet thick (a saprolite¹; Photos 9). The boundaries between soil, saprolite, and bedrock are gradational, but thin. We did not observe visibly weathered bedrock even though weathering on a microscopic level exists. We did not observe obvious alteration/mineralization of bedrock. One of the weathering effects on both the sandstones and siltstones is that as weathering increases, joint spacing and persistence is reduced and joint density increases. The above descriptions are based on our visual field observations.

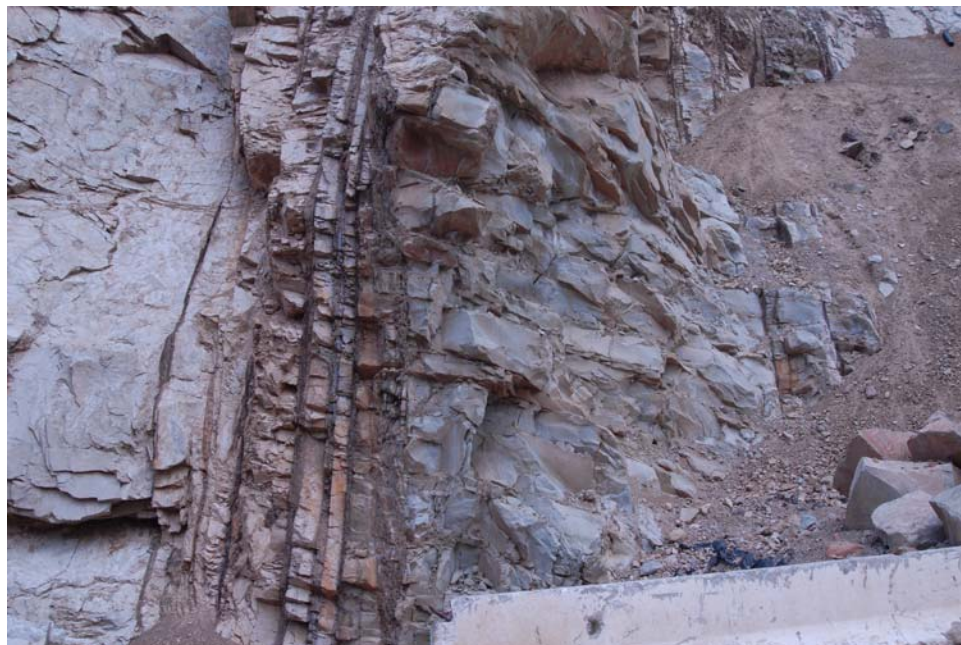
Photo 10: Jointing patterns in Domain A sandstones.

The majority of the joints are thin (most less than 1/8 inch wide to tight; Photos 5, 10, 11, and 12). Most joints were not filled, but some contained a thin fill. Occasional slickenslides were observed. Virtually all of the sandstone units have been blasted. Blasting widened many of the joints and locally increased joint density. The majority of the observed joints dipped out of the quarry faces. Most dip between 30 and 45 degrees. The dip direction of most joints is perpendicular (± 20 degrees) to the quarry face. No bedding parallel joints within the sandstones were observed. No free/flowing water was observed in the quarry. No indications of long-term, historic water flow were observed in the quarry.

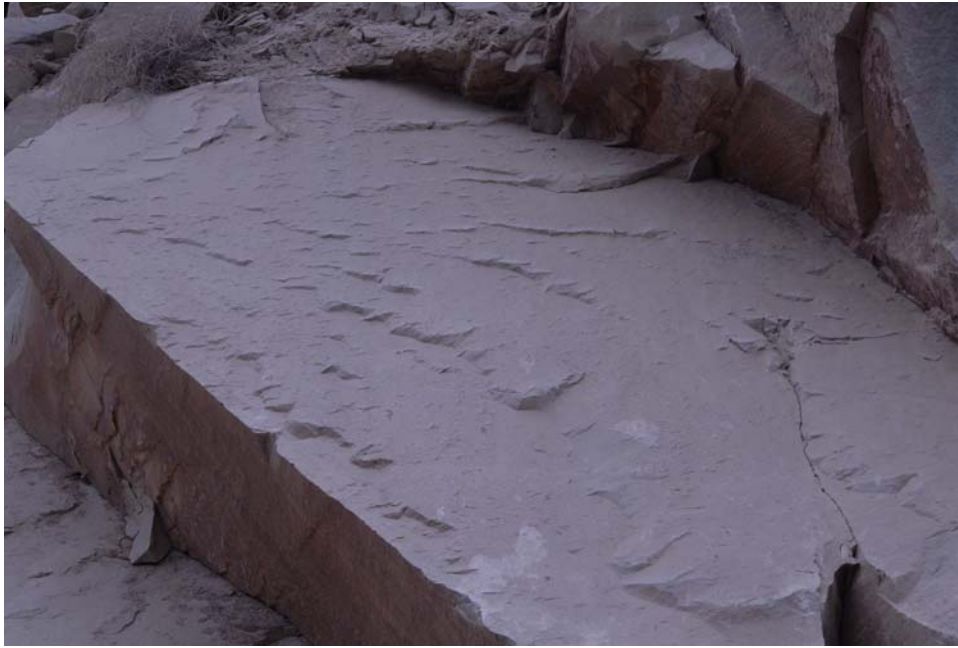
Photo 11: A joint surface in Domain C sandstones.

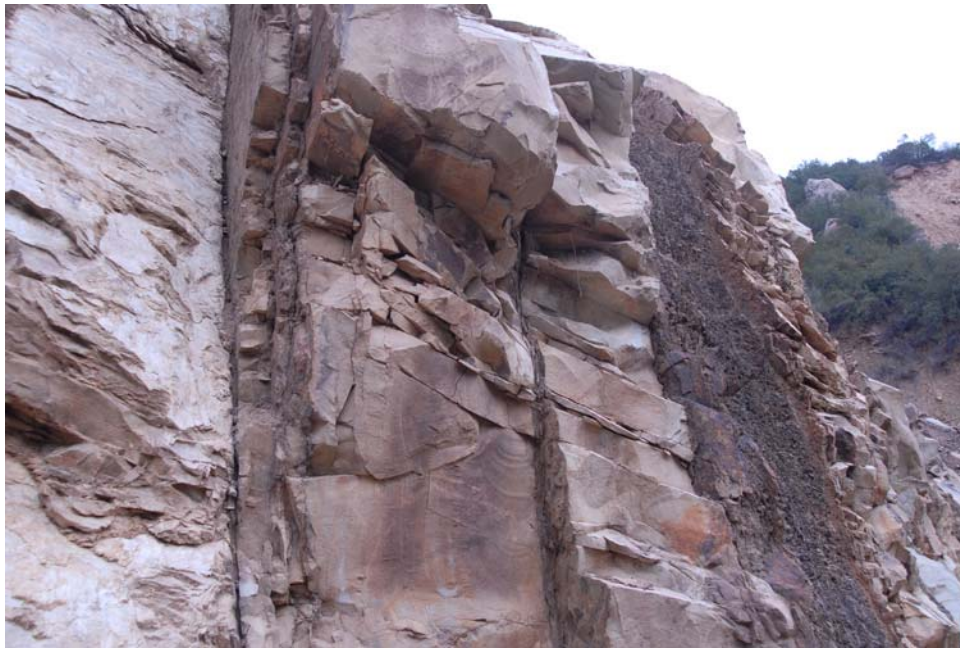
Photo 12: Jointing patterns in thicker sandstone beds in Domain A.

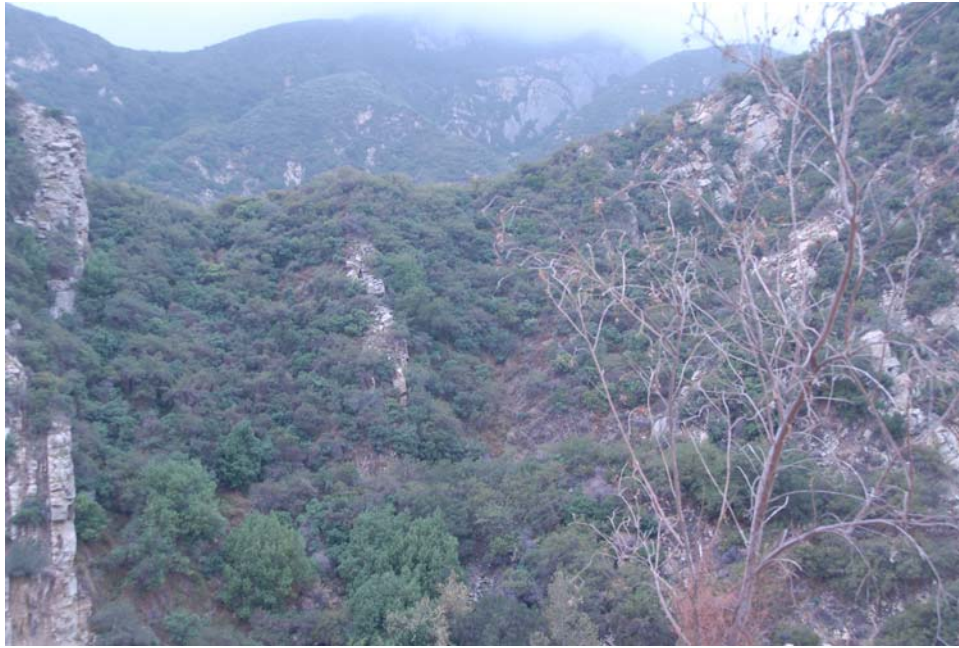
- Photo 13: The siltstone bed on the other (west) side of Rt 33 from the quarry. This bed is more than double the thickness of the siltstone bed in the quarry. This may be the result of structural thickening. The sandstones on the right have rotated about 40 degrees counter-clockwise with respect to the sandstones on the left. The sandstones on the left have a strike and dip similar to the sandstones in the quarry.
